Water Inflows at Phalen Colliery in the Sydney Coalfield and their Relation to Interaction of Workings

By P. Cain¹, D.J. Forrester¹ and R. Cooper²

ABSTRACT

5th International Mine Water Congress, Nottingham (U.K.), September 1994

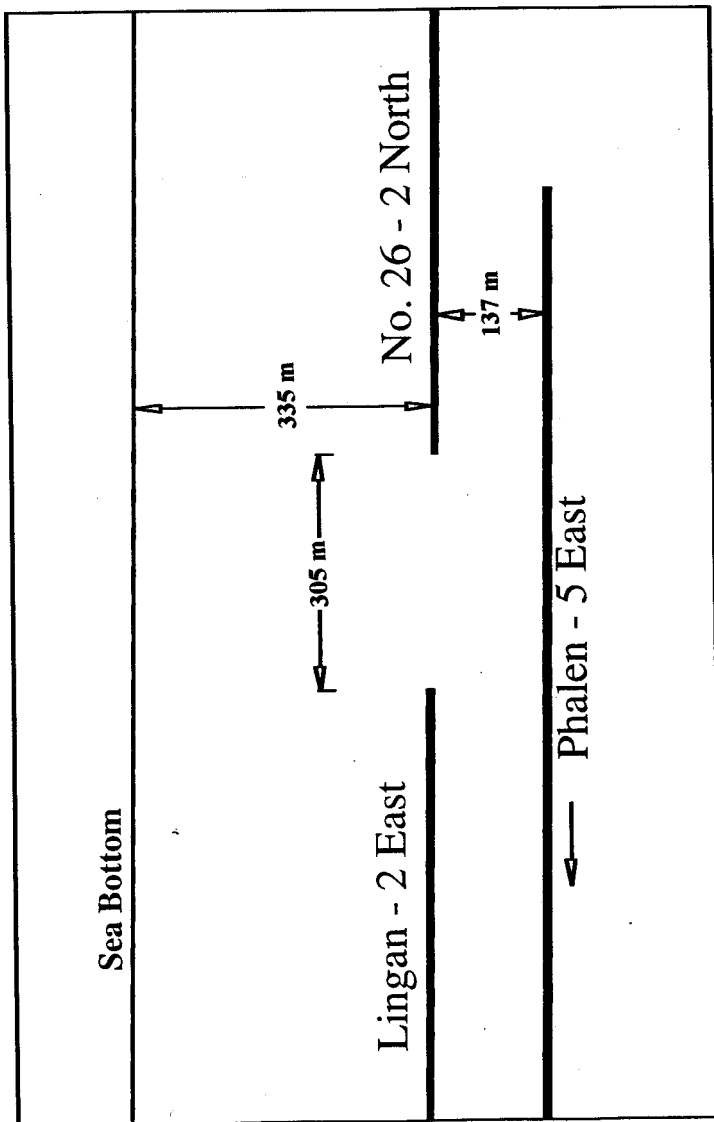
Figure 3: Profile, Harbour and Phalen Seams

In mid-October 1992, the 5 East Panel at Phalen Colliery was retreating beneath the pillar separating workings in No. 26 and Langan Colliery (Figure 3). Face workers reported 'weighting' activity in the form of a series of bumps from the roof, with associated water inflow. A number of yield valves of the powered support system needed repairs and the problem was eventually controlled and roof conditions returned to normal.

The configuration of old Harbour Seam workings which the Phalen 5 East panel underworked is shown in Figure 3. This included a barrier pillar with a minimum width of 325 m between No. 26 2 North Panel and Langan 2 East Panel. Langan 2 East Panel, which was a 180 m wide advancing longwall face in the Harbour Seam, worked between February 1975 and December 1977 and was sealed off as a sump in 1982/83.

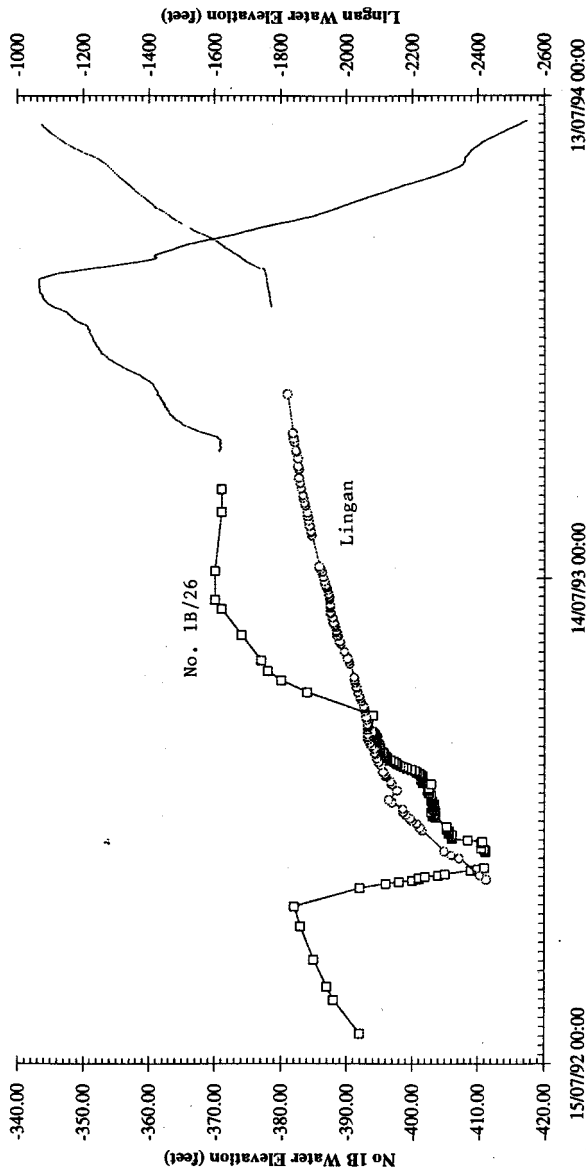
Figure 4: Water levels in No. 26/IB Shaft and at Langan Colliery, 1992 to 1994

Also at this time, water level monitoring at the No. 1B shaft revealed a drop of 1.5 m (5 ft) in the water level in the abandoned No. 26 Colliery complex. The water level continued to fall, indicating a hydraulic connection between the No. 26 and Langan Collieries. In order to try to reduce the head acting on the inflow into the Langan 2 East, pumping from the No. 1B shaft was started on November 25. The estimated capacity of this pumping system was also 4000 gpm.

The investigation of the 1992 incident started as soon as the water inflow was noticed. The investigation aim was to determine the cause and mechanism of the water flows and assess the requirements to allow safe resumption of operations. It involved CBDC staff, local and international consultants, and the CANMET CBCRL at Sydney, N.S. The key areas of investigation were: monitoring of water levels and pressures in Lingan and No. 1B/No. 26 collieries; determination of water chemistry; monitoring of interaction; empirical modelling of the caving/fracturing process above the Phalen Colliery workings; and numerical modelling of the interaction effects. Readings of water levels at the No. 1B shaft and at Lingan Colliery, as it slowly flooded, were taken with vibrating-wire piezometers and datalogging (Figure 4).

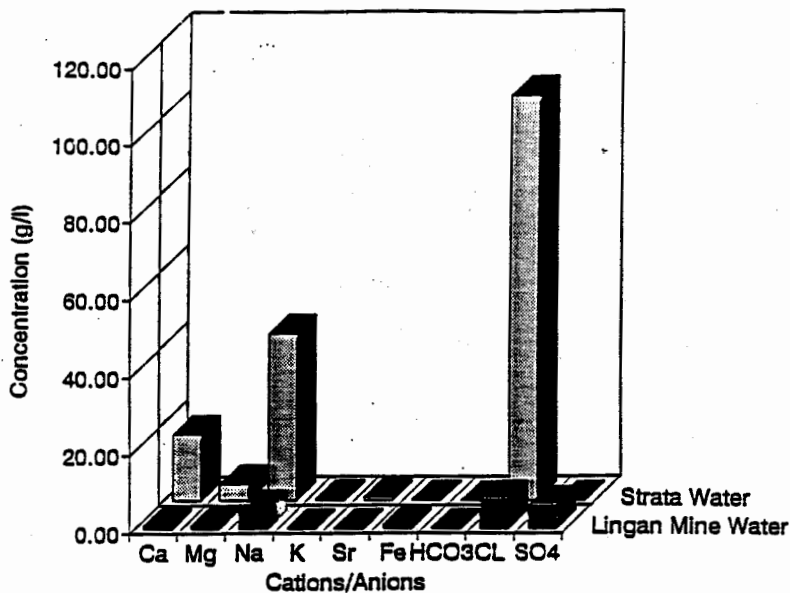
Figure 5: Typical water chemistries (after Bursey, Fracflow Consultants)

Since the November 1988 inflows, groundwater seepages and flows have been regularly sampled and tested by chemical analysis and for conductivity. The ions tested were typically, Calcium, Carbonate, Chloride, Iron, Magnesium, Potassium, Strontium, Sodium and Sulphate. From time to time special analysis for Tritium has also been carried out. Water from strata and old workings have distinctively different chemistries (Figure 5).

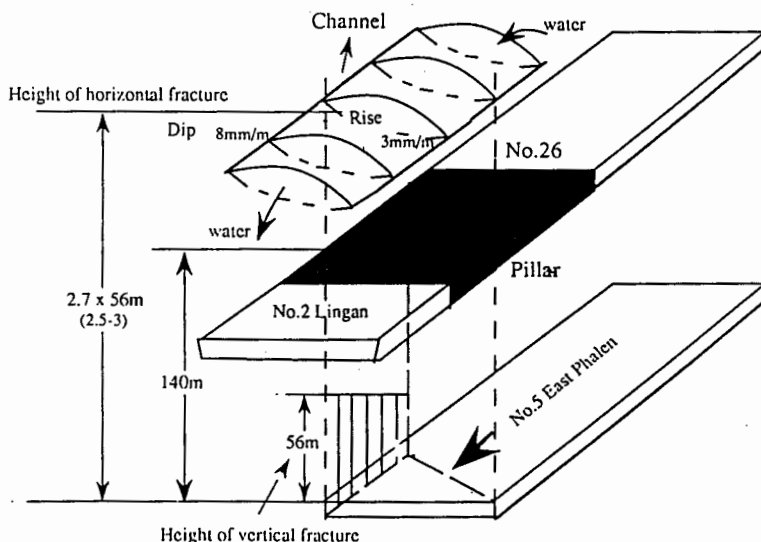
Figure 8: Possible bed separation mechanism

- as these deformations migrated upwards over time and eventually reached up to the seabed, strong strata (e.g. sandstones) bridged the larger settlements induced in weaker strata (e.g. mudstones), causing bed separation cavities to form (Figure 8);

- where these cavities formed below sandstone either just above or below the Harbour Seam in the No. 26 workings they linked, through fractures, to the flooded old workings and filled with water;

- as Phalen 5 East retreated, under but towards Lingan, these cavities formed in a continuous lateral pattern parallel to the 5 East retreat direction and remained hydraulically connected to No. 26 workings, probably above the ribsides/gob area of Phalen 5 East;

- as Phalen 5 East retreated from under the barrier pillar to beneath the old, mainly dry Lingan 2 East Gob, these laterally continuous cavities connected with open fractures around the Lingan 2 East Gob to provide a direct hydraulic connection from No. 26 to the sealed Lingan 2 East Panel. This then filled with water at about 3000 gpm.
