IN-MINE SEALING OF WATER INRUSHES

By **Zsolt Kesserü**

5th International Mine Water Congress, Nottingham (U.K.), September 1994

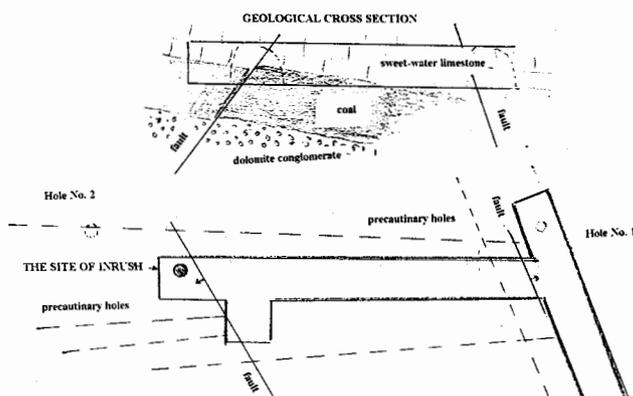
In February 1987, a single roadway had been driven some distance away from the depressurised zone to open up a new coal field. The depth of operations was 360m, some 260m below the piezometric head of the bottom reservoir. During approach to the dolomite conglomerate, precautionary holes were drilled to detect faults and to achieve local drainage. The yield of water drained from five holes was around $0.05\text{m}^3/\text{s}$. Despite the precautionary measures, water inflows occurred and increased up to $0.53\text{m}^3/\text{s}$ from a fault just at the face. The water transported some 1000 tonnes of solids (dolomite gravel/powders) within the first two days. Later, smaller yields of dolomite sands/powders occurred occasionally. The piping in the bottom dolomite conglomerate caused extensive failures in the area around the face. The geological cross-section with the location of the inrush is shown in Fig. 1.

Fig 1. The site of water-solid inrush in Nagyegyháza Mine

As the total water output of the mine exceeded the environmental limit, the inflow had to be sealed. Staff of the mine and the Institute (KBFI) examined a number of alternative plans. The selected plan included a bulkhead and conducting pipeline in close proximity to the inrush and two holes bored from the surface (Fig. 2).

Hole No. 1 served initially for supply of materials for bulkhead construction. It was also equipped with a high pressure pipeline for secondary grouting. Hole No. 2 was directed towards the fault on the dolomite conglomerate where the main channel of the inflow and caves due to piping were supposed, with the objective of sealing them. A grouting plant was established on the surface at the site of the boreholes. Temporary roads, water and electric supply were also established.

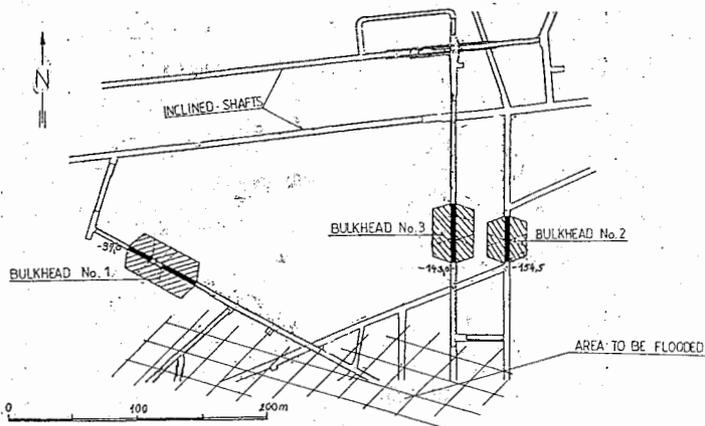
Amongst other environmental protection measures, the company decided to close the field and open a new one with a lower water inflow. Three bulkheads designed for 28-32 bar pressure and weak rock conditions were applied. Fig. 3 shows the situation.

Fig. 3. The location of the bulkheads for closing a group of inflows in Mány Mine

Design and in-situ measurements commenced in March 1987 and construction of the first bulkhead started in December 1987. Coal getting continued until June 1988 and the closing of the field was completed in June 1989. No unforeseen incidents occurred. The repeated testing and treatment of the rock around the bulkheads occupied about two-thirds of the total construction time. During pressurising of the extremely weak clay by hydrofrac-grouting, strong visco-plastic movements of the clay were observed at all three bulkheads

- a) The weak clay around the bulkheads necessitates a special bulkhead structure which enables continuous testing and grouting of the rock along the whole length of the bulkhead to be carried out.
- b) In weak rocks the balance between the actual water pressure and the status of rock stress (fissure re-opening pressure) must be preserved. If the water pressure exceeds the fissure re-opening pressure, the water will create its own channel.
- c) In spite of the extremely weak clay surroundings ($\sigma_B < 4$ MPa), the bulkheads and surrounding clays even now in good condition. Direct sealing of each inflow channel was not necessary. The safe pathway in the properly-pressurised clay is much shorter than the empirical value. This fact also validates the failure theorem of the author [3].

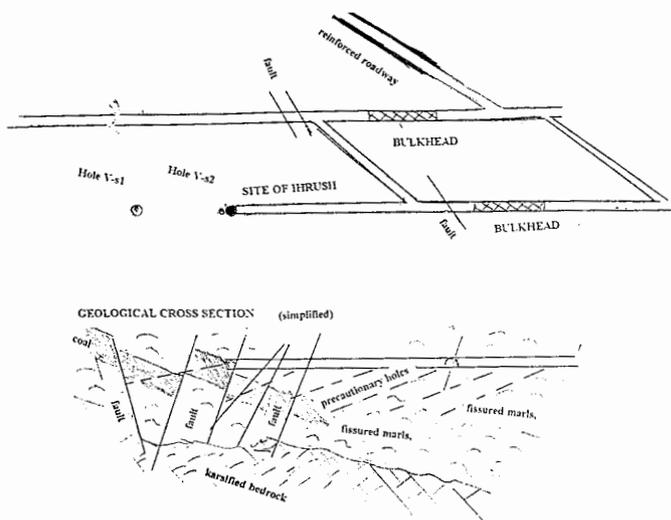
On the 12th January along one of the lined, cemented holes water inflow started and increased up to $0.13\text{ m}^3/\text{s}$. Impact of an earthquake was also supposed due to its time coincidence with the inflow. The water flow caused failures in the surrounding area of the face. The solids transported by water endangered the pumps.

Fig. 4. The site and the conception of sealing in Kanizarica Mine Slovenia

Hole No V1s directed to the fault (just to the boundary of the marl and of the limestone) to grout the channel at the bottom-reservoir. Hole No. V2s served to fill the caves in and around the roadway and to stabilise the failed zone. The two bulkheads were sited into medium hard marls, at equal distance from the closest roadways.

- Special form for the body is not necessary because the pipings of the seepage-pathways in the surrounding rocks are the weak elements. Systematic grouting is necessary to fill the fissures and to modify the rock stress properly. It will require same time as in Nagyegyháza.
- The surrounding rock between the bulkhead and the road of close location should be filled/pressurised properly. Against 26 bar water pressure cc 23 bars of shut in pressure is necessary according to the experience in Mány.

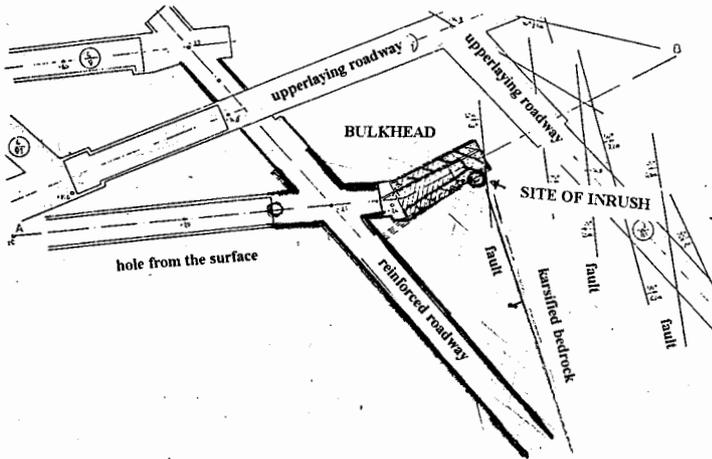
The first job has been the biggest inflow (0.2 m³/s) at a dead end of a roadway surrounded by operating roadways as presented in Fig. 5. The price, the cost of sealing was a fixed one!

Fig. 5. The site, the geology and the structures for sealing in Lencsehegy Mine ($0.2 \text{ m}^3/\text{s}$)

The water inrush occurred in January 1990. The contract entered into validity in March 1991. Due to the impact of the water the vicinity of the inflow and the road crossing were ruptured and swelled strongly. Small water inflows were discovered even in those areas which must not be closed.

- Hole was bored from the surface to serve first the material supply of constructing the bulkhead and for the last in-mine grouting.
- Due to the cost limits our effort was to form a sealed zone just under the barrier layers in the fissured zone of the limestone, instead of filling a cave of 3000 m³.

- Special bulkhead, (similar to the bulkheads in Mány) was built in (see Fig. 5.)
- The surviving roads were reinforced by shot concrete and by the grouting pipes working also as rock bolts.

- The treatment of the barrier consists of systematic grouting/hydrofrac grouting and of step-by step detecting the shut-in pressure. The distance between the channel of the inrush and the closest point of the reinforced roadway has been 7 meter. The zones of proper stress have to be formed even in this thin barrier, taking into consideration the limited loading capability of the reinforced road-support.

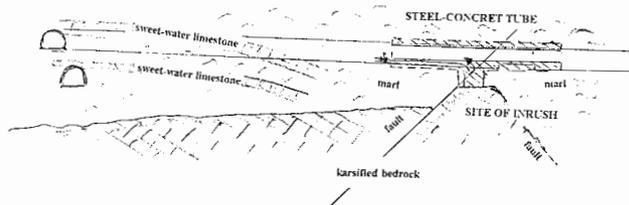
The site of the inflow has been in the bottom of a settling basin located in ventilation-roadway. The time of occurrence was unknown. Only the difference between the inflow and outflow rates (0.04 m³/s) have detected the presence of a new "spring" in the basin.

The new in mine holes detected a small "horst" of the karstified bedrock. Except for this small surface the thicknesses of bottom barriers are sufficient. The virgin water head was estimated as 100 m above the operations. The medium weak marls with small limestone interbeddings provided quite favourable conditions for sealing.

Fig. 6. The site and the structures for sealing an old inrush in operating ventilation drift

The staff of the mine enlarged and supported the channel of the inrush down to the bedrock by applying Flyght pump in the bottom face of this small shaft.

Thick steel concrete tube equipped with injecting pipes served to carry all loads of hydrofrac grouting. The site and the sealing structures are presented in Fig. 6. Comments are not necessary.
