CASE STUDY ON THE REMEDIATION OF THE DEFUNCT COAL MINE ARBOR COLLIERY, IN MPUMALANGA SOUTH AFRICA¹

Chris Waygood², Mike Palmer, Rod Schwab

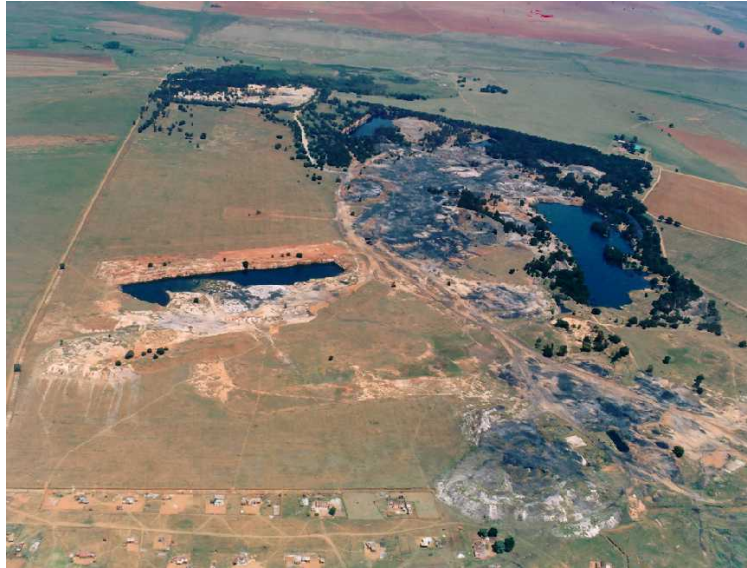
Figure 2: Aerial view of Arbor Mine

An aerial view of the mine is shown in Figure 2. Various pits can be noted, and sampling of water within the pits indicated acidic conditions in the pits (pH of between 2 and 3), elevated sulfate levels (between 106 and 1353 mg/l) and elevated metals (Fe ranging from 0.2 to 17.6 mg/l; Mn ranging from 2.3 to 2.8 mg/l; and Al ranging from 9 to 102 mg/l).
