UNDERGROUND TREATMENT OF FLOODED FULLY MECHANIZED MINING FACE

¹CHUNLAI YANG and ²GUODONG LI

¹Professor and Senior Engineer
China Coal Scientific and Research Institute

²Engineer, Henan Pingdingshan Coal Mining Corporation

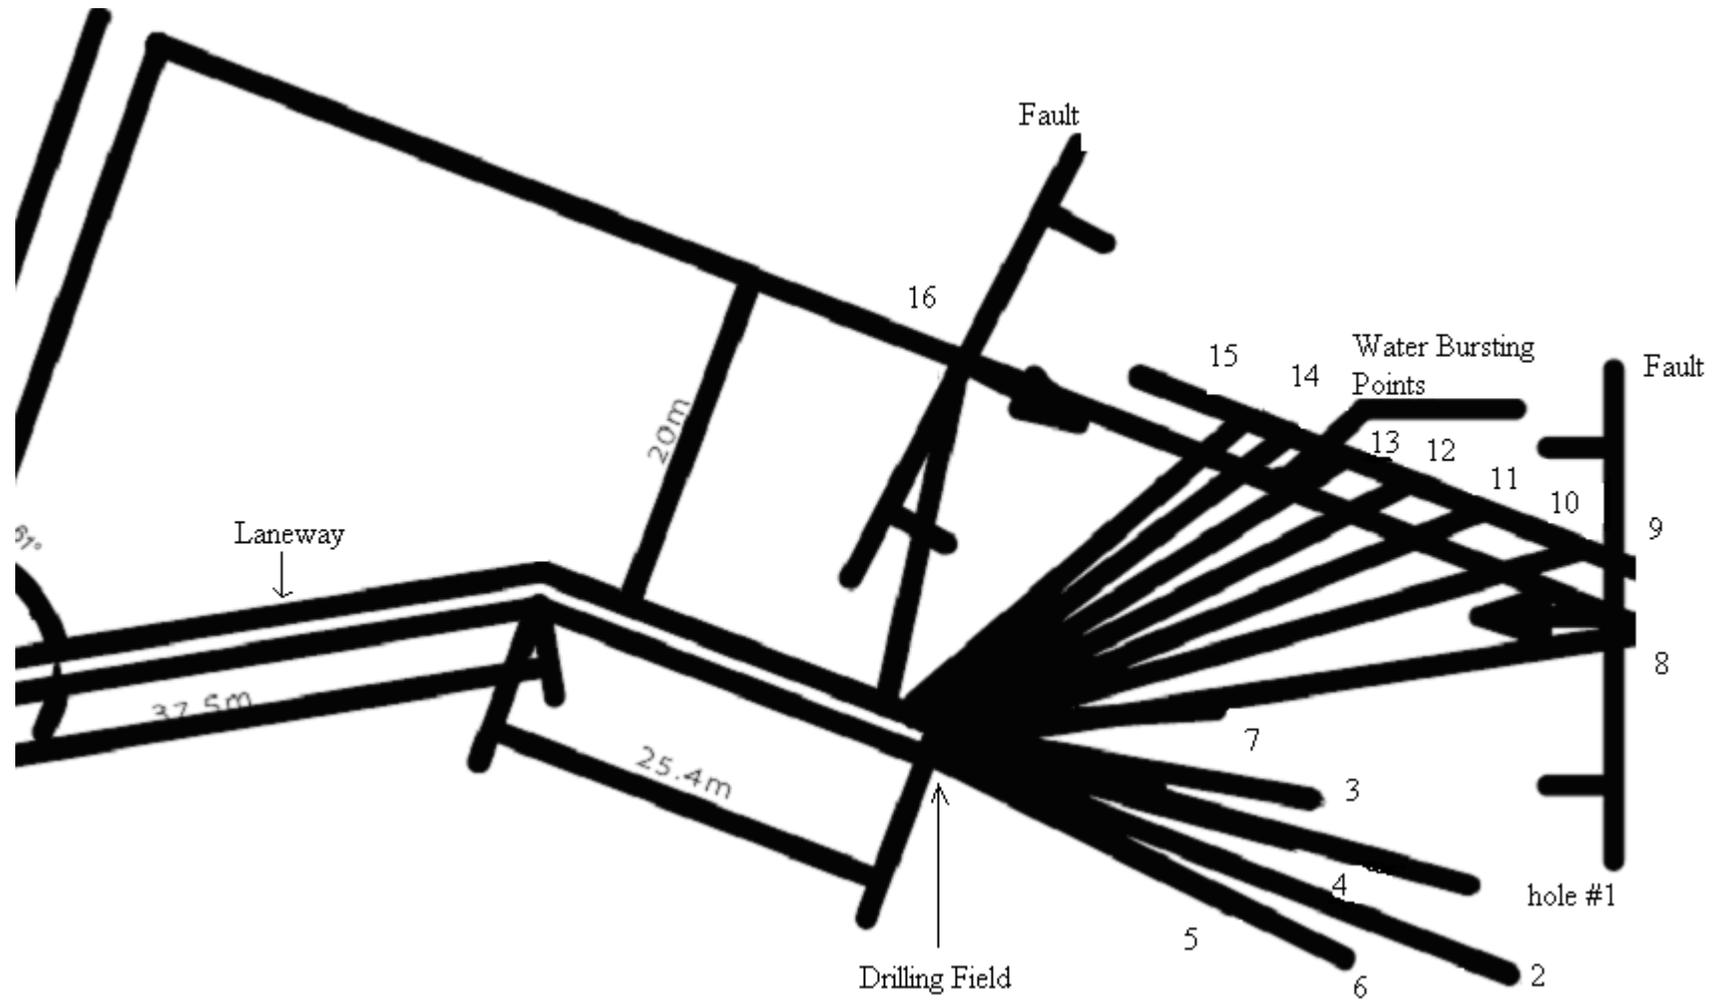
Figure 1. Floor Plan of No. 1 to 16 Grouting Holes

Within the solid coal body of coal seam No. 10 a 3x2m tunnel was excavated as the drilling area, where air pressure pipes, water pipes, and power lines were available. Figures 1 and 2 show the layout of the tunnel and drilling site.

Figures 1 and 2 also depict the positions of the 29 drill holes. Table 1 reports their construction parameters, including orientation, depression angle, and hole depth, etc. The whole project consisted of drilling and flushing 133 times in total, excavated 2,747 meters in depth, and used 434 ton of cement, 160 ton of water glass, and 39.6 ton fly ash.
