Assessment of Safety Status of Open Excavations and Water Quality of Pit Lake at Abandoned Nyala Mine in Limpopo Province of South Africa

Sphiwe Emmanuel Mhlongo, Francis Amponsah-Dacosta

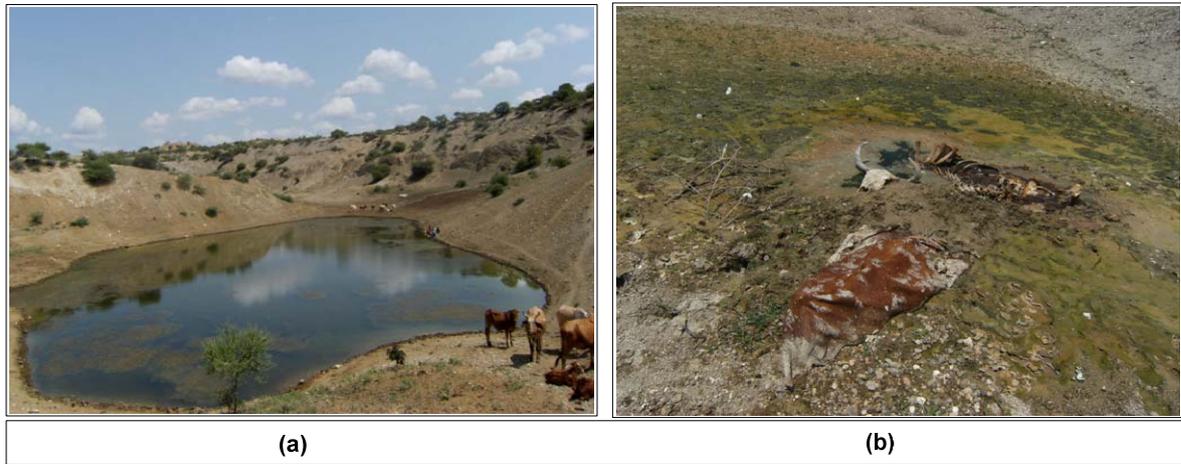
The existence of fish in the pit lake and the fact that animals such as cows, donkeys and goats have been drinking the water in the pit for a long time without any health problem are indications that the pit lake may have some beneficial uses. However, there have been numerous reports of cattle being trapped by mud on the pit floor of the pit lake and subsequent death. Part of the skeleton of an animal (cow) which died as a result of being trapped by mud in relatively dry portion of the pit lake is shown in fig. 1b.

Fig.1 The abandoned Nyala Mine pit lake, (a) animals from drinking water in the pit and (b) skeleton of the dead animal trapped in mud at the pit floor

The site description showed that the major safety threatening features of the pit lake are sticky mud in the pit floor and few unstable pit walls. On the other hand, the surface water flow model indicated that the pit receive high runoff from high grounds disturbed by mining. This contributes substantially to fine sediments deposition in the pit floor thus increasing physical hazards associated with sticky mud. Therefore, in ensuring safe access to the water in the lake, reshaping of unstable pit walls and installation of erosion control measures to limit or eliminate the deposition of fine sediments in the pit floor should be considered.

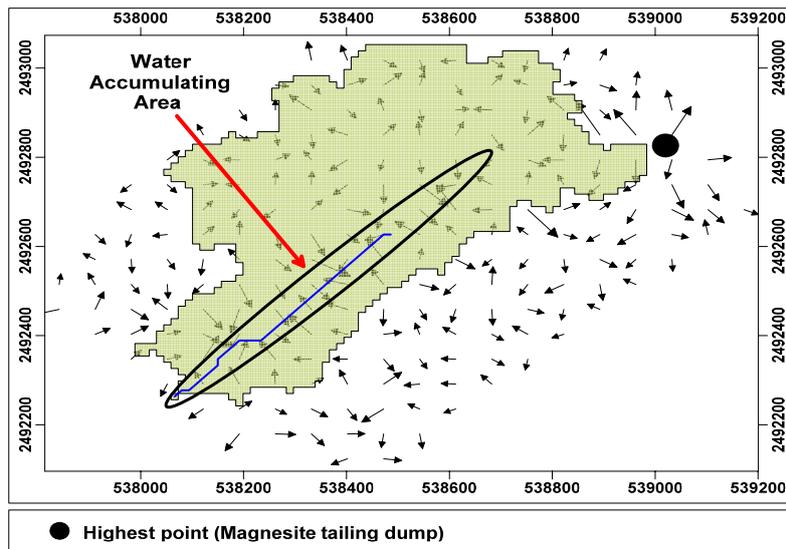
The modelling of the watershed areas around the abandoned pit at Nyala Mine revealed that the pit receives most of the runoff water from the north western part of the pit lake. This means that effective and most appropriate engineering erosion control measures to limit or eliminate sedimentation in the pit floor need to be erected along identified high runoff potential areas. The superimposition of the vector map showing the direction of rain water flow along the terrain within and around the abandoned excavation on the watershed areas gave a clear indication of the expected direction of surface runoff. The map showed that much of surface runoff water is expected to start from the north eastern part of the excavation

characterised by elevated grounds covered by one of the tailings dumps in the area. The watershed area and the direction of surface water flow in the area are shown in fig. 2.

Fig. 2 An illustration of watershed areas in the hazardous pit
