Drainage Control for Underground Mines

Hydrogeological Problems and Their Resolutions at the Friedensville Mine

by Kenneth R. Cox, Manager, Friedensville Mine,
The New Jersey Zinc Company,
Center Valley, Pennsylvania, USA

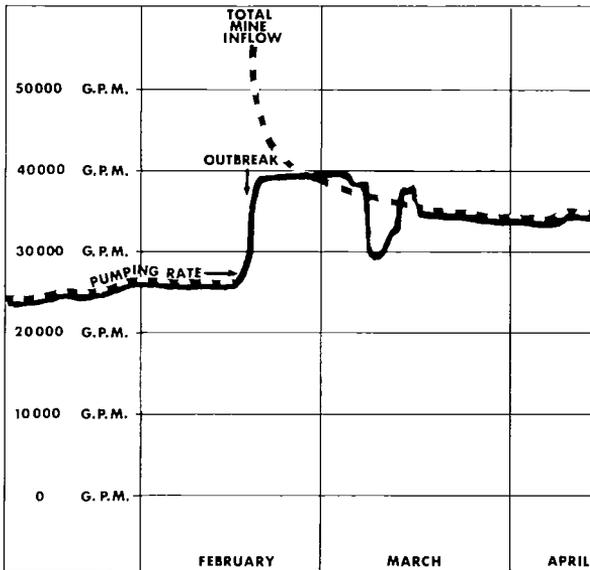
The Engineering Department established that the rate of inflow from the outbreak was nearly 35,000 gallons per minute. This flow, combined with the existing mine discharge of 26,500 gallons per minute, totaled approximately 60,000 gallons per minute or 86,400,000 gallons per day.

It is of interest to note that under the existing conditions it was quite difficult to measure an inflow of this size. However, personnel from the Engineering and Geology Departments utilized all measurements available and projected that the high water mark would be reached very early in the morning of February 25. Actual cresting occurred at 4:30 A.M. that morning after the water had risen well into the 1170 level. At 7:00 A.M., the water for the first time was going in a positive direction.

Inflow vs. Pumping Before and After the Outbreak

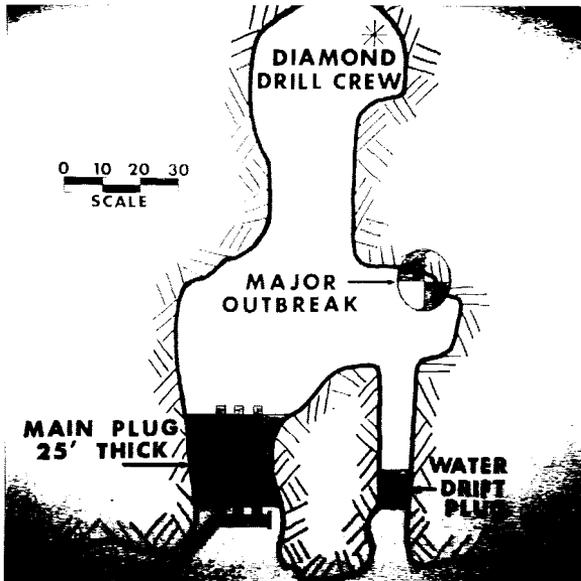
Plan View Of The Outbreak Area

A diversion drift measuring 50 feet long by 8 feet wide by 8 feet high was driven to intercept the water near the base of the outbreak. Upon completion of this drift, the primary water route was then prepared for installation of the first concrete plug. This plug which measures 25 feet long by 21 feet wide by 15 feet high was filled with coarse

aggregate and then injected with sand and cement. Through the base of the plug, three - 20 inch pipes with valves were provided to carry the water.

After completion of the first plug, the water was allowed to flow through the 20 inch pipes and diverted away from the diversion drift. The small water drift was then prepared for construction of a 10 foot long solid plug.

Both plugs were pressure tested and grouted where necessary. The final phase of this project included installation of a 30 inch pipe line which carried the water to a system of water raises discharging into the sumps of the 1520 level pump station.

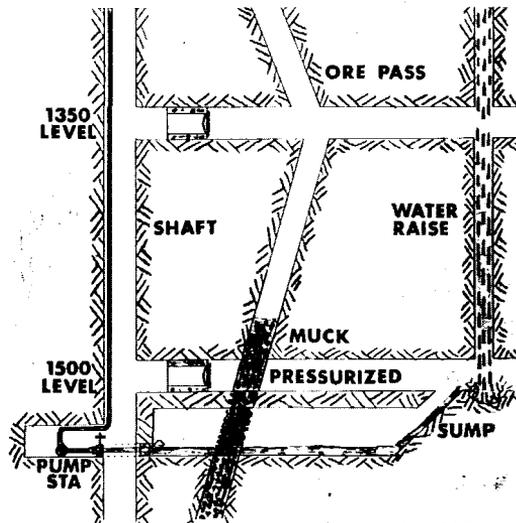
For the first time, we realized what had taken place behind the door to cause the emergency. Thirty thousand plus gallons per minute of water was falling down a vertical raise from the 1350 level to the 1500 level sumps. The water raise was acting as an air pump, and the filling of the ore pass with crude ore above the level blocked the only exit for the increased volume of air.

Our system for measuring water depth in the sumps and activating the pumps is accomplished automatically through the use of a probe tank located in the pump station. This tank is connected with the sumps and normally the water elevation in the probe tank is the same as the sump, regulating the demand for pumps as needed. However, during the time of this incident, the air pressure behind the bulkhead door was much greater than atmospheric pressure. The water elevation in the probe tank was much higher than the actual sump level, causing the pumps to pull the sumps lower than desired. In fact, it was later felt that the suction screens were exposed. When this occurred, our suction screens became partially blocked by mud and plastic materials which made their way into the sumps.

Idealized Section Of The Pressurized Area

The problem causing the condition was known, but opening the door was still another matter since we couldn't budge the door. After a harrowing several hours of jacking the door open with one - 50 ton and two - 35 ton jacks, along with fighting wind and a muddy water spray, the door was finally opened wide enough for atmospheric equilibrium. With this, another crisis ended.
