THE STABILITY AND CONTAMINATION OF SOME TIPS AND TAILINGS DAMS IN NORTHERN ENGLAND

R. A. Forth

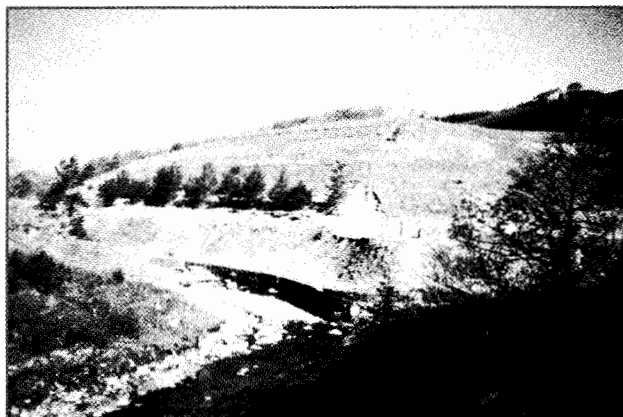
In the context of the above a contract is presently underway to remediate three large tailings dams in the Nenthead area of Cumbria, UK. These tailings dams are a relic of a once thriving lead/zinc mining industry. The earliest mining probably took place in Roman times, but became significant in the Middle Ages when there was a demand for lead for roofing and drainage purposes for monasteries. The mineral rights were owned by the monks, but on the dissolution of the monasteries by King Henry VIII the mineral rights were sold off and numerous private mining ventures started. In the remote Nent valley of the northern Pennine hills the London Lead Company became the backbone of the local economy. Towards the end of the 19th century zinc, found in association with lead, became the more profitable mineral, as Britain was flooded with cheaper imports of lead from Spain. The area remained commercially viable until 1921 and, after years of neglect, sprang to life again during the Second World War as a source of zinc for the war effort. In fact it was reworking of the original tailings dams that created the three large tailings dams seen today. The largest of these is some 23 m high, 200 m long and 130 m wide (Figure 1).

Figure 1. Tailings Dam above River Nent.

The tailings dams are now over 50 years old and have been subject to both river erosion at the toe and sub-aerial erosion, compounded by rabbits burrowing into the banks. As a result there are obvious signs of deterioration as illustrated by the collapse of a gabion wall at the toe of one of the dams. There is this obvious concern that a major failure of the dams could cause massive pollution of the River Nent, a tributary of the much larger River Tyne which passes through Newcastle on the way to the North Sea at Tynemouth.

Comprehensive studies of the stability of the tailings dams were carried out using conventional site investigation techniques. Standard Penetration Tests (SPT) confirmed the low relative density of the sandy material corresponding to a friction angle of around 30°. Since some of the slopes exceeded this angle and there were obvious signs of distress it was obvious that slope regrading was necessary to provide an adequate factor of safety.
