# THE FAILURE OF & REMEDIALS TO A RIVER DIVERSION FOR AN OPENCAST MINE IN THE WITBANK COALFIELD OF SOUTH AFRICA

Arthur Louis Mc Ewan

## ABSTRACT

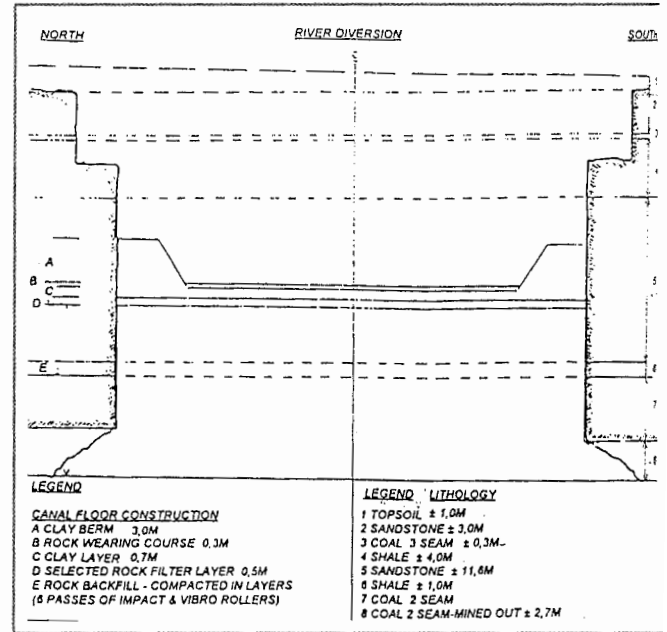
Figure 8. Diagrammatic section. Showing the lithology and canal as built (backfilled portion).

Underground bord and pillar workings of the previously mined areas at depths of, on average 6-8 m below the canal bed over a length of approximately 350 metres complicated operations at the downstream end (Figure 7). It was feared that heavy blasting could cause the roof of the workings to collapse. It was therefore decided to excavate the remaining coal beneath the diversion down to coal floor and backfill to engineered fill specifications with waste rock overlain with a 750 mm thick impervious layer and 250 mm thick coarse rock wearing course over a suitable filter (Figure 8). The revenue of the coal mined was offset against the extra cost of this operation. As an additional measure a berm wall 3 metres wide by 3 metres high of engineered impervious fill was constructed on either side of this section of the canal.

were observed cascading down the side rockfaces of the canal. Leaks developed through the backfill leading to the formation of large openings in the fill. The water entering the openings flooded the underground workings adjacent to the canal which in turn flooded into the opencast pit. This was as a result of the mining of the boxcut at the north end of the pit intersecting the old workings to remove additional coal (pillars and roof coal) as part of the opencast mine plan (Figure 7). A total of approximately eight hundred and fifty thousand cubic metres of water flowed into the pit in a period of about twelve hours.

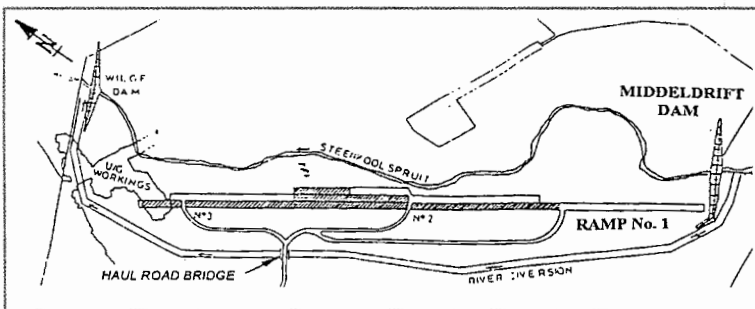
Figure 7. General mine layout. Showing the Steenkoolspruit and river diversion.

The canal was opened to the full flow of the river on 20<sup>th</sup> October 1992. On the afternoon of 9<sup>th</sup> November 1992 an estimated peak flow between 50-100 cumecs entered the canal owing to a series of storms in the upstream catchment of the Steenkoolspruit. At the same time a short duration storm with 34 mm rainfall occurred on-mine and large volumes of water

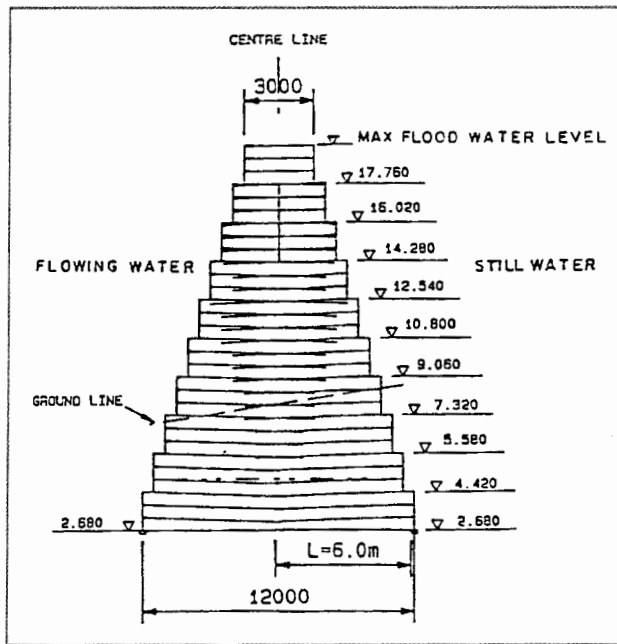
Figure 9. Typical section thru grid wall.

To redirect the flow at right angles to pass under the Spoonet railway bridge (Figure 7) at the downstream end of the canal, a novel free-standing guide wall was designed using reinforced rockfill. This wall was founded on rock and on the downstream rockfill zone of Wilge dam. It was a simple solution to a potential problem, (Figure 9).

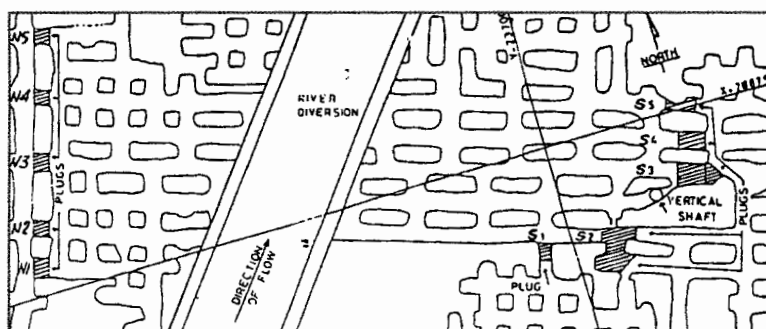
Figure 10. Showing the river diversion. Underground workings and plugs.

Difficulties were experienced in sealing the interface concrete/coal and during an inspection leakages were noted at the roof of plug S2 which had not been completely grouted and approximately 0,7 m<sup>3</sup>/s was spilling over the plug while minor spillage was also occurring over plug No. S4. This was discovered after protracted daily rains forced the mine to redirect the flow down the canal earlier than planned (the flow had begun exceeding the 10 m<sup>3</sup>/s the dam drain pipes could discharge) – rainfall recorded on mine during the previous week was as follows (Table 2).

On Christmas day (25<sup>th</sup> December 1992) at 10h20 mine management received a report that the pit was flooding. After re-directing the flow down the river course the plugs could only be inspected on 29<sup>th</sup> December, when it was found that a large portion of the floor beneath plug No. S3 had washed out. It was subsequently found to be an excavation in the floor, backfilled by the "old timers" which had not been detected. Emergency remedial measures were carried out by installing large grout bags (three No. 5m x 4,5m utilising ventilation brattice cloth) into the void below the plug and grouting from surface. This was completed together with plug S2 remaining work on New Years Day (1<sup>st</sup> January 1993), substantially reducing the flow into the pit.

The layout of the old underground workings was such that only five concrete plugs were required in the bords on either side of the river diversion (Figure 10). The plugs to the

The concrete was initially pumped into the southerly plugs S1 and S4 via the ramp in the canal after installing shuttering of chicken wire mesh, steel fabric and gumpoles with tube-a-manchette grout tubes to the roof and side walls of the bords. This was altered to concreting direct from surface down holes drilled into the workings above the plug site which proved more successful. The tube-a-manchettes were not successful in grouting the sides and roof concrete to coal interfaces and this operation was also subsequently changed to pumped grout from surface. Work on the plugs was completed on 11<sup>th</sup> December and backfilling of the ramps commenced.

Further grouting of smaller voids was carried out and the mine recommenced coaling on 4/1/93. It was also decided to reinforce all the south plugs by rockbolting the floor on the downstream side of the plugs and casting an extension to plug No. S3 to form a buttress, achieving additional stabilisation of this plug. These remedials were monitored for several weeks and proved stable. Water pressure testing for leak detection (to a pressure of 4 bar) was then carried out in holes drilled into the strata round each plug to check the interface coal/concrete and grout and the immediate surrounding coal / rock for fissures, jointing and other potential flow paths. The test work was completed in early February 1993 and a monitoring system including regular plug inspection, leakage monitoring and water level dipping adjacent to the plugs instituted. To date there have been no further problems with these plugs; in fact the decision has now been made to leave the diversion in its current position permanently.
