Evaluating the role of groundwater in the stability of slopes in an open pit coal mine with shallow dipping multi-seam stratigraphy.

W Harding, R Connelly L F Contreras (SRK (UK) Ltd)

ABSTRACT

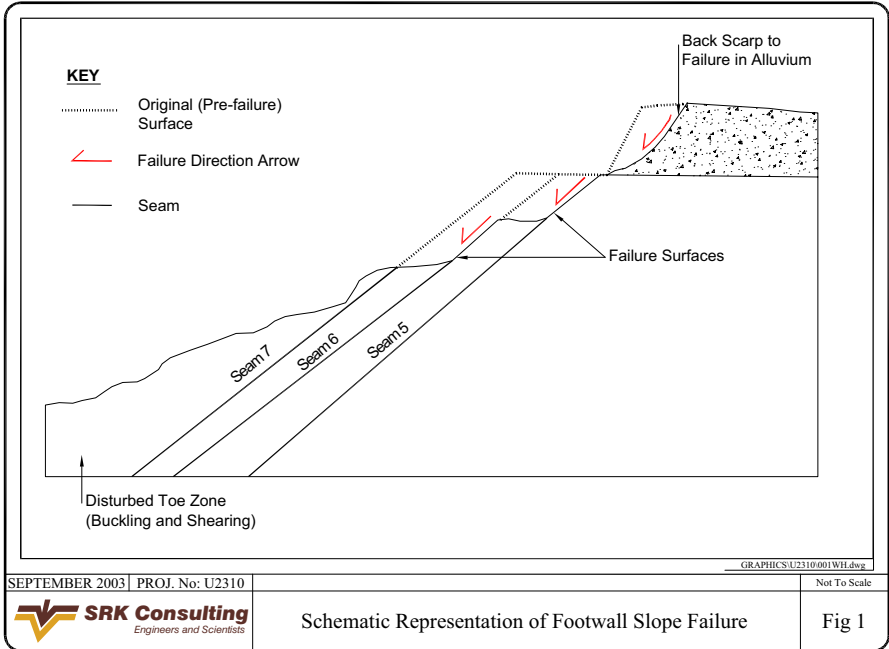
The coal seam being mined on the footwall of the active pit at the time of the failure was Seam 7, and was around 60m high (Figure 1). Failure occurred by planar sliding along the clay layers at the top of Seam 6, but also along the top of Seam 5, in places. The layers between the failure surfaces buckled extensively, both at the toe and further up the failed 'slab'. The main reason for the failure was the steepness of the dip of the strata (up to 35 degrees at the crest). The expected average dip of the footwall in the failed area had been 17 to 18 degrees.

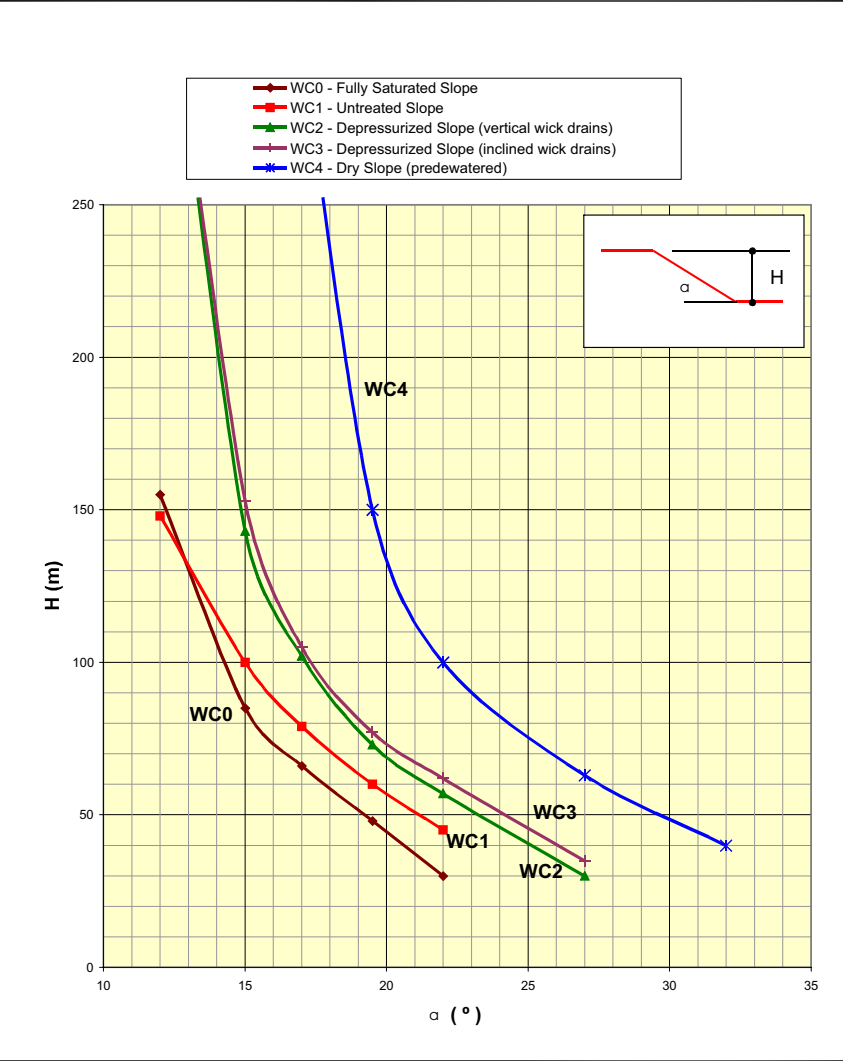
Fig 2

The situational slope stability analysis has produced design charts of slope height versus dip angle for a range of water conditions, representing the majority of the structural conditions present (Figure 2). Water pressure is important and the slopes need to be depressurised and drained to achieve stability. The situational analysis enabled design charts to be developed, which allow stabilisation strategies to be analysed using the assessment of the various components of straight slabs.

SLOPE ANGLE (α) vs
 MAX. ACC. SLOPE HEIGHT (H)
 STRAIGHT SLOPES - FOS = 1.25

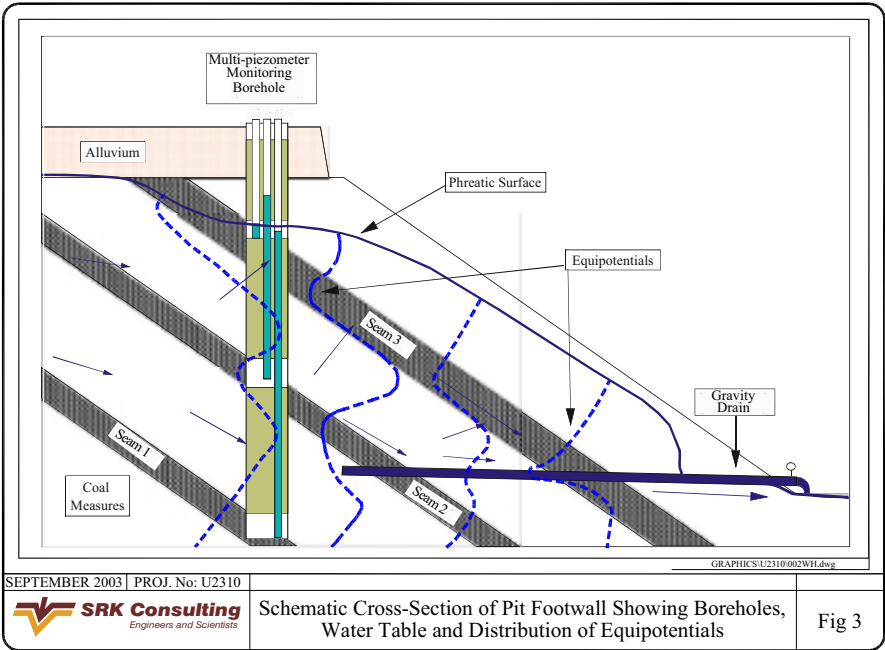
At the actively mined pit, three holes were drilled at about 5 degrees upwards to depths ranging between 113 and 149m. The final target seam was originally Seam 3. However, detailed scrutiny of the geological logs from the drainage holes and from the nearby vertical monitoring hole indicated that the drainage holes probably terminated just beyond Seam 2 (Figure 3).

The depth of the observation holes ranged between 62m and 125m and intersected the Seams 1, 2 and 3 (as illustrated in Figure 3). The topmost piezometer in several of these wells was installed in the alluvial aquifer within the near surface water table.

4. In support of this observation, it was noted that the water levels in the vertical monitoring well behind the crest of the footwall (Figure 3) all appeared to react to pumping from the pumping hole, but that this response was fastest in Seam 2, followed by Seam 3, and lastly, Seam 1;

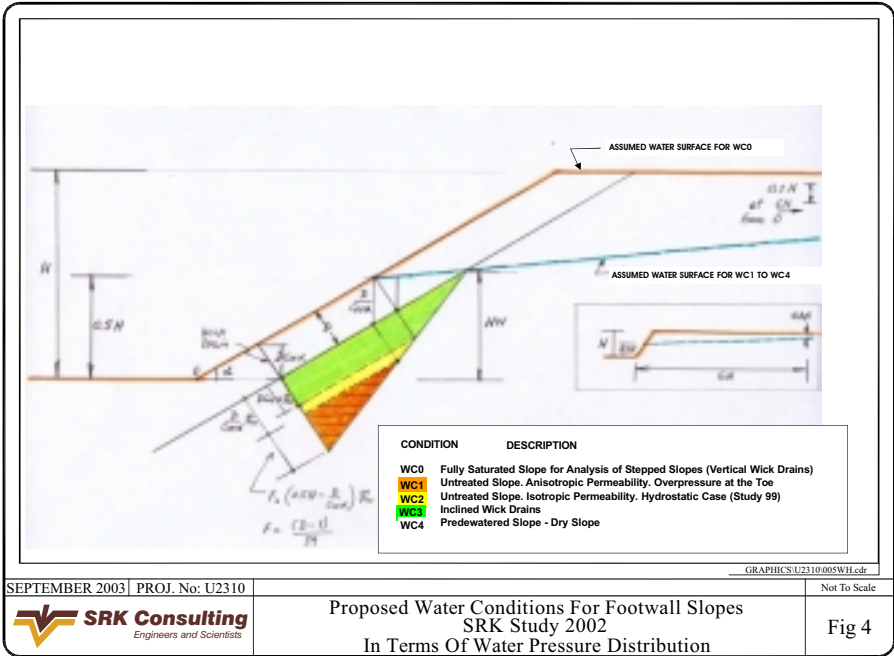
The slope stability analysis identified five key conditions that required analysis (Figure 4), namely:
