## REMEDICATION OF THE FORMER LEAD-ZINC ORE MINE AND THE MINE WATER TREATMENT ON THE SITE (GYÖNGYÖSOROSZI, HUNGARY)

*Mihály Csővári, József Éberfalvi, Gábor Földing and László Bakk  
MECSEK-ÖKO Zrt, Esztergár L. 19 7233 Pécs, Hungary*

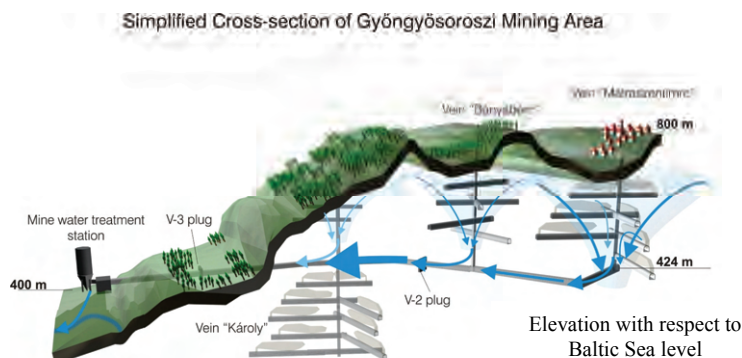
**Figure 1. Simplified cross-section of the Gyöngyösoroszi mining fields (three groups of veins).**

The adit links the three principal mining fields. The biggest of them is the vein "Károly", which has been totally flooded after termination of the mining. The two others are located at higher altitude, so they are in part under permanent dewatering and influenced by the atmosphere.

Prior to deal with the mine water treatment issues it should be mentioned that a plug, a concrete barrier (V-2 plug in Fig. 1), was built in the main adit in October 1987, aiming at flooding the highly pyritic mining field (vein “Mátraszentimre”) for stopping the oxidation process there. But after some months of operation, under the huge pressure of water during rebound, the barrier and the rocks in its immediate vicinity were seriously damaged. In August 1988 the accumulated highly contaminated mine water escaped through the mine adit causing serious contamination of the receiver *Toka-creak*. So the plugging experiment has failed. It is worth mentioning that a rapid change of the water quality in the plugged mine was observed. These data are presented in Table 1.

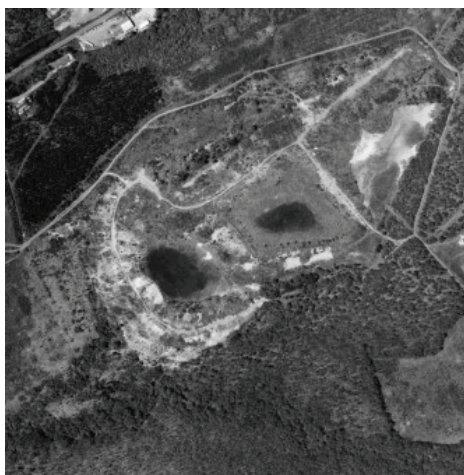
Detailed investigation of the tailings (among others in the frame of EU-tailsafe project in 2002-2005) led to the conclusion that the tailings are acid-producing having 30 kg CaCO<sub>3</sub>/t net acid generation potential. But at the same time the pH of pore water inside the pile is in the range of 7-8, though in some spots in the upper layers it is lower, likely because of the oxidation processes. In any case, the seepage from the pile is neutral. The planned remediation of the tailings pile started recently; it includes stabilization of the dams, and weak surfaces,

**Figure 2. Tailings pile with free water on the top.**

dewatering, recontouring, and multi-layer covering of the tailings; the latter comprises a clay layer on the top and lime at bottom for buffering the pH of the percolating water.

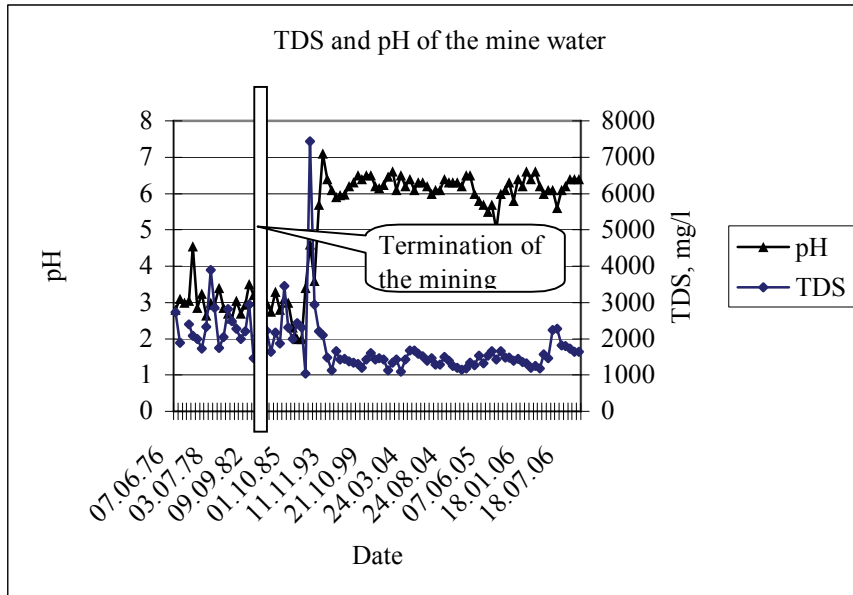
**Figure 3. TDS and pH in the mine water during activity and after the mine closure.**

It can be seen that the termination of the mining led to remarkable increasing of the pH in mine water from pH~3 to pH~6.2, and decreasing of the TDS from 2.3 g/L to 1.6 g/L. The concentrations of Zn and Fe have been slightly dropping, too. The acidity of the water decreased from 630 to 300 mg CaCO<sub>3</sub>/L. Mine water composition in 2006 is presented in Table 2. Previous data collected in 1985 are also given for comparison. Data for the three main mining fields are also presented, but these data are only estimated values. This estimation was carried out because at that time the three mining fields were not accessible, so direct water sampling from the fields was impossible. Nevertheless, for some reasons (e.g. remediation of mining site) it was necessary to give some estimation regarding the composition of the three mine water streams. The estimation was conducted taking into account the former data (relative to the active mining period), geochemical

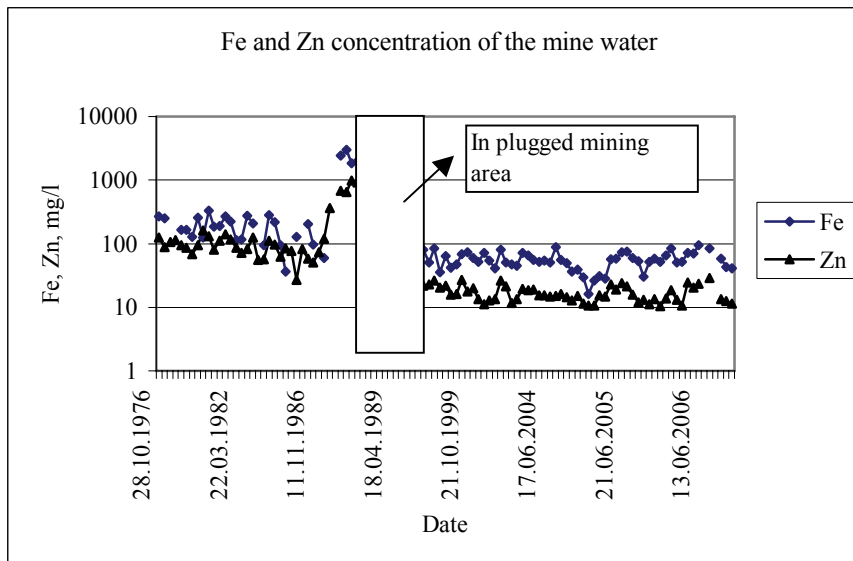
It can be seen that the zinc, iron and manganese concentrations rose very quickly and the total dissolved solid (TDS ) of water has achieved 29 g/L during 220 days working period of the barrier. The results point out that in closed mines affected by rebound the water can become very highly contaminated (Nordstrom, 2005). Therefore

**Figure 4. Zinc and iron concentrations in mine water. Very steep increasing of the concentration of components was observed in the plugged mine field during rebound.**

the accumulation of water in the mine cavities (which are subjected to aeration) has to be avoided. One possible way to do this is the backfilling for decreasing the effective volume of the pit. Change of the mine water quality over three decades (for the period of 1976-2006) is presented in Figures 3 and 4. The termination and the failed closing “experiment” are also indicated.

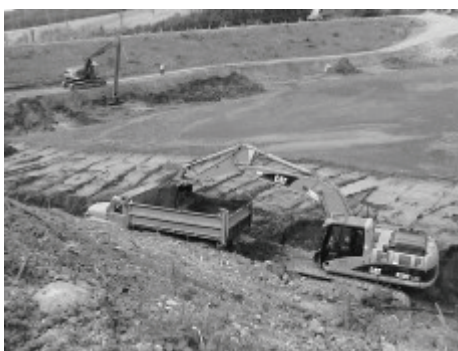
**Figure 5. Transportation of water treatment sludge to the hazard waste repository.**

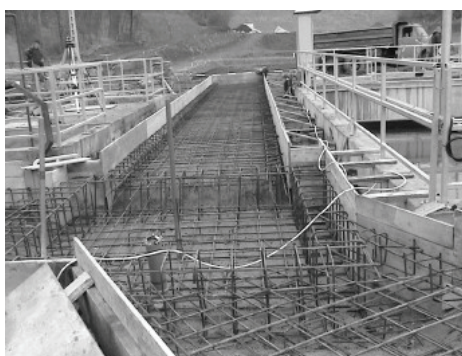
**Figure 6. View on the construction of the new sedimentation and dewatering unit.**

Taking into account the international practice (Murdock et al., 1994) and the experience at the Horden (UK) (Croxford et al., 2004), it was decided to improve the technological process of water treatment. During the reconstruction, some essential parts of the former facility were maintained (i.e. lime milk preparation, neutralization and aeration tanks). But instead of sedimentation ponds, two sedimentation tanks were built together with one centrifuge for dewatering. Also, polyelectrolyte was used to facilitate the sedimentation process.

The new reconstructed mine water treatment station (planned capacity is 4800 m<sup>3</sup>/d) has been working well since March 2006, though the solid content in the centrifuged sludge has to be further increased (at present it is about 40%). In Table 3 some data on the composition of the sludge and treated water are presented. Unfortunately, the sludge is regarded as a hazard waste, especially for its arsenic content (>0.1%). However, the treated water fits very well the established discharge limits. The construction of the new sedimentation tanks is illustrated in Figure 6.
