Highlights & Lessons Learnt

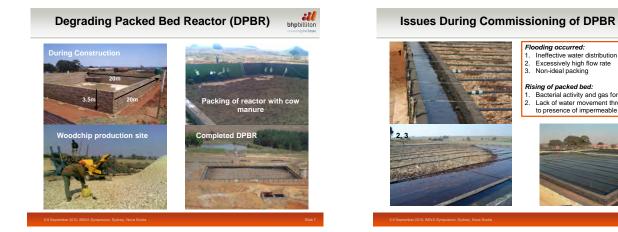
Rising of packed bed:
Bacterial activity and gas formation
Lack of water movement through bed due to presence of impermeable layers
