The advance detection and treatment of karst collapse columns – A case study of the Renlou Coal Mine in Anhui Province, China

Yajun Sun¹, Zhimin Xu¹, Yuhua Wu², Shitian Zheng³

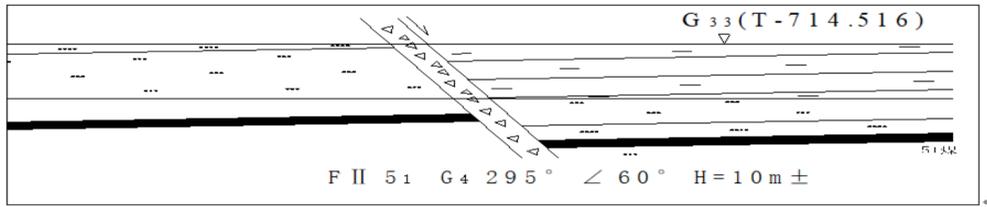
Fig. 2 Sectional view of the upper section along the heading of the II₅₁ track roadway

The strata of the II₅₁ mining area compose a nearly monoclinic structure with a yield of $90^{\circ} < 16^{\circ} \pm$. The exposed lithology of the roadway is mainly fine sandstone and mudstone. The DF8 normal fault is exposed at 3 m (lower) and 12 m (top) before G33; its occurrence is $295^{\circ} < 60^{\circ} - 69^{\circ}$, and its fault throw is 10 m. The fault fracture zone is 1 m with no water seepage through it (Fig. 2). The lithology in the middle and lower parts of the head section is characterized by several small

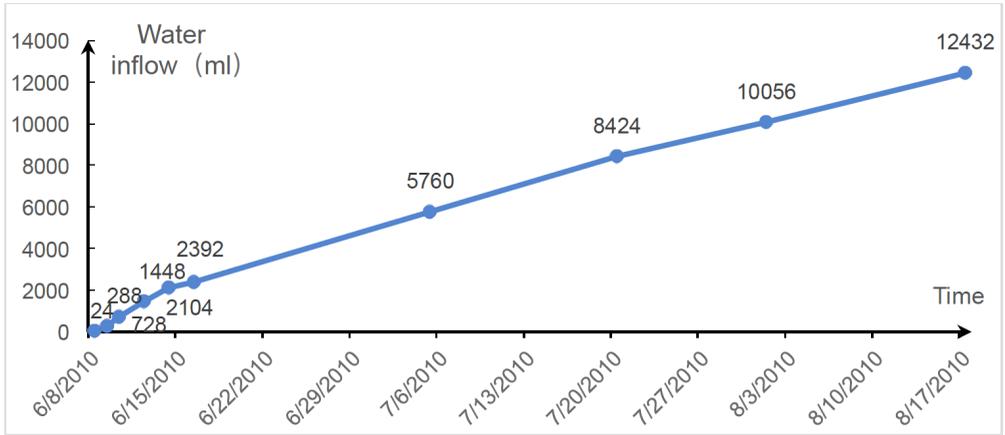
Fig. 3 Total water volume at the exit point of the II₅₁ track roadway

excavation reached approximately 31.5 m in front of G33, the amount of water increased. The total water volume rushing out of the three anchors in the upper construction area was nearly 30 m³/h, and the single-hole (aperture of 32 mm) maximum water output was 16 m³/h. After performing the initial grouting to plug the water, the water volume was stable at 8 m³/h, and there was no decrease in the inrush rate (Figure 3). According to the increase in the amount of effluent water and the stability of the water volume after plugging, the comprehensive analysis suggests a relatively stable supply from the water source.

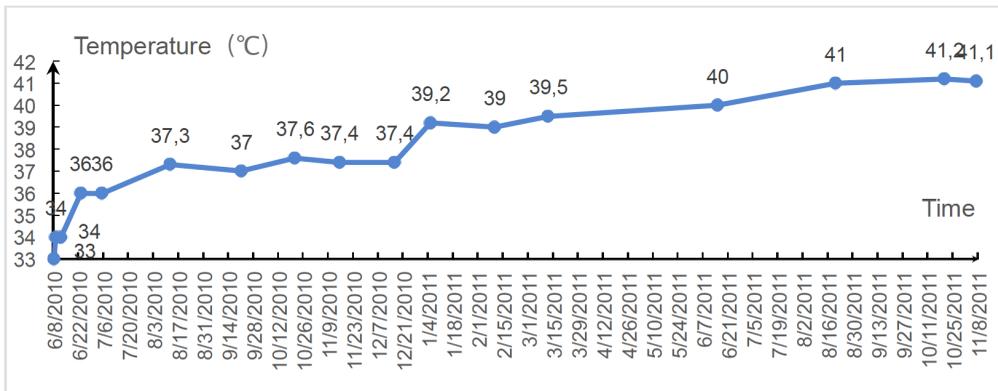
On June 8, 2010, the water temperature was 33°C, after which the effluent water temperature gradually increased to 41°C on November 29, 2011 (Figure 4). According

to the normal geothermal gradient of 3°C/hm at the Renlou Coal Mine, the normal ground temperature is 34–36°C; hence, there is an abnormality in the head-on effluent temperature along the II5₁ track roadway. Based on a comprehensive analysis of the abnormal increase in the water temperature, which is higher than the normal ground temperature, the water is preliminarily determined to be sourced from a deep, high-temperature water supply.

Fig. 4 Curve of the change in the head-on water bursting point temperature along the II5₁ track roadway

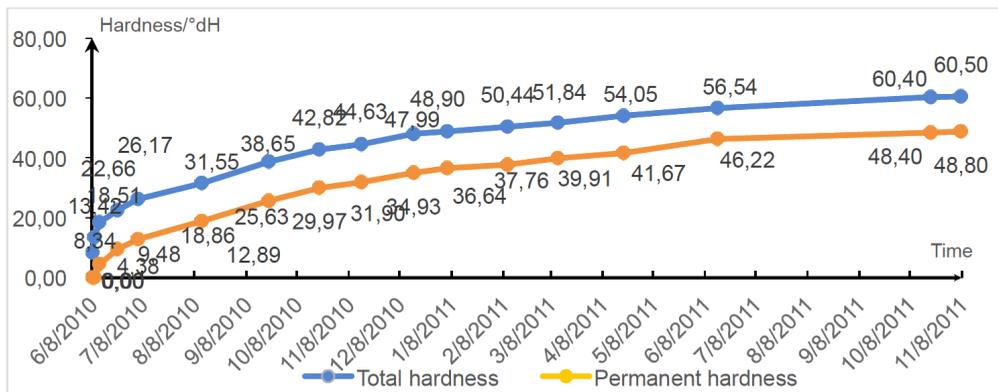
Fig. 5 Curve of the change in the water quality at the water inrush point along the II5₁ track roadway

June 8, 2010, to November 2011, the total hardness increased from 8.34 to 60.58°dH, and the permanent hardness increased from 0 to 48.81°dH. The full hardness and permanent hardness of the water displayed an increasing trend (Figure 5).

An analysis of the main hardness of the effluent water quality along the II₅₁ track roadway conducted from scratch shows that the water hardness and permanent hardness were generally increasing. This implies that there may be a deep water supply with a high hardness (Ge et al. 2007). Comprehensively, according to the increase in the effluent water volume, the rise in the water temperature and the abnormal water hardness and water pressure along the II₅₁ track roadway, it is concluded that the water outlet point may be connected to a deep water reservoir with a high temperature, a high hardness and a stable source of replenishment (Gui 2005). Combined with the abovementioned geological prediction results, hidden karst collapse columns are suspected at the point of water inrush along the II₅₁ track roadway, seriously threatening the safety of further mine production.

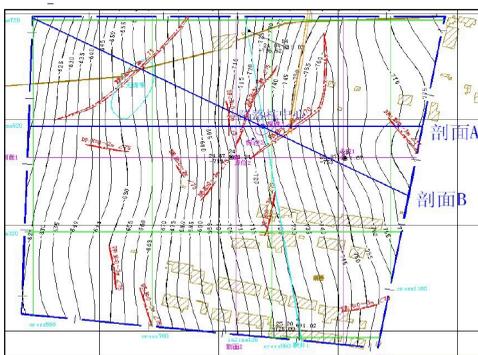
1. On the west side of the water inrush point, the reflected waves at the top interface of the Ordovician limestone are disorganized and broken, indicating a fissure development zone.
2. There is a suspected collapse column approximately 350 m ahead of the main roadway.
3. There are water-rich areas in different layers to the southeast of the main roadway, and there are abnormal superpositions. To the southwest, there are water-rich areas distributed at the 5₁ coal roof and the 7₂ coal floor.

Fig. 6 Surface three-dimensional seismic results

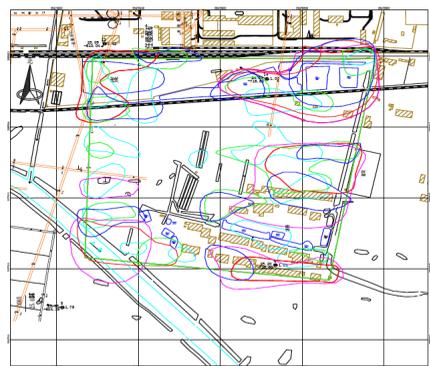
Fig. 7 Comprehensive results of the surface transient electromagnetic survey revealing water-rich anomalous areas

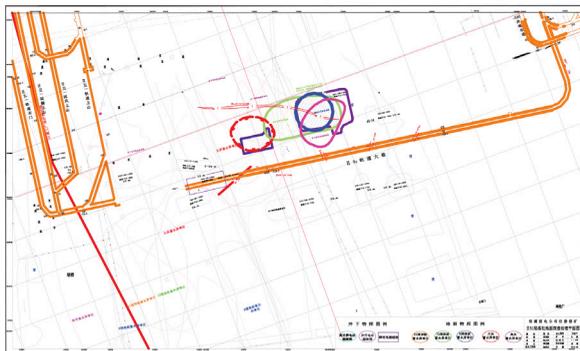
Comprehensive analysis of the above various geophysical exploration results and other data: the conductor of the II5₁ track roadway is a water-conducting collapse column, and preliminary analysis shows that this column is located 65–115 m behind the roadway at horizontal distances of 38–65 m.

Fig. 8 Comprehensive results of subsurface geophysical exploration

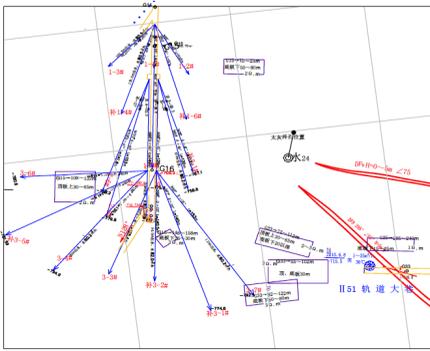
1. Underground drilling exploration. A total of 19 boreholes in 3 groups were used for the up roadway, and 6 boreholes were drilled for the haulage roadway.
2. Surface-guided directional drilling. Four column exploration holes (the first hole revealed the collapse column) and 1 underground branch hole based on the abnormal area delineated by geophysical exploration were drilled. The four column exploration holes all exposed the collapse column.

Figure 9 Drilling plan for the II₅₁ up roadway

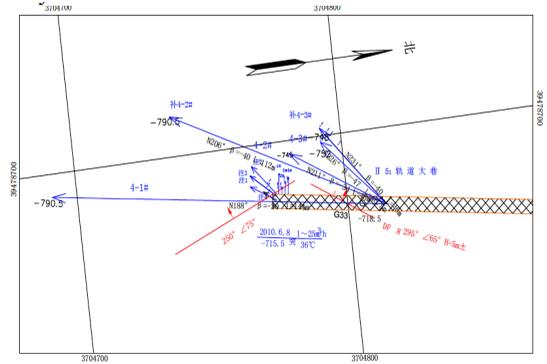
Fig. 10 Drilling plan for the II₅₁ track roadway

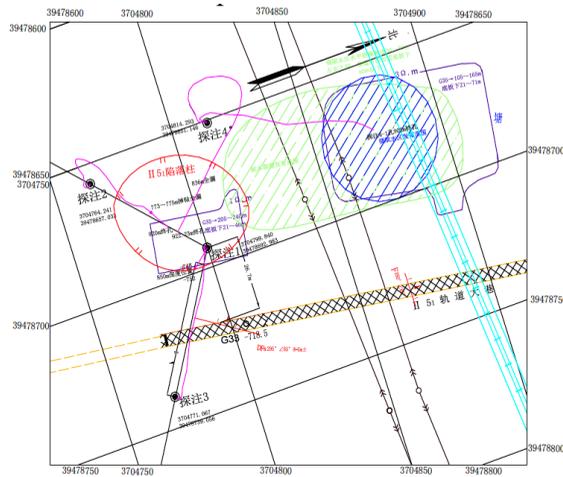
Combined with the drilling verification described above, the collapse column was accurately mapped, and the spatial position, boundary and height of the collapse column were controlled. At the same time, the drilling verification also showed that the identification and comprehensive detection results of a

Fig. 12 The collapse column boundary
