# Pumping borehole for saline mine water in Whitburn, North East England: Problems and novel resolution

Lee M Wyatt, John Leyland, Ian A Watson

Coal Authority, 200 Lichfield Lane, Mansfield, NG18 4RG, leewyatt@coal.gov.uk

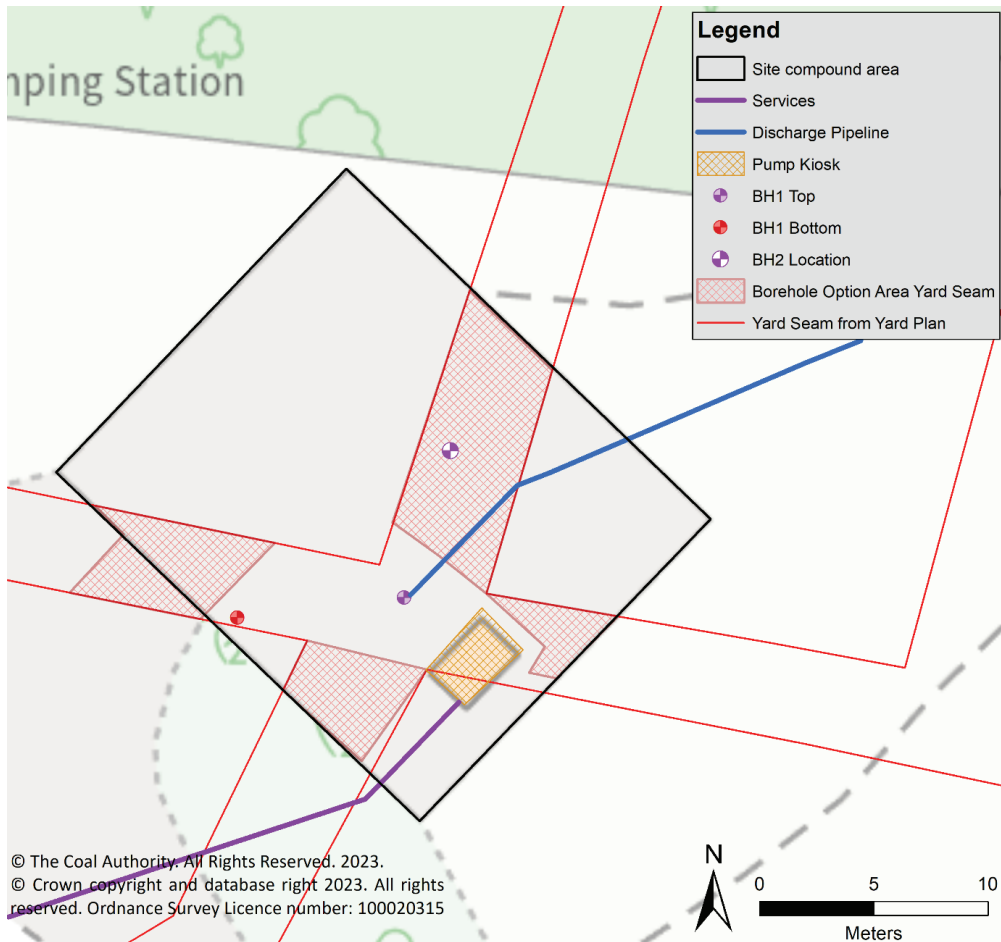
Figure 1 Whitburn site compound with expected underground mine workings in the Yard Seam

The borehole at Whitburn was constructed in 2010 and targeted an underground roadway (125 m from the No.2 shaft) in the Yard (regional index G) Seam (fig. 1). The borehole

drilled borehole. Further review of Yard Seam workings shown on other seam plans, indicated it to be probable that the borehole was to the west of the roadway, and likely within 1 m.

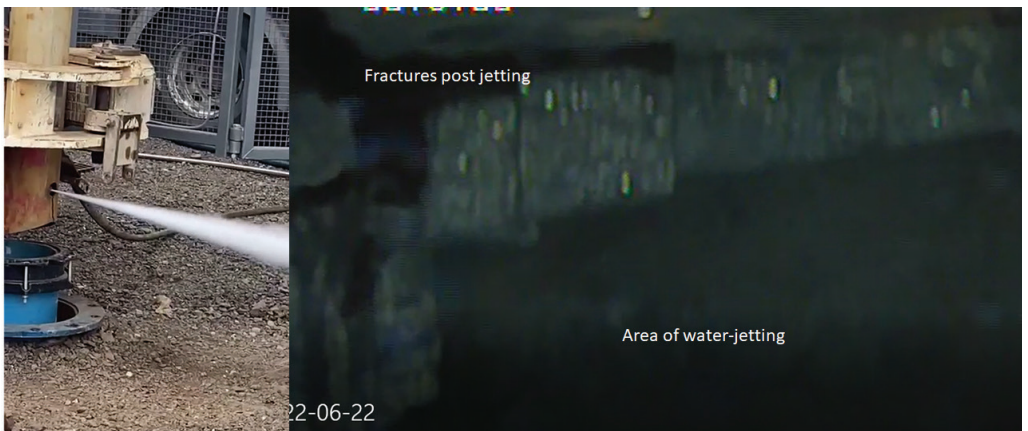
Figure 3 Water jet test at surface (left), and borehole CCTV image post-water jetting (right). Photograph from Integrated Water Services and European Geophysical Services

Based on the post jetting tests, it was estimated that the works created a slot in the coal seam, approximately 120 to 150 mm wide and 300 mm high, in the east side of the borehole. The slot dimensions are considered to be similar to the open-hole section in the roadway of the original BH1.

The water-jetting has been successful and increased the yield of the borehole from <0.01 L/s to >30L/s, this is likely because the jetting created a pathway through the coal to the roadway. Acoustic images and geophysical surveys were taken post water-jetting, the data shows possible fracturing and / or collapses that appeared following the water-jetting works. The precise extent and dimensions of the fractures etc. are unknown. It is also uncertain if the pathway is direct result of the water-jetting, or a secondary result from collapse above the water-jetting zone. Collapses of the borehole between the roadway and base of casing would likely deposit material in the sump at the bottom of the borehole (approximately 8m below the roadway) and at the time of the works, the borehole was seen as effectively not fit for purpose of pumping mine water.
