# Flow Failure of TSF Brunita in 1972, SE Spain

Joanna Butlanska<sup>1</sup>, Aldo Onel Oliva-González<sup>2</sup>, Jose Antonio Fernández-Merodo<sup>3</sup>,  
Roberto Rodríguez-Pacheco<sup>4</sup>

<sup>1,2,3,4</sup>Consejo Superior de Investigaciones Científicas, Centro Nacional Instituto Geológico y Minero de España, 28003 Madrid, Spain

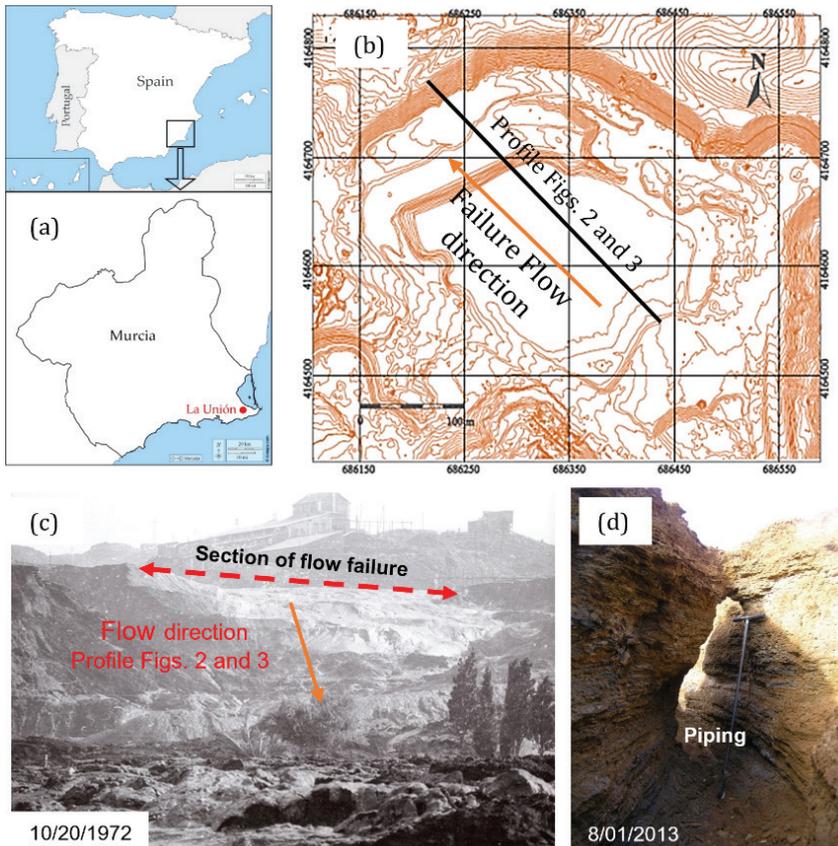
Based on the information consulted and field mapping (Fig. 1), it is hypothesized that the flow failure of the TSF Brunita was due to a poor drainage system. The Brunita's drainage system consisted of rigid, ceramic, and perforated pipes (2 m length and 20 cm inner diameter) installed at the bottom of the valley. Pipes were joined together with the cement as the deposit grew. Moreover, pipes were not protected against the entry of fines. The failure of the drainage system facilitated the development of piping around the pipes (Fig. 1d). To validate this hypothesis, two cases of TSF stability analyses were considered: I) a deficient drainage system, and II) an efficient and sufficient drainage system.

Figure 1 TSF Brunita, a) localization, b) topography of the TSF before the breach including the profile used in calculations, c) area affected by a flow failure and d) piping in TSF Brunita 50 years post-failure.

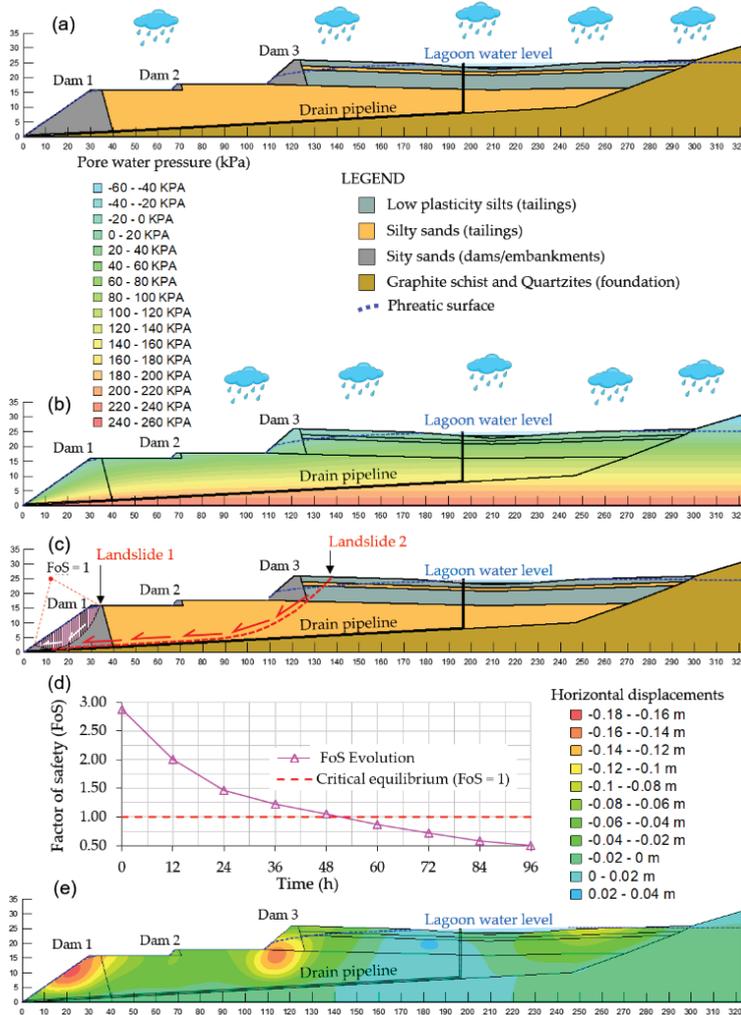
The results of the numerical simulation (Fig. 2) confirmed that the hypothesis regarding the insufficiency of the drainage system as the main cause of the failure was correct. The simulation indicated that the

drainage system in place at the time of the rainfall was inadequate to evacuate the water stored within the facility. Fig. 2b shows a distribution of pore water pressure resulting from the saturation of the tailings from heavy rain, with the flooded surfaces of dams 1 and 2. The loss of stability is confirmed by the drop in the safety factor of the TSF (Figs. 2c and d). As shown in Fig. 2d, the factor of safety (FoS) reached 1 (limit equilibrium) 48 hours after the onset of rainfall, which aligns with the first landslide experienced by the TSF Brunita as described by MIN (1972). The slipped zone shows displacements of the mass of embankment 1 of 0.18 m (Fig. 2e),

Figure 2 Behaviour of the TSF Brunita with an insufficiently drainage system: (a) conceptual model, (b) pore water pressure resulting from tailings saturation (time = 48 h), (c) slip surface of TSF Brunita, (d) reduction of FoS of the dam 1 of TSF, (e) displacements computed in TSF (time = 48 h).

while the displacements at the base of dike 3 are 0.12 m. The water flow through the dam 1 slope at the time of failure was 11.27 m<sup>3</sup>/s (Appendix 1 Fig. 3).

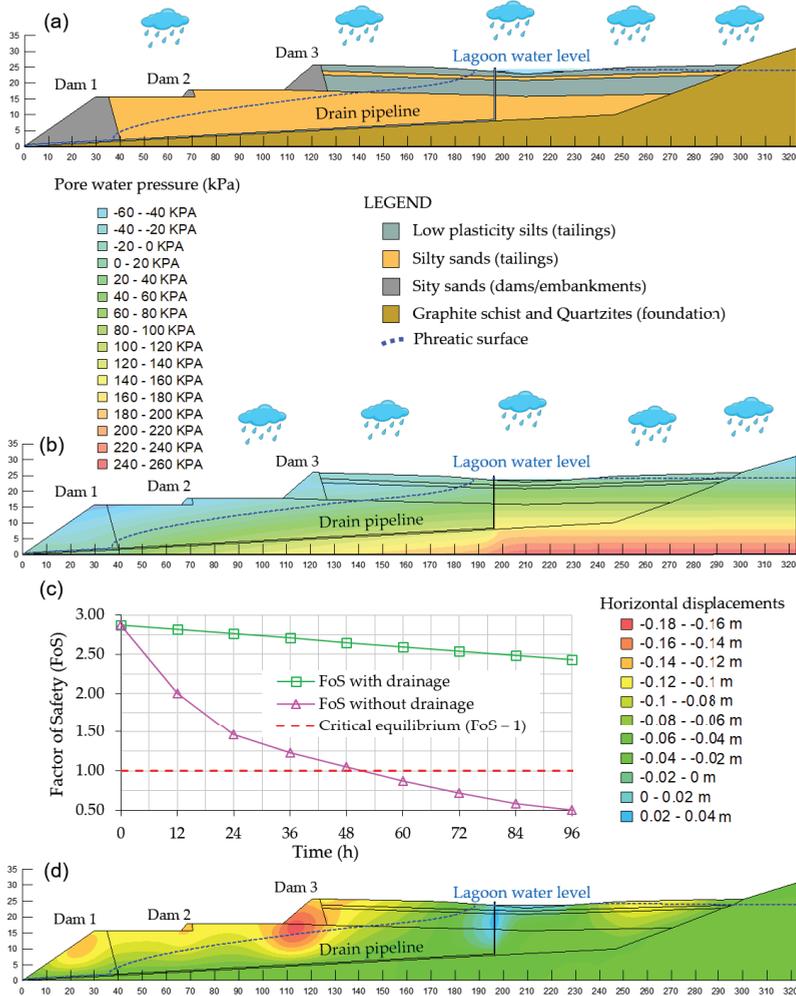
In this case, a drain with a saturated hydraulic conductivity of 0.001 m/s was installed. When the drain is functioning, there is no increase in pore pressures (Fig. 3b). As shown, all three embankments remain in an unsaturated condition. If the drainage system can evacuate the volume of infiltrated water throughout the period of heavy rainfall,

the factor of safety (FoS) remains higher than 2 (Fig. 3c). As seen in Fig. 3d, no large deformations occur in embankment 1. The largest deformations occur in embankment 3, which is consistent with the increased saturation of the tailings.

Figure 3 Behaviour of the TSF Brunita with a sufficiently drainage system (a) conceptual model, (b) pore water pressure resulting from tailings saturation (time = 48 h), (c) comparison of the safety factor of tailings dam 1 for the case with and without drainage, (d) displacements computed in TSF (time = 48 h).

- **Design and maintenance:** It is essential to design and maintain adequate drainage system that should include more elements to evacuate water (impermeable membranes, drainage canals, tailings dewatering, etc.) to mitigate the risks of severe weather events, which are increasingly common due to climate change.
