International Journal of Mine Water, Vol.4, No.4 (1985), pp.21-35 Frinted in Madrid, Spain

VENTILATION SHAFT WATER INFLOW CONTROL

ROSSARDEN TIN MINE, TASMANIA, AUSTRALIA

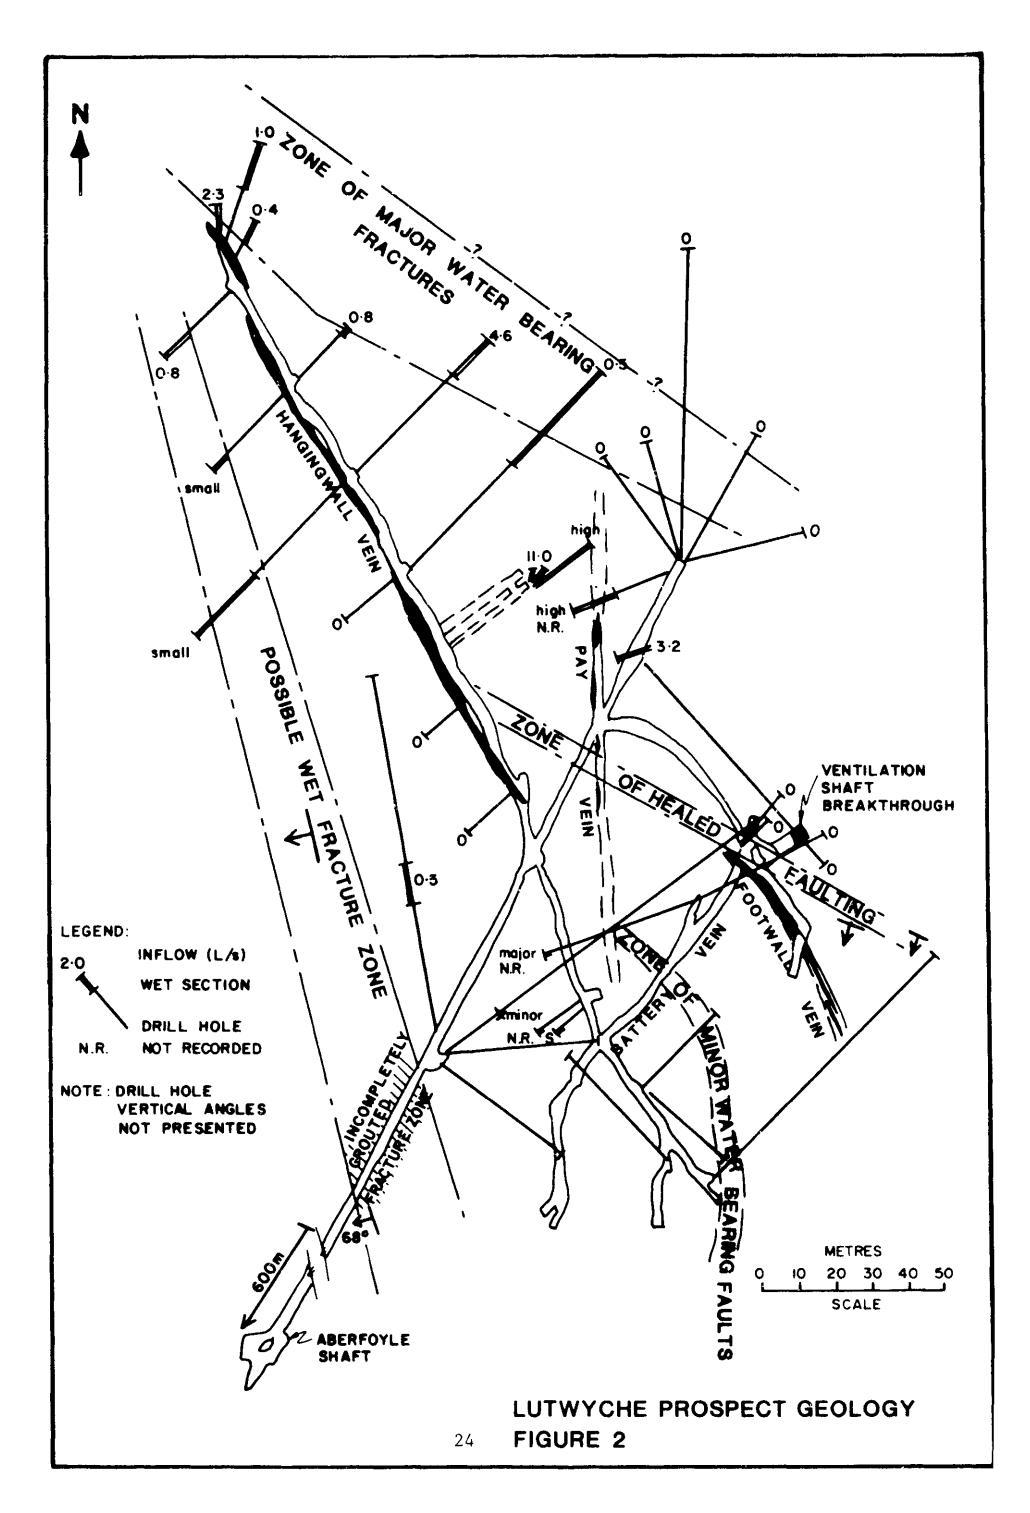
It has been concluded that, even though the faulting and fracturing post dates the mineralization, the Hanging Wall Vein and the Zone of Healed Faulting (Figure 2) have affected the persistance of the fractures as hydrological conduits and fractures east of these structures generally exhibit high sustained flows while those to the south and west only show high initial burst flows.

The ventilation shaft was proposed to intersect the Lutwyche Project level immediately adjacent to the zone of Healed Faulting (Figure 2). No geological information existed on the section to be intersected by the shaft. No investigation holes had been drilled for reason of economics.

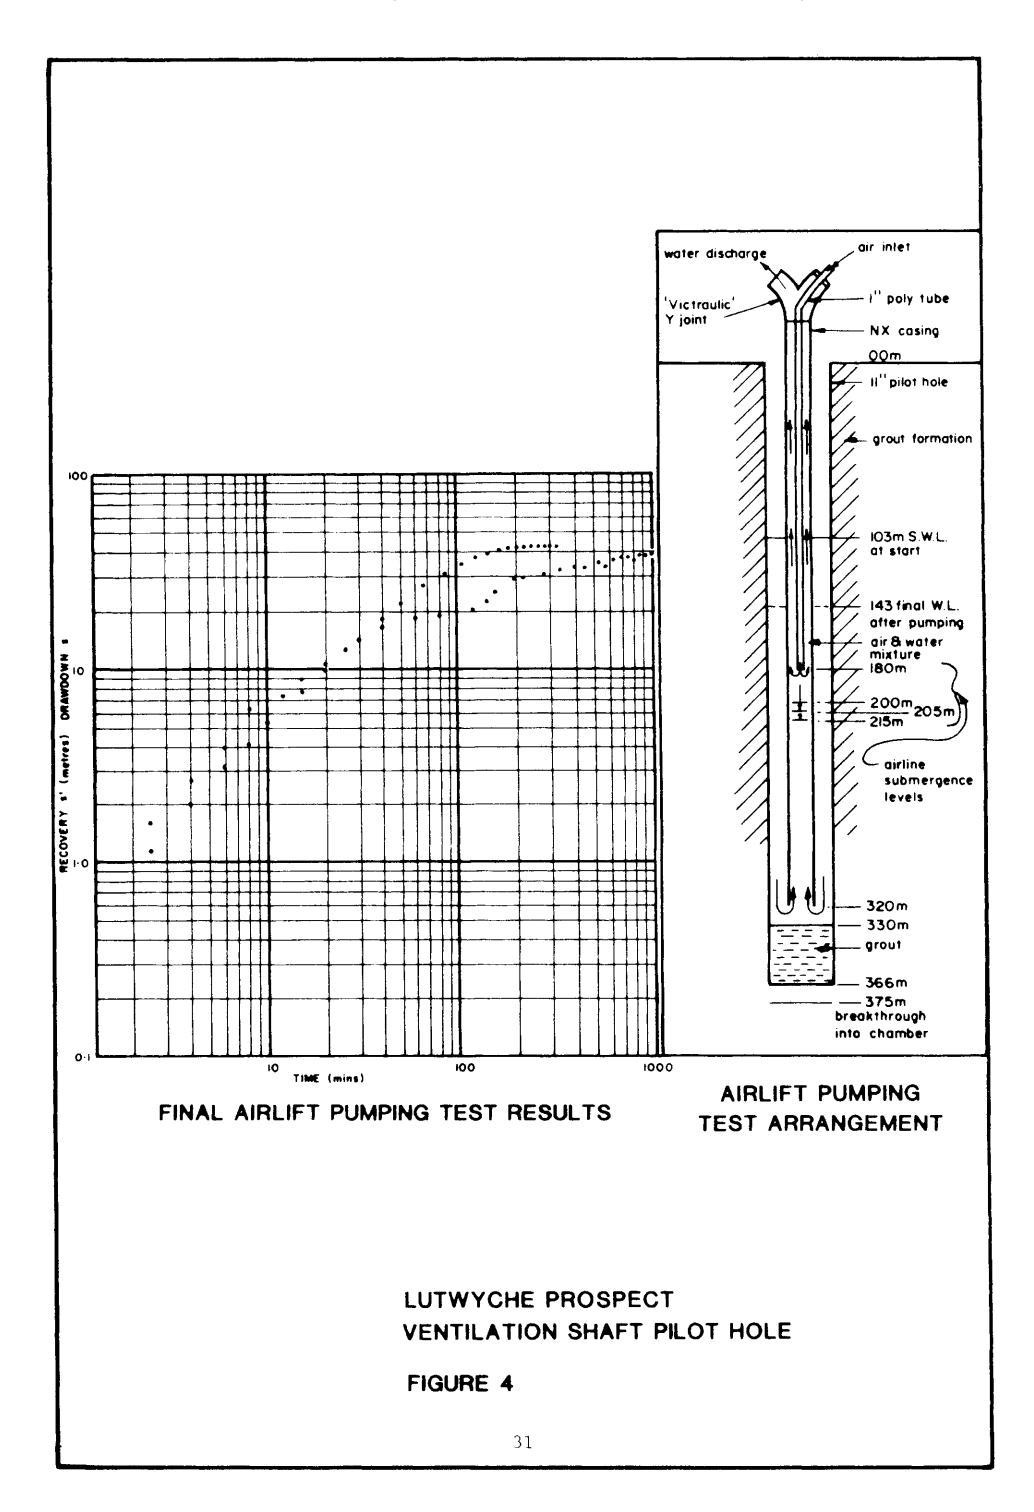
An air lift pumping test was conducted with an eductor pipe as shown in (Figure 4) on completion of drilling and in advance of break through. The test was run for 1,060 minutes with the air inductor line being progressively lowered to ensure constant submergence, constant hydraulic efficiency and thereby, constant discharge. The pumping test curve shows the impact of the hole volume in the test results. The pumping test data both for drawdown and recovery were analysed using the techniques of Papadopulos and Cooper (1967). This analysis indicated a residual fractured rock transmissivity to the hole of $0.5m^2/d$. Estimating storativity at 1 x 10⁻⁷, the inflow to the shaft at full diameter was estimated at less than 3.8 L/s. The actual inflow recorded on completion of reaming was 3.75 L/s. This inflow falls within the tolerable limit for the shaft and mine operation.
