**Mid-Conference Excursion 1**  
**Eric Parsons, Bob MacDonald**

**Surface Remediation**

**International Mine Water Association**

## Former DEVCO Sites—Surface Remediation

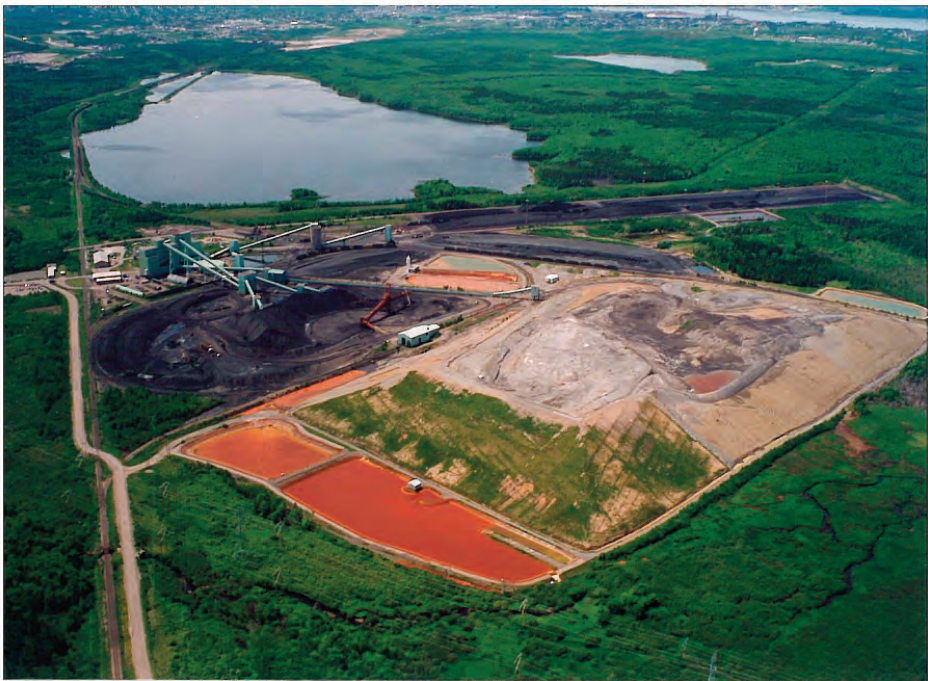
*Figure 1 Victoria Junction 2001 - Prior to remediation activities*

Initial activities involved the demolition of the above ground structures. This work was followed by an assessment, planning and design program to determine the best approach to mitigate impacts to the local environment. The outcome of this program was a design to reduce/eliminate water contact with the waste rock and coal fines at the site. The waste rock pile was graded, shaped and capped with a high density polyethylene (HDPE) liner. In addition to the work at the waste

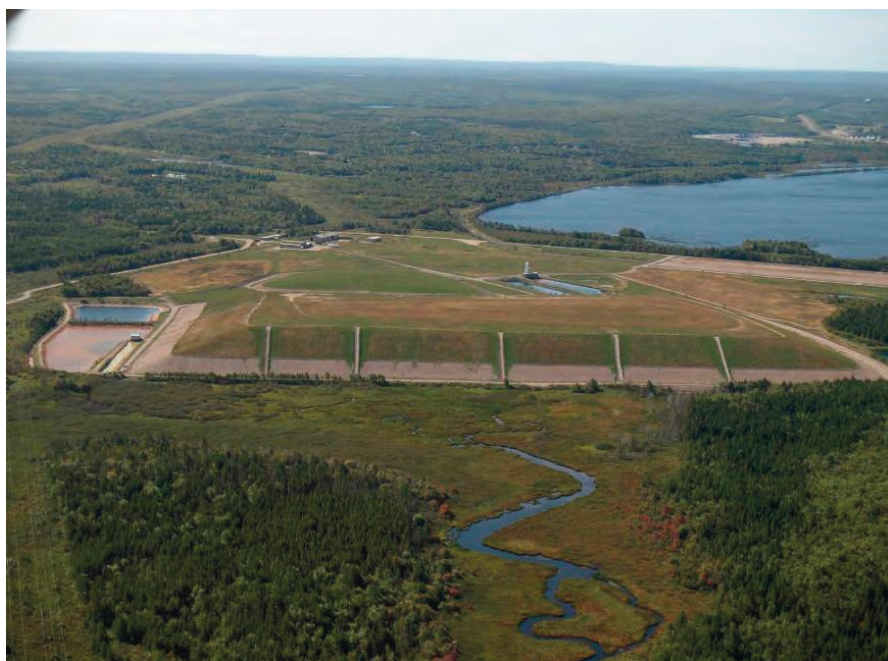
*Figure 2 Victoria Junction 2007 - Post remediation activities*

rock pile, the same approach was applied to coal waste located at the centre of the site. In both cases, the premise was to reduce the movement of water through the waste rock/coal waste resulting in a reduction in the production of ARD and metals and subsequent positive impact on the local environment. The project was completed in 2008.

As with all of the sites, a long-term care and maintenance program has been established to monitor the performance of the cover system and to better understand the effect of the remediation/reclamation approach on the surrounding environment. To date, there has been a significant reduction in the height of water within the waste rock pile in addition to improvements in the adjacent wetland area.

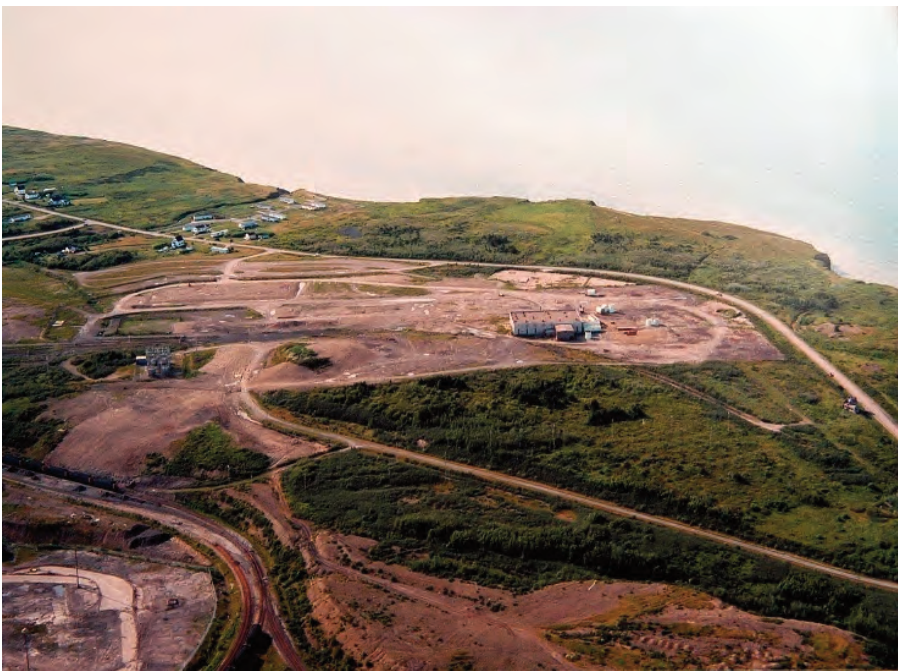
*Figure 3 Former Lingan Mine – Prior to remediation activities*

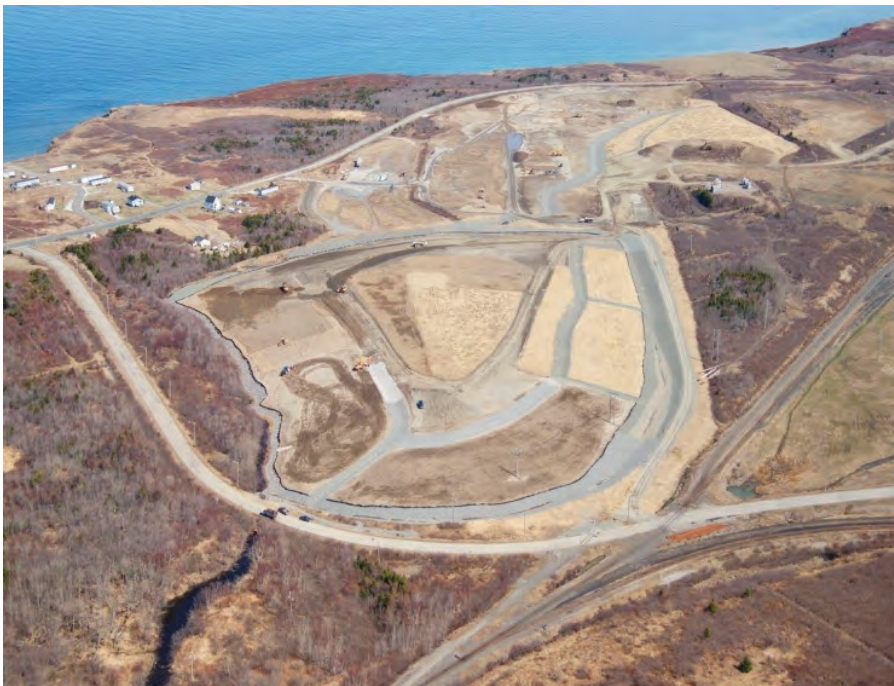
*Figure 4 Former Lingan Mine – Post remediation activities*

As with the majority of the sites associated with the site closure program acidic rock drainage (ARD) and metal impacts in soil, groundwater and surface water were the main issues that drove the remediation/reclamation of the Lingan site. Remediation/reclamation activities were complete in 2010. The Lingan waste rock pile has been graded and a soil cover installed and hydro-seeding completed to support vegetative growth. In addition, perimeter and drainage ditches were installed at the site to help manage rainwater and prevent soil cover erosion. Toe protection has been installed at the base of the pile for long-term protection and stability. As with all of the sites, a long-term care and maintenance program has been established monitor the performance of the cover system and to better understand the effect of the remediation/reclamation approach on the surrounding environment.

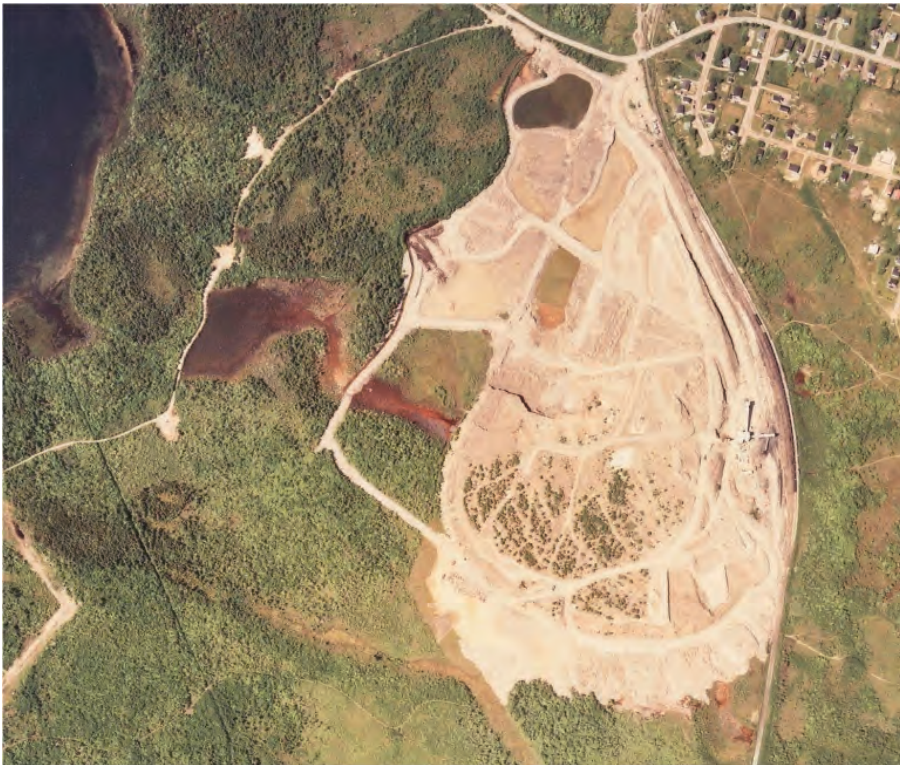
*Figure 5 Summit Waste Rock Pile – Prior to remediation activities*

In 2003, assessment activities were completed to support planning and design activities for the reclamation of the site. Results determined issues linked to the waste rock and ARD: acidic paste pH of 3.5 to 4.7; contaminated surface run-off (elevated metals) to Kilkenny Lake Brook and Irish Brook; groundwater impacts (elevated metals) moving toward Waterford Lake (water supply for the Town of New Waterford); and lack of vegetative growth in certain areas of the waste rock pile.

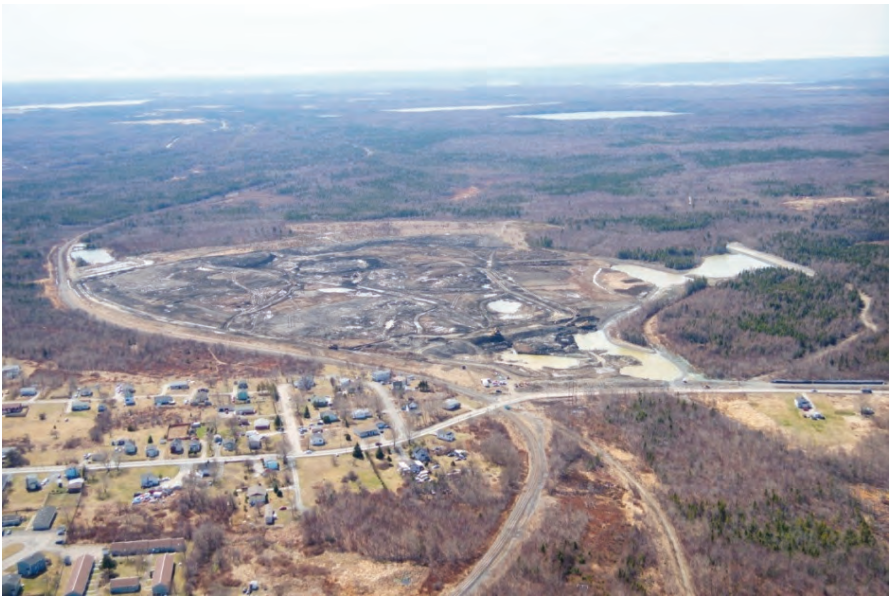
*Figure 6 Summit Waste Rock Pile – Currently under construction*

In 2009, following detailed assessment and groundwater modeling it was determined the waste rock pile should be reshaped and consolidated and an engineered cover placed over the pile to deal with the issues identified at the assessment stage. The cover will include a sand layer, a HDPE liner, a geonet drainage layer, a soil layer and vegetation, as well as drainage features for the management of surface run-off.

Consolidation efforts in the north area of the waste rock pile are under way to reduce the final footprint of the pile. It is anticipated that the cover project will commence in October 2010 with completion planned for September/October 2011.

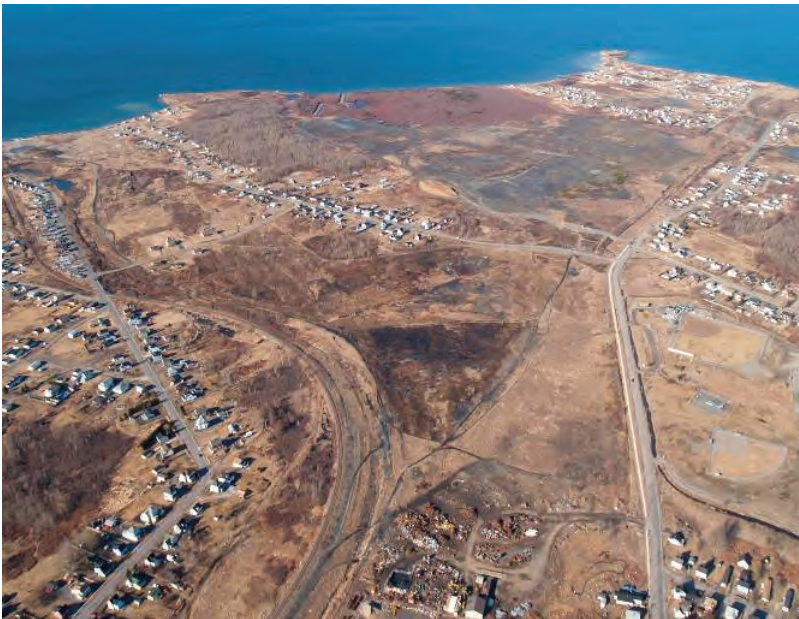
*Figure 7 Former Princess Mine – Prior to remediation activities*

As with the majority of the sites associated with the site closure program acidic rock drainage (ARD) and metal impacts in soil, groundwater and surface water were the main issues that drove the remediation/reclamation of the Princess site. To date, the federal government has spent over \$15 million dollars on remediation/reclamation at the Former Princess Colliery site. Much of the work has been focused on the plant site and waste rock areas. Cleanup work on the Plant Site is

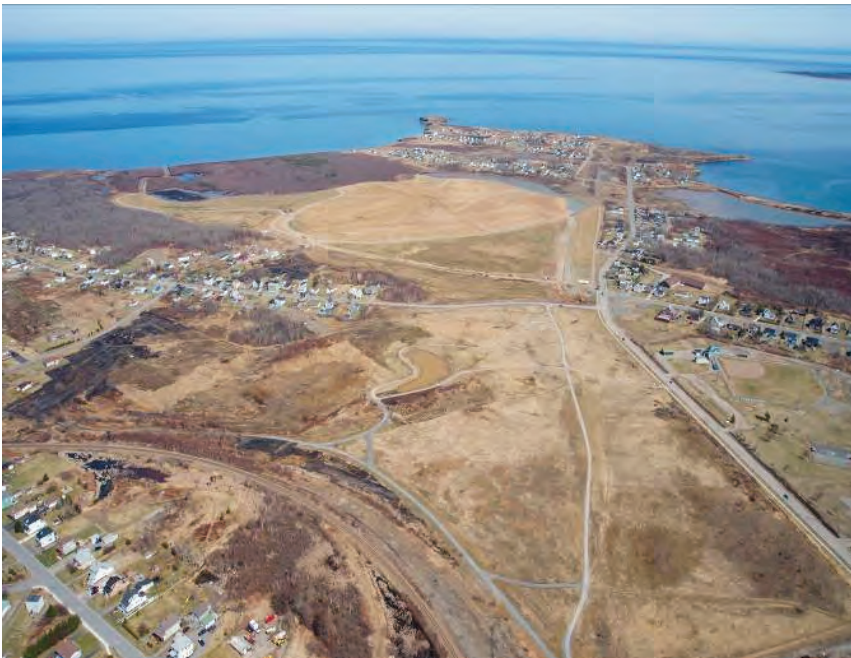
*Figure 8 Former Princess Mine – Post remediation activities*

complete. The area has been landscaped with a green field, walking trails, a pond that can be used for skating in the winter, and interpretative panels telling the story of the site. Work on the Course Waste Rock Pile has involved grading, reshaping and installing a high-density polyethylene liner. The northwest quadrant of the coarse waste rock pile has been capped with a soil cover and vegetation has been established. The eastern edge of the site along Pitt Street has been cleaned, graded, covered and vegetated. The last phase of this project will involve the remediation of Edwards Pond. Edwards Pond is a small pond to the east of the Waste Rock Pile and is connect to the main site via a small brook. The outlet of the pond discharges to the ocean. This pond has been impacted by waste rock and coal fines over the years. Remediation/reclamation is scheduled for late Fall/early Winter 2010. As with all of the sites, a long-term care and maintenance program has been established monitor the performance of the cover system and to better understand the effect of the remediation/reclamation approach on the surrounding environment.
