# The potential environmental impact of the decant of water from Witwatersrand

**Henk Coetzee, Uwe Horstmann, Gabriel Ntsume & Leon Croukamp**

Council for Geoscience, Private Bag X112, Pretoria, 0001, South Africa.

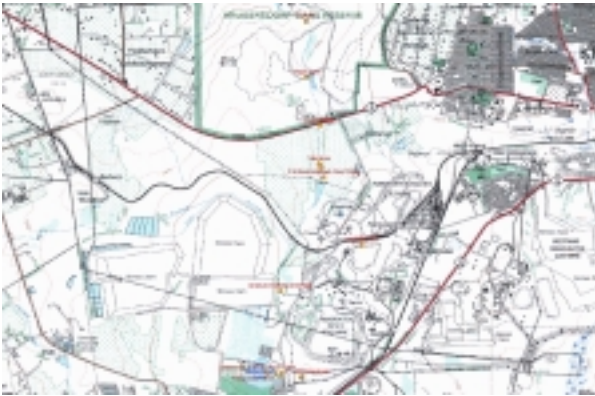
Figure 1. Locality of the area affected by discharge from West Wits Gold Mine. Sampling points are shown and annotated

In July 2002, an official of the Krugersdorp Municipality noticed water entering the Tweelopiesspruit from West Wits Mine and flowing towards the Krugersdorp Game Reserve. On the 28<sup>th</sup> of August, it was determined that the source of the water was a borehole immediately upstream of the Game Reserve. At this time, the water was disappearing into the dolomitic aquifer upstream of the "Dry Dam" approximately 400m into the Game Reserve. Around the 2<sup>nd</sup> or 3<sup>rd</sup> of September a large volume (estimated at 9MI/d) of water began to discharge from an abandoned shaft, now named "Buks se Gat" (See Figure 2), in the Tweelopiesspruit valley immediately upstream of the Game Reserve boundary. A map of the area, together with the sampling points used for the second part of the study is shown on Figure 1.

On 7 November 2002, a sampling trip was undertaken. The aim of this trip was to collect samples and to establish hydrogeochemical conditions in the field. The sample positions are shown on Figure 1 and the layout of the site is shown schematically on Figure 3. Also shown on this figure are the locations of sampling points, and seepages. At two sites, Harmony Gold have started water treatment activities. These are also indicated on the diagram.

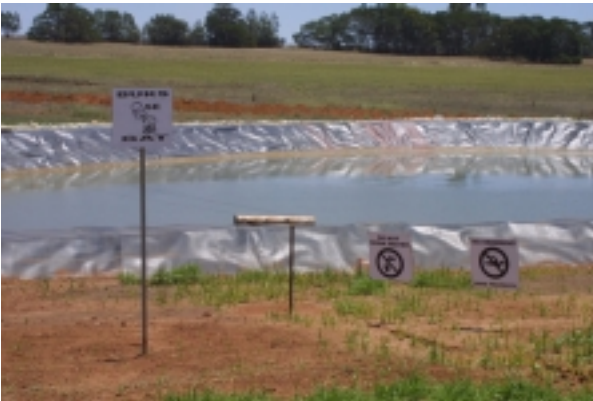
Figure 2. Temporary dam constructed to store water at Buks se Gat.

When the water started to decant from the shaft, the mine operator built a sump and began introducing a flocculent into the water at the discharge point. The water was initially diverted to a nearby dam, where a significant amount of ferric hydroxide has been seen to contaminate the dam sediment, but was later pumped to Robinson lake with a limited holding capacity. Water has been observed seeping from the sump into the Tweelopiesspruit. Within the sump, the small dam where water was originally pumped and the seepage, ferric hydroxide precipitate was noted.

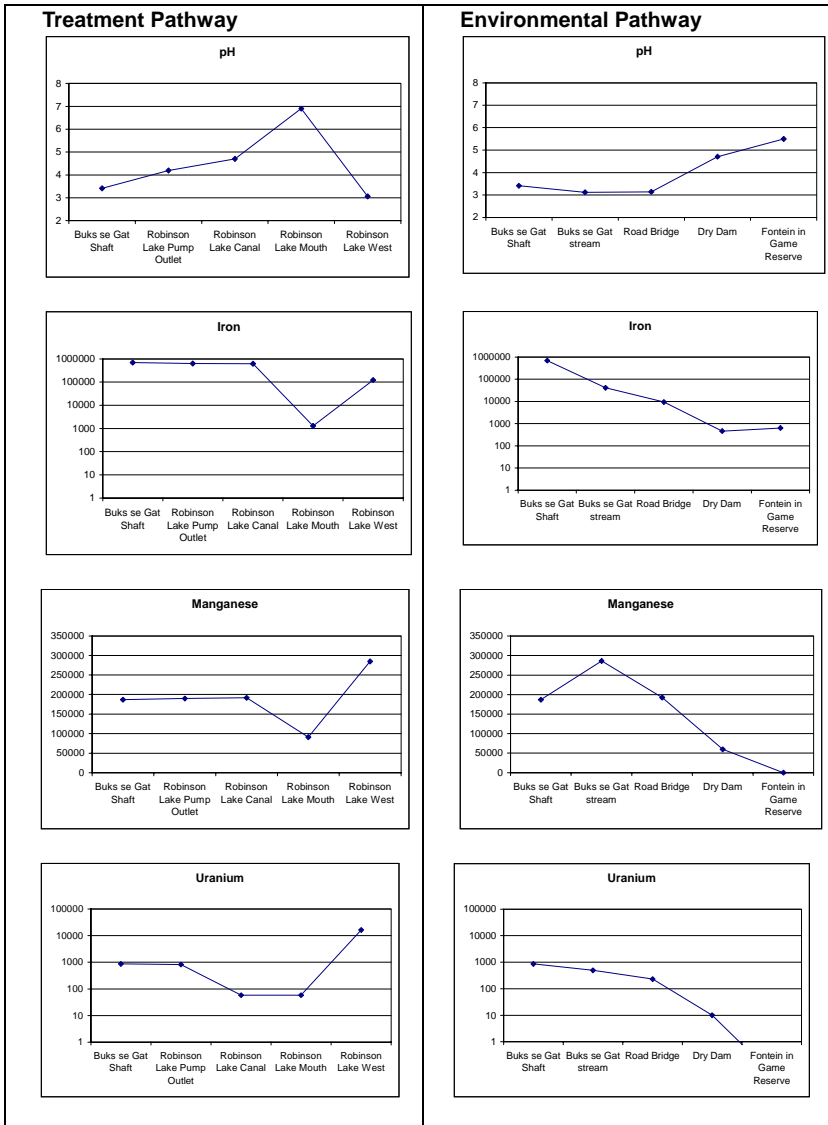
Figure 6. pH, iron manganese and uranium for the treatment and environmental pathways. (Note that iron and uranium have been plotted on a logarithmic scale.)

Graphs of the concentrations of selected elements are shown on Figure 6 The following trends are seen in the data:

In the environmental pathway all parameters tend to improve with increasing distance from Buks se Gat, indicating the natural attenuation of pollution. It should however be noted that conditions inside the Krugersdorp Game Reserve are unacceptable, particularly in the Dry Dam, which is currently home to two hippos (See Figure 7). S du Toit of the Mogale Municipality reports that the water level in this dam has been steadily rising for several months. The current water quality is relatively poor.

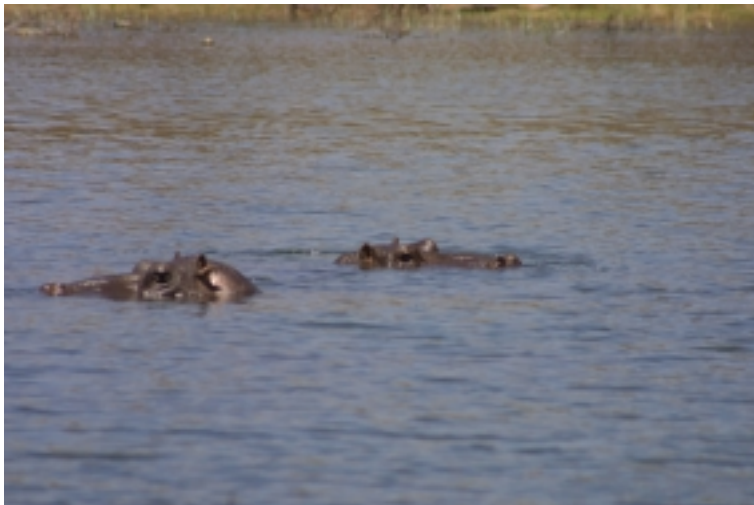
Figure 7. Hippos in the "Dry Dam" in Krugersdorp Game Reserve

During this period, the Dry Dam began to fill with water, in response to a raised water table in the underlying dolomite. The water level in the dam is approximately the same as in an adjacent borehole.

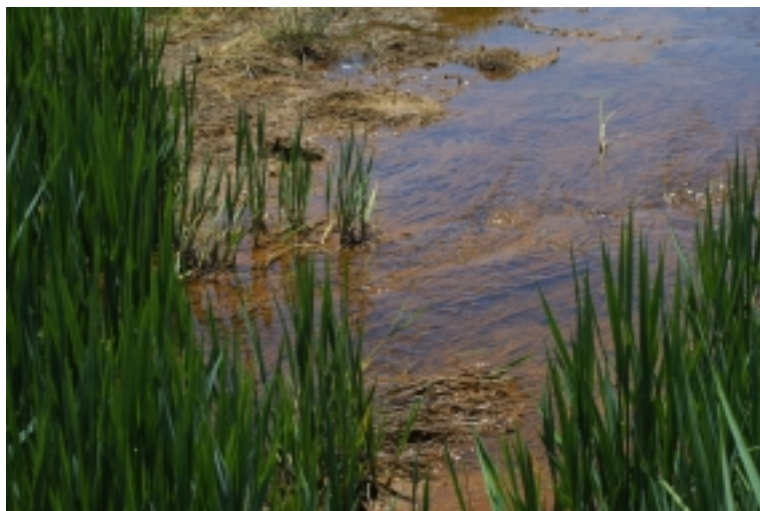
Figure 8. Wetland downstream of Buks se Gat. Note the orange ferric hydroxide gel coating the vegetation and sediment.

A greater concern is that the wetland between Buks se gat and the Road separating the mine property from the Game Reserve is having only a minor influence on water quality. This could be due to the short residence time of the water in the wetland, as well as the coating of the reactive surfaces in the wetland with a ferric hydroxide precipitate (See Figure 8). A laboratory experiment conducted at the Council for Geoscience indicates that the same precipitate is likely to form when water reacts with dolomite surfaces, with the precipitate forming a gel that armours the dolomite preventing further neutralisation reactions. This precipitation of ferric hydroxide from the water as soon as it enters an oxidising environment will be a major constraint on any use of dolomite as a neutralising agent either in passive treatment plants or in any natural attenuation scenario. It is likely that the low pH value seen at the Spring in the Game Reserve illustrates the inability of the natural environment to fully attenuate the pollution from Buks se Gat. Nevertheless, the natural attenuation pathway is seen to outperform the limited treatment which has been undertaken.

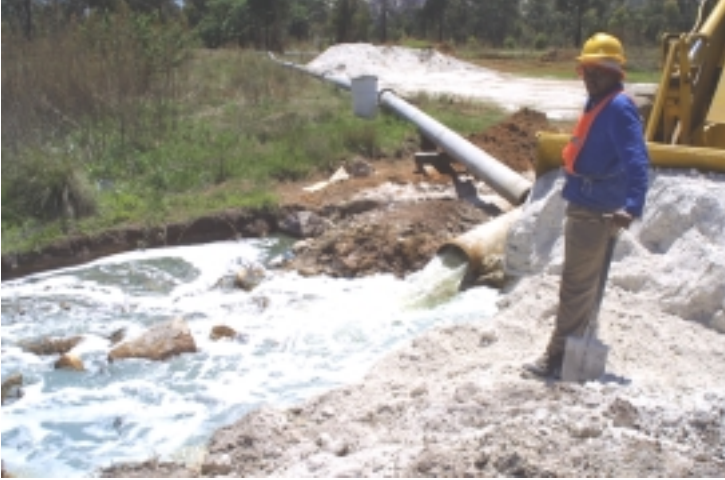
Figure 9. Worker adding lime to the water from Buks se Gat at the discharge into Robinson Lake.

The condition of Robinson lake is also most likely a result of the oxidation of  $\text{Fe}^{2+}$  to  $\text{Fe}^{3+}$  and the precipitation of ferric hydroxide. Water is pumped from Buks se Gat and discharged into Robinson Lake via a short canal, where lime is added in an attempt to control the low pH of the water (see Figure 9).

This action has an immediate effect on the low pH of the water, raising it from 4.19 at the discharge to 6.9 at the end of the canal. Unfortunately, this does not adequately address the acidity of the water<sup>1</sup>. After entering the lake, the water mixes with the aerated water in the shallow lake (see Figure 10). The soluble  $\text{Fe}^{2+}$  is oxidised to insoluble  $\text{Fe}^{3+}$ , which forms ferric hydroxide, removing hydroxyl ions from the water, leaving an excess of  $\text{H}^+$  and consequently a lower pH. This low pH will also increase the solubility of a number of metals in the water. The increased concentrations of manganese and uranium in Robinson Lake seen on Figure 6 and Table 2 probably result from this decrease in pH and interactions with sediment in the lake, which was historically used to store cooling water for a now defunct coal-fired power station, and is likely to have been impacted on by local mining activities over the past century.
