Mine Water Movement in Shallow Medieval Mine Jeroným (Czech Republic)

Key words: medieval Mine Jeroným, mine water, hydrogeological monitoring, Czech Republic

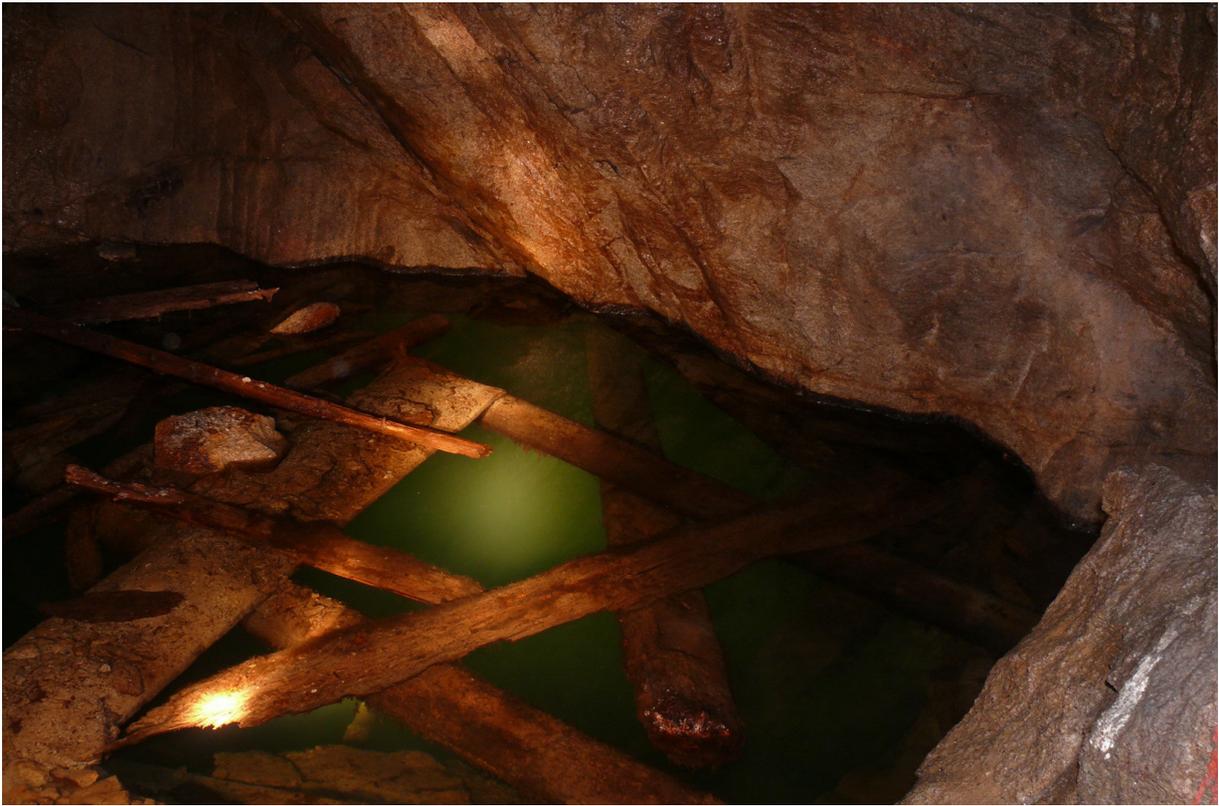
Supplement 1 Backwater

Supplements 1- 3 document types of mine water in Mine Jeroným, supplements 4- 6 document measured locations V2 and V3 (including of decrease of mine water in 2003) and supplement 7 – 8 document mining activities from the 16-17th centuries.

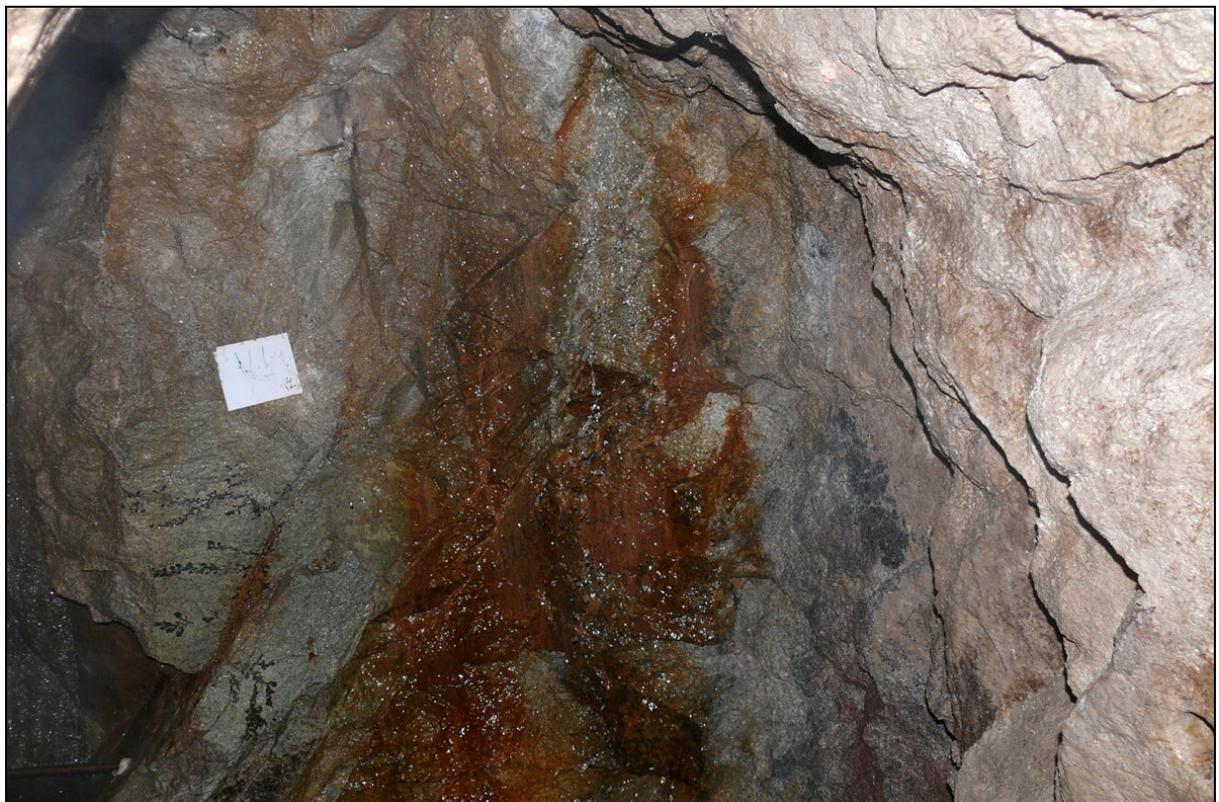
Supplement 2 Running water from crack

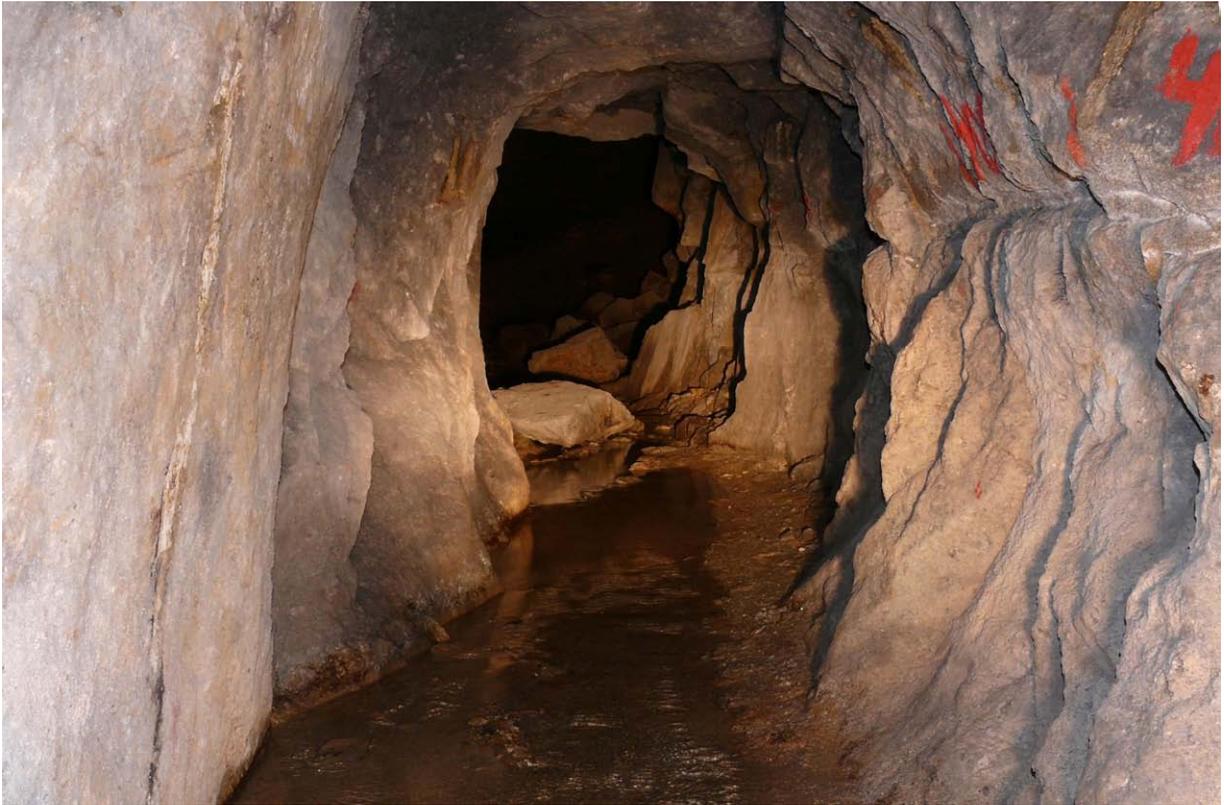
Supplement 3 Outgoing water from backwater (V3 location)

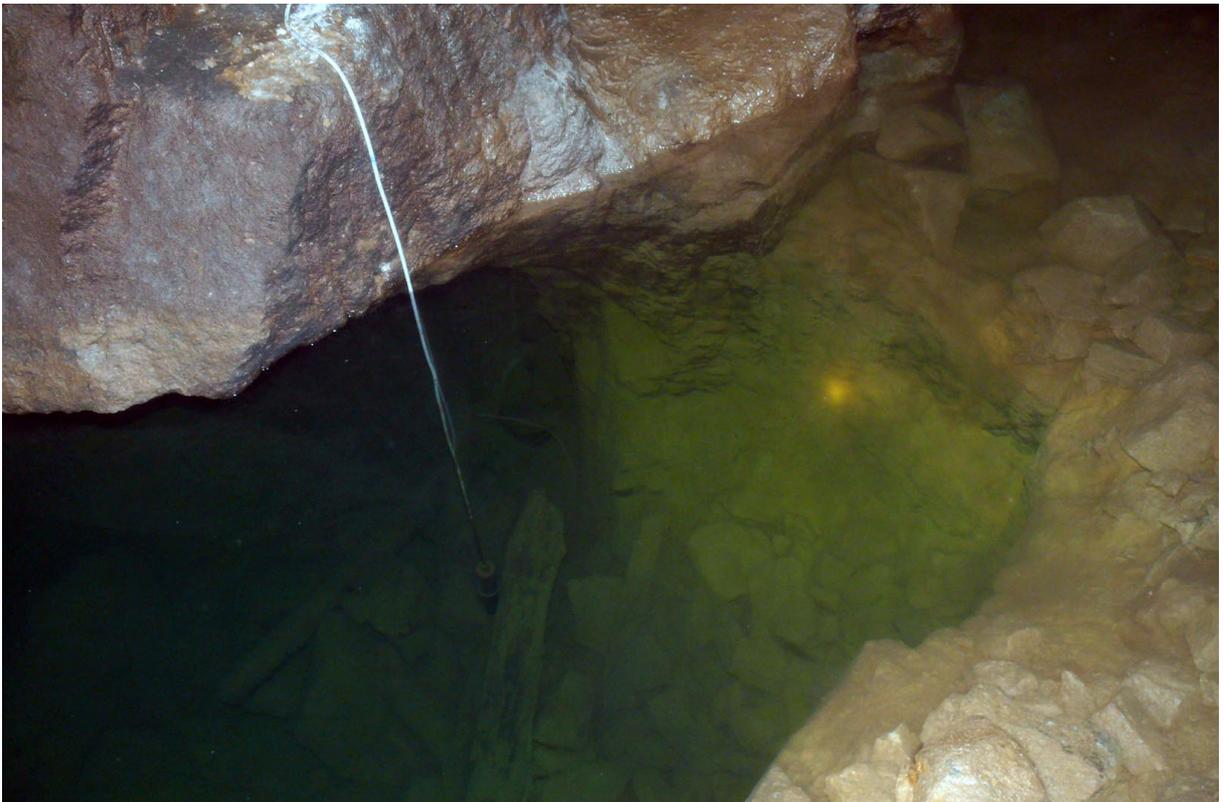
Supplement 4 Probe for continual measurement of fluctuation of mine water level on location V2

Two locations for measurement of the mine water level fluctuation are situated above gallery level near the Jeroným shaft (V1 and V2), rest of the two ones are approximately at level of the Jeroným adit (V3 and V4). Strain-gauge sensors are used for continual hydrogeological monitoring of water level fluctuation at the location V2 since March 2006 and at the station V3 since April 2006. The sampling time is one hour. Knejzlík (2006) presented detailed description of instrumentation. Measured values are relative, again, and were compared with the previous values. Relative values are more suitable for quick orientation and mutual comparison than absolute altitudes. The most important results were obtained from part called Stone Bridge (V2); results from this measurement (Fig. 1, Fig. 2) are briefly described in this chapter.

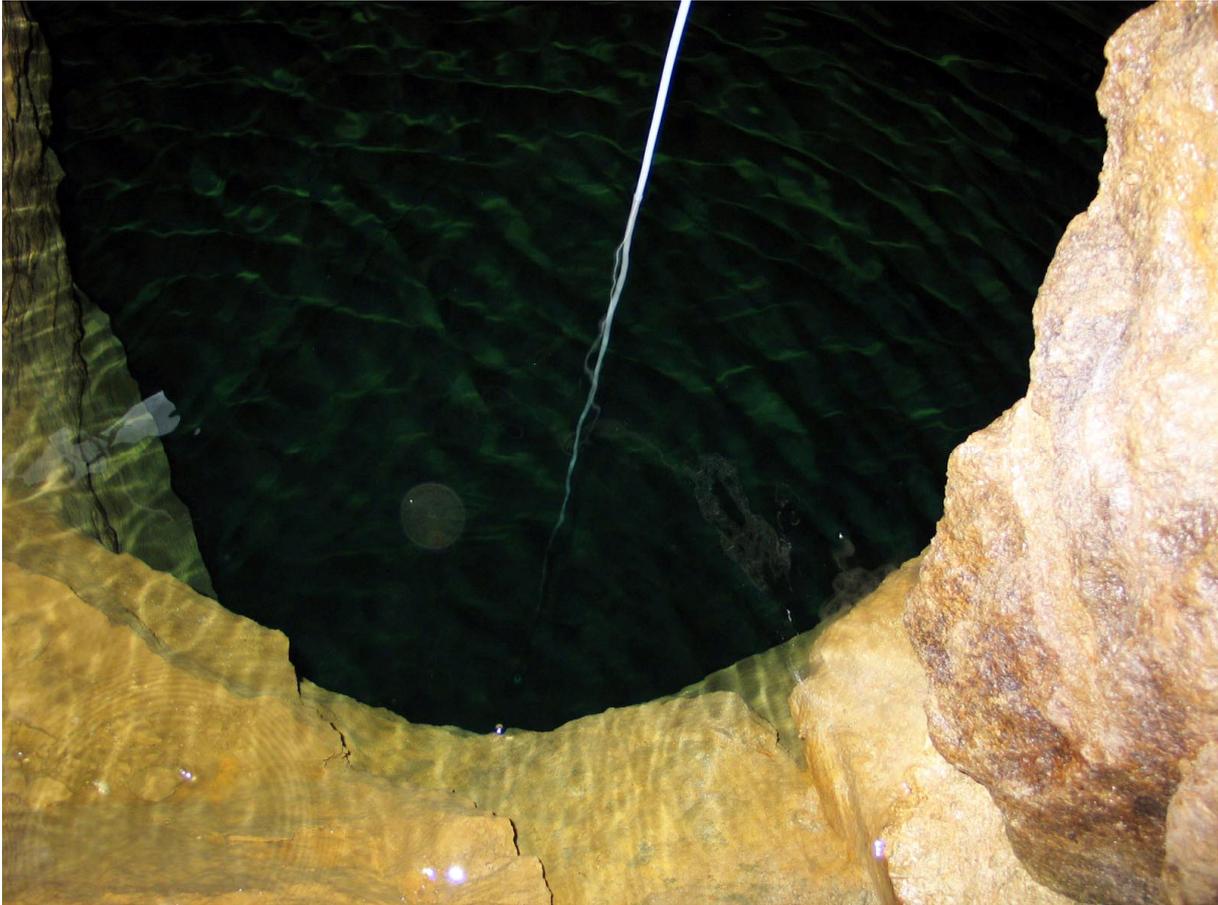
Supplement 5 Probe for continual measurement of fluctuation of mine water level on location V3

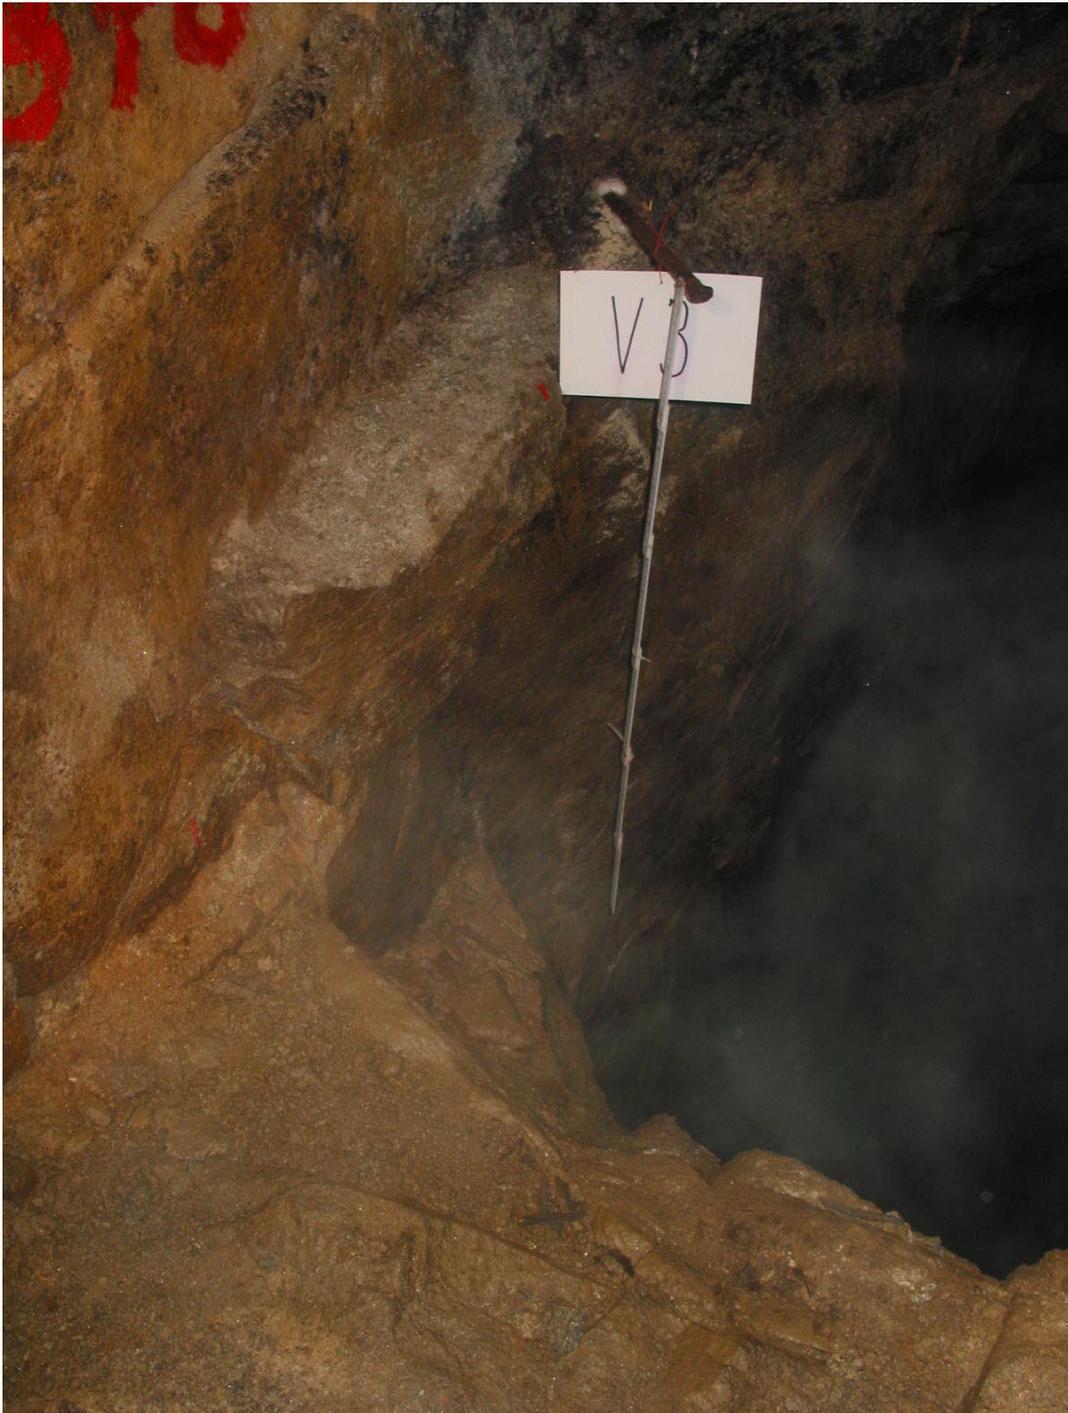
Supplement 6 Sudden loss of water on V3 location in 2003 (fixed meter for quarterly measurements)

Measurement on the V3 location (Fig. 3), excluding measurement at autumn 2003, doesn't show changes – permanent overflow from this separated space is documented. Significant decrease of mine water occurred in 2003. The measured relative value was about 3 m. The evaluation of this fact is difficult because it is not known volume of flooded space and bottom pattern (bottom is covered by stones). Also, dynamics of this decreasing is not possible to evaluate from quarterly observations. One of the hypothesis is existence of next drainage adit that is permanently defuncting.

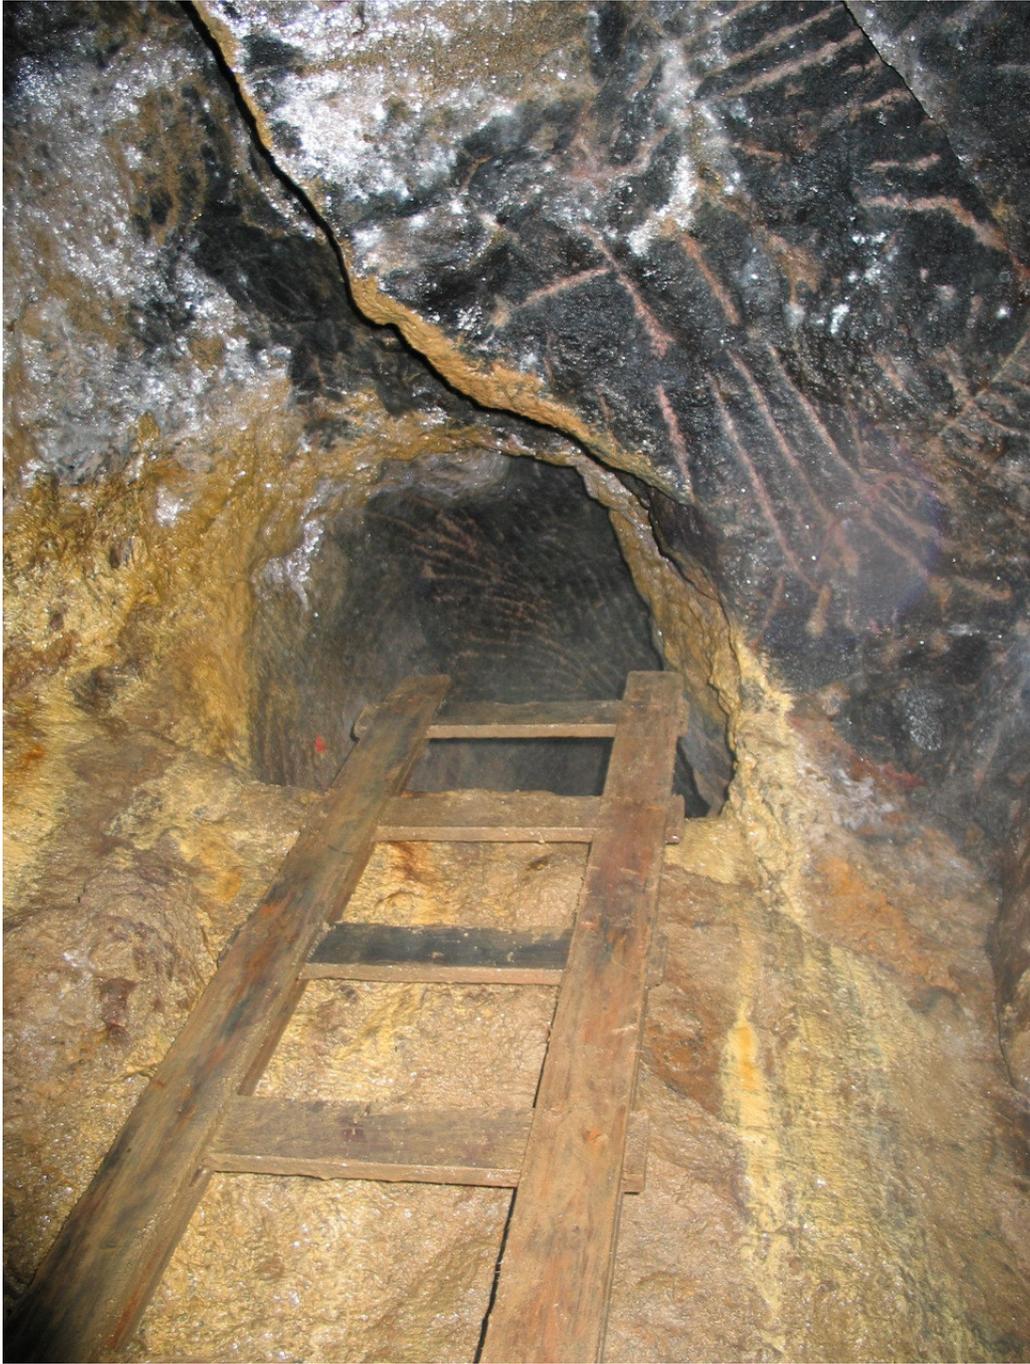
Supplement 7 An example of manually stoped-out adit from the 16-17th centuries

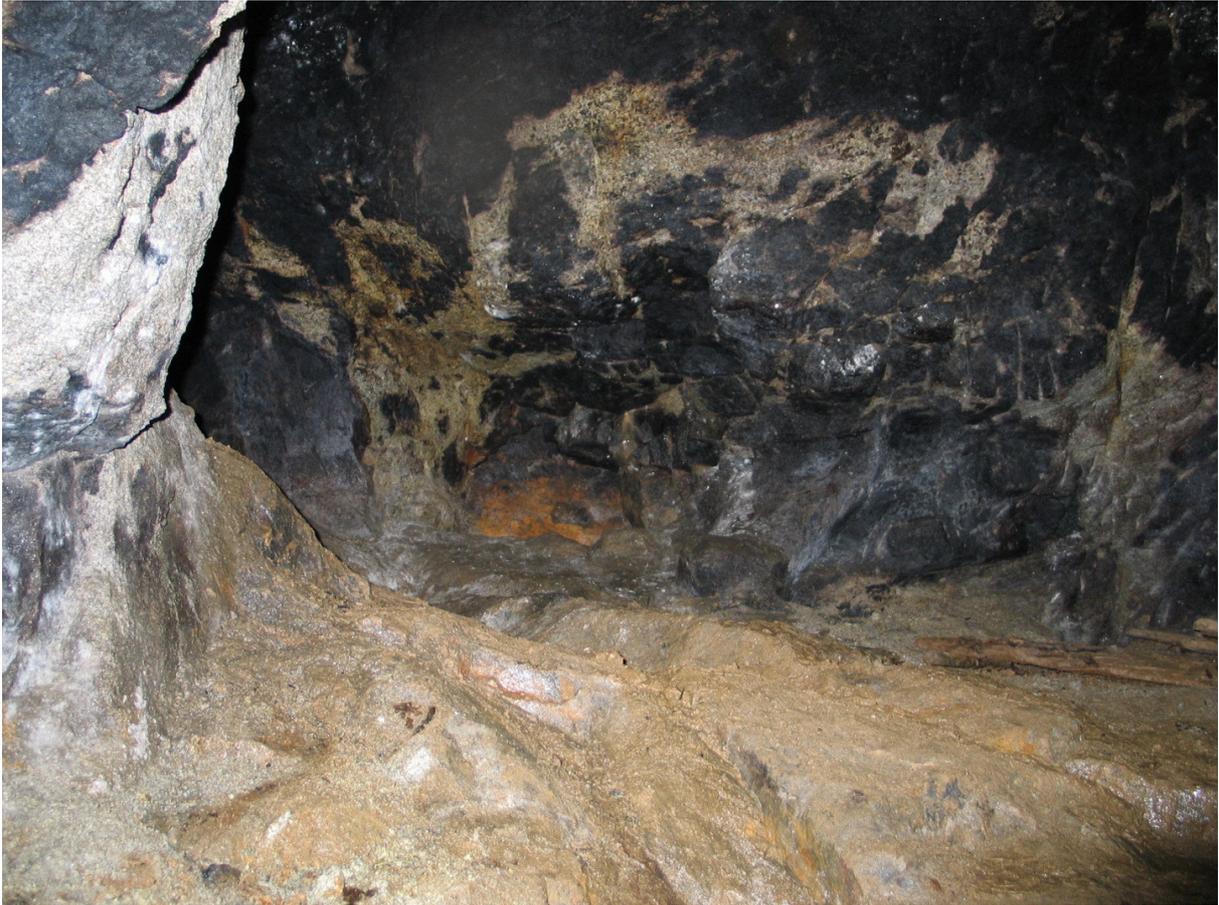
Supplement 8 An example of firing work (soot in underground spaces)
