Under Ice Treatment and Discharge Of A Tailings Impoundment – A Case Study From The Lupin Mine Nunavut, Canada

Andrea Bowie¹, Arlene Stearman¹, Tom Sharp¹ and Patrick Downey²

Abstract Water management and treatment in cold regions faces many challenges, a core one being the limited open water season. In 2015, treatment and discharge of water stored in a tailings impoundment extended into the winter season under complete ice cover. Lime was added to raise the pH (4.7) of poorly buffered water (alkalinity <2.0 mg/L as CaCO₃) into an acceptable range for discharge. In total 2,171,000 m³ were discharged to the environment in 2015 with an average pH of 7.0 (alkalinity 4.4 mg/L as CaCO₃). Under ice water quality remained consistent during discharge and highlights the possibility for extending treatment programs when circumstances warrant it.

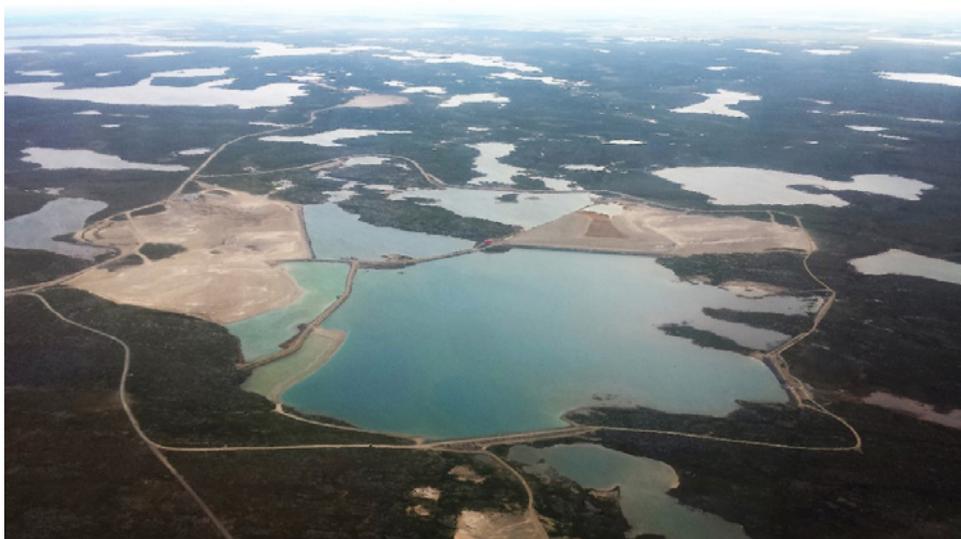
Figure 2 Lupin Mine Pond 2 of the Tailings Impoundment Area

The tailings impoundment is comprised of solids retention cells (Cells 1, 2, 3 and 5) and three liquid polishing ponds (Cell 4, Pond 1 and Pond 2) (Figure 1). All precipitation and runoff falling within the facility ultimately reports to Pond 2 (the Pond) (Figure 2). The Pond is contained by geomembrane lined perimeter dams, Dam 1A and Dam 2. The design allows for the aggradation of permafrost into the dam's core. In order to maintain conservative operating freeboard levels at the perimeter dams, water needs to be treated and discharged every two to four years. The frequency, depends on cumulative runoff and precipitation as well as the amount discharged during the last treatment campaign.

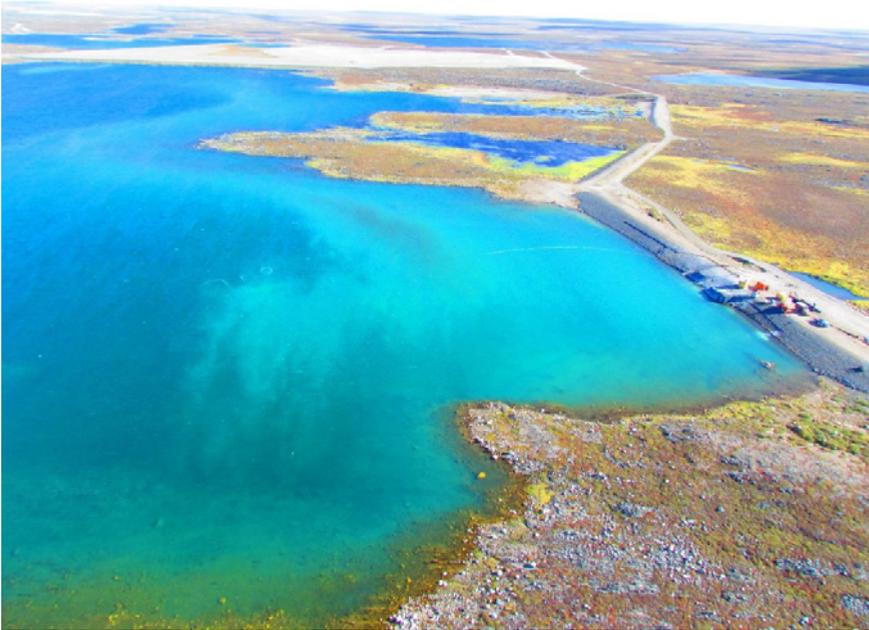
Figure 3 The Bay area in Pond 2 during the 2012 Treatment Campaign

In total 1,067,000 m^3 of treated water were discharged from Pond 2 in 2012. Five points within the lake were monitored for pH, temperature and conductivity during the treatment program: Site 1 through Site 5 as depicted in Figure 1 (Site 1 is water sampling and monitoring station Site-102). The treatment plant was located on Dam 1A (compliance sample point LUP-10 is downgradient of the siphons on this dam [Figure 1]). The 2012 program was designed to focus on treating water within a Bay area spanning from the sample point LUP-17 out to Site 2 in Figure 1 (Figure 3).
