# Monitoring of waste rock dump surface water drainage and channel infiltration

A series of low-cost, high-resolution game cameras (flow-imagery) and resistance sensors (inundation sensors) were installed in unlined drainage channels at a reclaimed waste rock dump (WRD) to determine the distribution, duration and estimated infiltration of surface water into the channel areas. Estimated drainage channel infiltration from the flow-imagery and inundation sensor data was 3.6 percent of the estimated WRD seepage collection volume during the same monitoring time period. The flow-imagery and inundation sensor monitoring results provided a clear indication that most of the water entering the WRD seepage collection pond is from a source other than drainage channel infiltration.

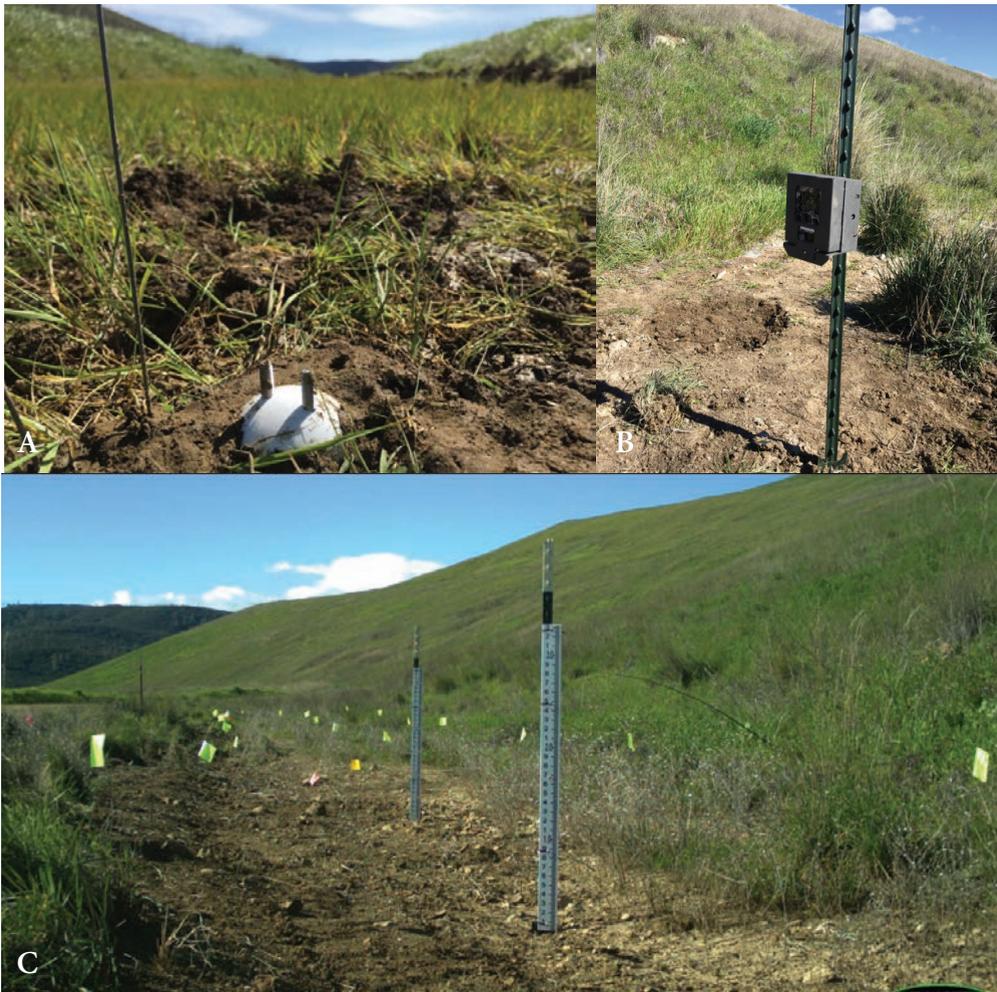
*Figure 1 A) Inundation sensor, B) camera installed on t-post for flow-imagery monitoring, C) sample flow-imagery image, including flagging.*

Game cameras (Reconyx Hyperfire, WI, USA) were fastened to t-posts and programmed to take a photograph every fifteen minutes (Figure 1). Two staff gages were in-

stalled at each location; one at 4.6 m and a second at 9.1 m from the camera. Reflective tape was placed across the gages at 15 cm intervals to provide added visibility for images taken at night. Pin flags were placed at 1.5 m intervals laterally from each staff gage, perpendicular to the field of view and towards the channel edges to allow for visual estimation of lateral water extent during inundation events.

Resistance sensors (GSA, AZ, USA) were installed at the low point in the drainage channels and connected to an EM50 datalogger (Decagon, WA, USA). These sensors function by measuring the resistance between two stainless steel probes exposed above the soil surface (Figure 1). Dataloggers were pro-

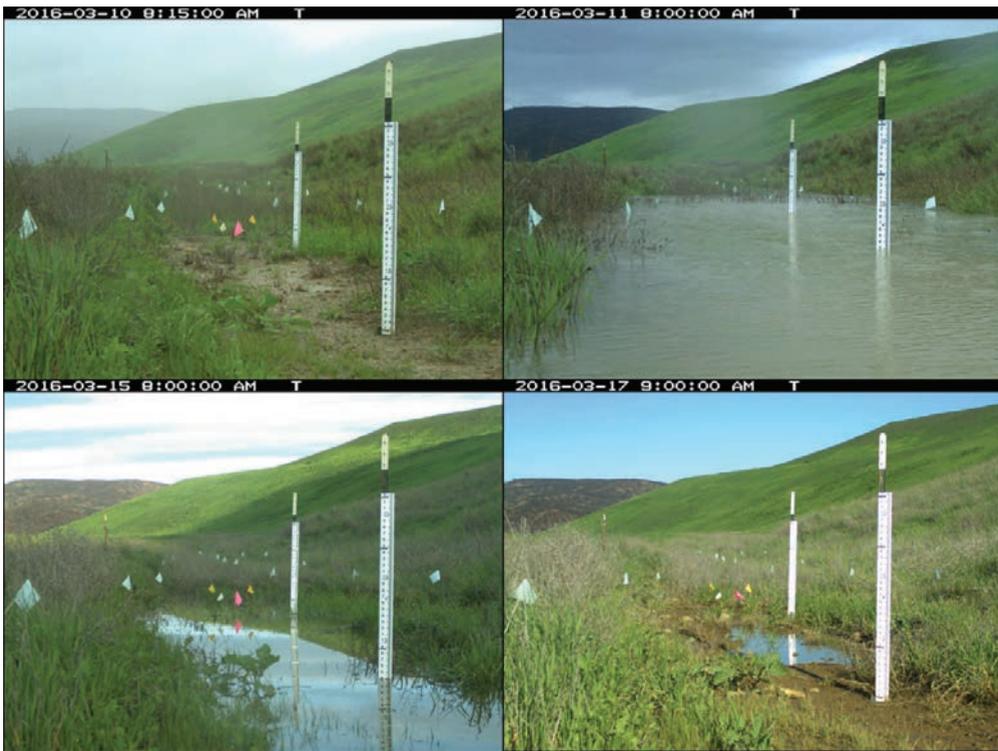
Figure 3 Inundation event from March 10, 2016 08:00 to March 17, 2016 09:00

Figure 3 presents an example of a flow-image during an inundation event at the S1 monitoring location and the change in water depth from the start to the end of inundation. Over the monitoring period, observed inundation water levels were generally below 15 cm, with the highest water level observed being 41 cm.
