Monitoring of a public water supply system: A case of groundwater contamination by acid rock drainage[©]

The present study shows hydrochemistry of shallow groundwater from two wells planned to supply public fountains in the north of Portugal. One of the wells suffers higher impact by acid rock drainage due to mineral-water interaction in a host lithology richer in sulfides. Dissolution of sulfate efflorescences, infiltration and recharge, structural faults, and high porosity of the terrain control the evolution trends of water chemistry. The study concludes by noting the strong contamination, including by toxic elements (Al, Mn, Cd), making impossible to use the water for public supply as planned.

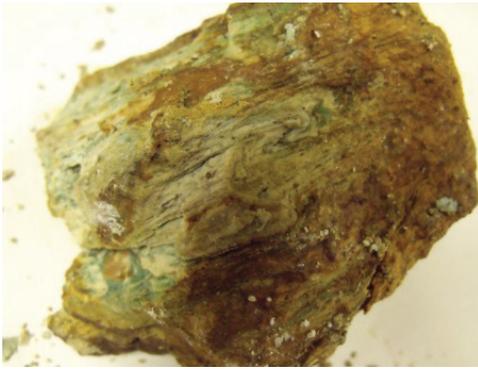
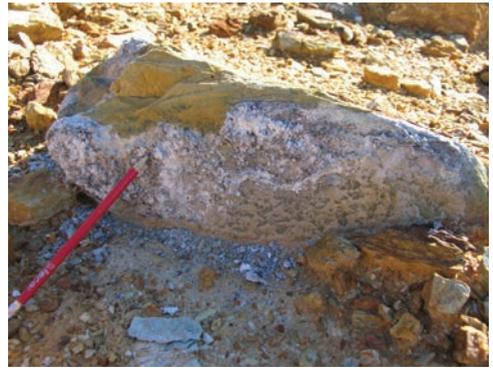
Figure 2 Images of rocks with volcanic affinity that typically have banded dissemination of sulfides (left); often covered by Fe-Al salt efflorescences (right).

From this works also resulted a small waste dump and some preferential channels for surface runoff (Oliveira et al., 2010). Before excavation, ferruginous colours were already observed on the exposed rocks as features of sulfide oxidation. Figure 2 illustrates the rock fragments that compose the waste dump and that are widespread in the area, reflecting the dominant lithologies.

The area shows evident manifestations of ARD, such as secondary minerals covering rock fragments (Figure 2 - right) and the typical ochre colours of the surface drainage (Figure 3 - left). Oliveira (2011) identified the salt efflorescences that cover rock fragments, revealing the dominance of Fe and Al-Mg-Ca sulfates.

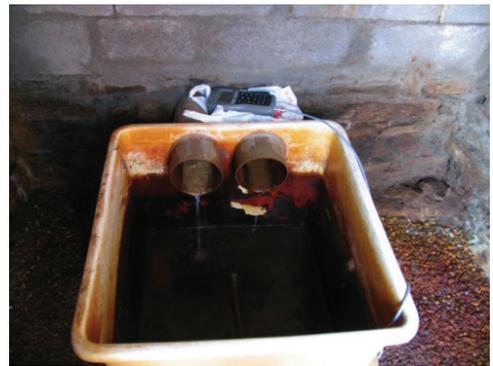
Figure 3 – Image of the ochre products in the study area. Crustification of surface drainage channels (left); Deposition of fluffy precipitates in the pipes, associated with the long term passage of the water (right).
