# Assessment of the Prospective Water Inflow Hazards Using Georadar: Case Study of Upper Kama Potash Deposit

Oleg Kovin

Perm State University, Geological Faculty, Department of Geophysics, Bukirev, 15, 614990, Perm, Russia, onk2004@netscape.net

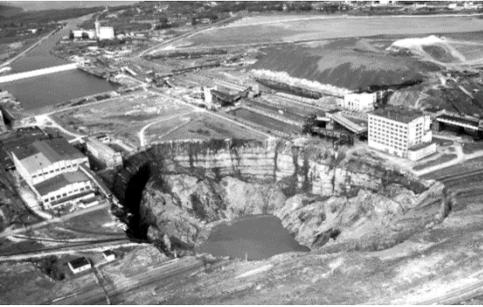
**Figure 2** Large collapse structure occurred at Berezniki mine #1 in 2007 after the water influx initiated in 2006. The size of structure achieved 446 to 335 m in 2009. Sinkhole cut the railroad Perm - Berezniki that is seen in the front of sinkhole (Berezniki 2009).

The problem of ground water influx is principal for the potash mines because salt is very soluble material. Dissolution of the water protective salt beds leads to flooding the mines, losses of reserves, catastrophic surface subsidence, collapse features, and consequent contamination of ground water, and damage of the buildings or different infrastructure objects (Figure 2).

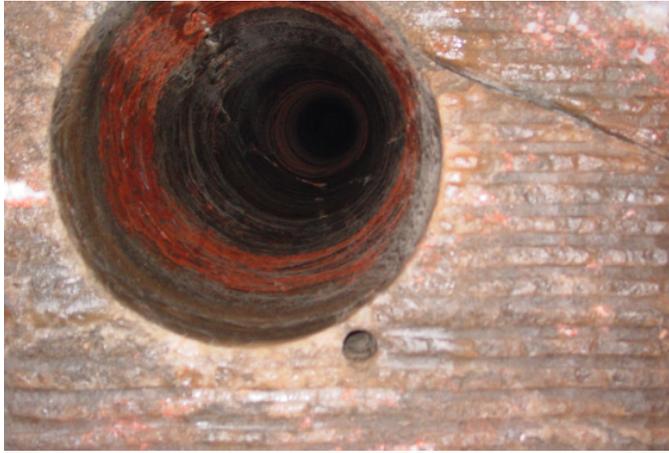
Figure 4 Exploration borehole intersects a fracture exposed in the roof at the sylvinitic mining level, Solikamsk mine #3.2004).

The largest set of open fractures discovered in the Upper Kama potash deposit was eventually exposed at the eastern edge of mining field of the Solikamsk mine #3 at the sylvinitic beds level (Figure 3). Upward exploration boreholes and visual observation of the roof showed that the fractures die out within overlying carnallite layer or interlayer clay seams (Figure 4).
