Effects of Coal Mining on the Lower Zambezi Basin, Tete Province, Mozambique

Keywords: Coal Mining, Mine Drainage, Mine Water, Tete Moatize-Mozambique, Zambezi Basin

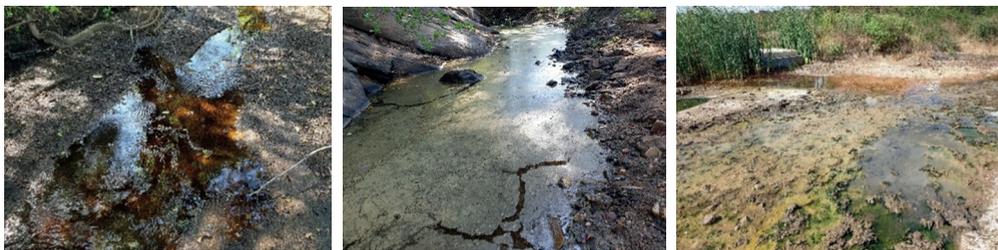
Figure 1 From left: sampling point 1, 2 and 3 in Mbirimbe River.

At the first sampling point, left figure 1, the water was brown-red. This could indicate a high content of manganese, iron or aluminium which can give this colour. Degradation of organic matter may also change colour of the water but should not have changed over two years since the mine got operational.

The oily floating layer at sampling point 2, middle photo figure 1, assumingly come from washing the machineries at the mine site with inadequate or no wastewater treatment. An oil-separator could be used to minimize this kind of effluent together with more sufficient waste management.

At sampling point number 3, where the mines wastewater is discharged to the river, the musty smell implied bad water quality as

well as the shifting colours and turbidity. It was obvious that the wastewater affected both the water and the biological activity as the type of algae, right picture figure 1, was only found on this spot and in the leakage water.

to dilute the mine discharge. The mine wastewater needs better treatment and storage for flow equalization.

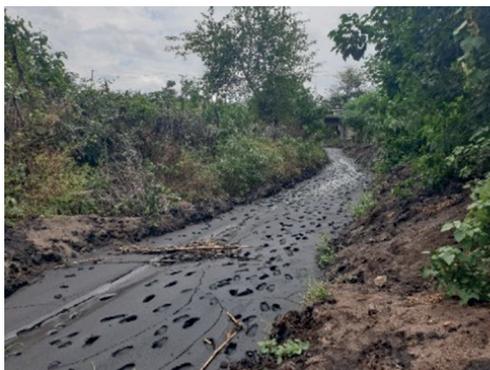
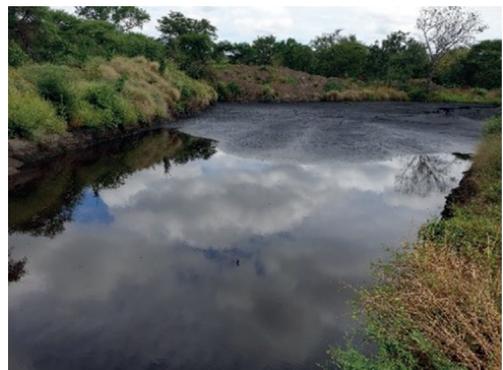
Figure 4 Left Nhanstanga River, right Mine B discharge point.

Nhanstanga River lies in Marara district, north east of Tete City. The river first merge into Chirodzi River, then Sanangua River which flows to the Zambezi River. Mine B discharge wastewater to this tributary and Nhanstanga River has been strongly influenced by the coal mine. What used to be a river that provided whole communities with good drinking water just a couple of years ago is now a black river of tailing from the coal mine. This is not sustainable and directly affects hundreds of people. The depth of coal was about 0.4 m where the river passes the community, left figure 3, about a kilometre from where the mine discharge. Due to low permeability in the coal and recent rain, the surface water found

in the river was assumed to be rainwater. At the discharge point, right figure 3, tailing was going straight into the river and will later end up in the Zambezi river.
