Water Inflows at Phalen Colliery in the Sydney Coalfield and their Relation to Interaction of Workings

By P. Cain¹, D.J. Forrester¹ and R. Cooper²

ABSTRACT

5th International Mine Water Congress, Nottingham (U.K.), September 1994

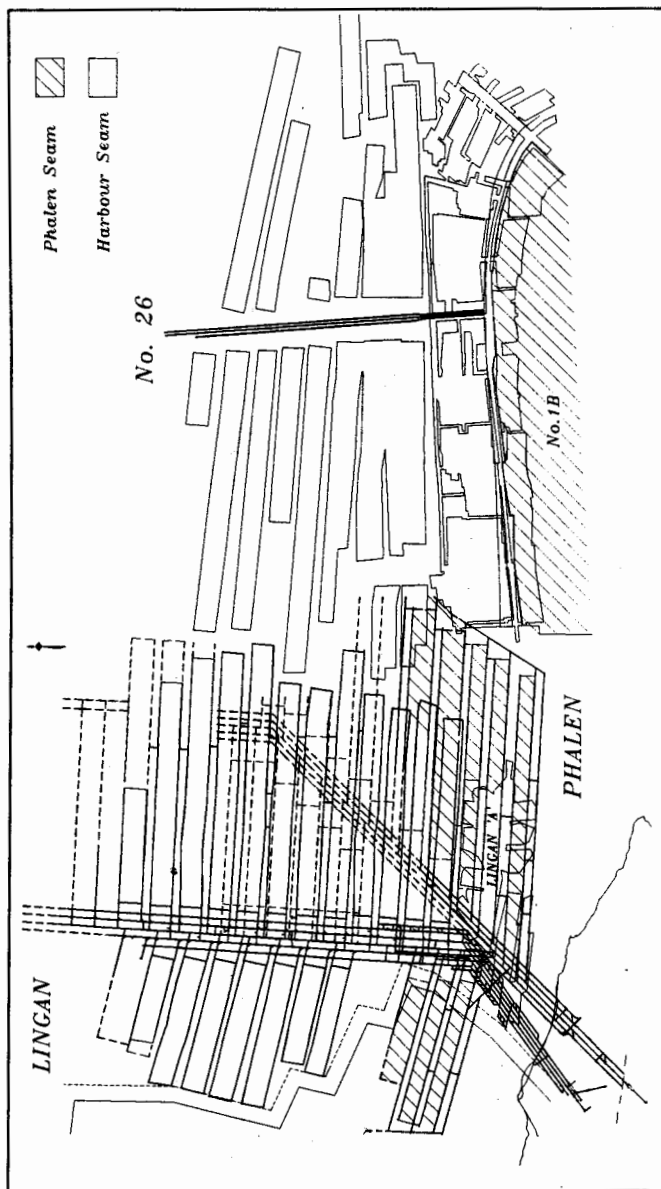
Figure 2: Mine Plans of Lingan, No. 26 and Phalen Collieries

In the Harbour Seam, the area immediately to the east of Lingan Colliery, includes the interconnected No. 26 Colliery and No. 1B Phalen Seam Colliery complex. Access was through a 200 m vertical shaft to No. 1B workings on the coastline at Glace Bay, which, in turn, gave access to the No. 26 Harbour Seam workings by a cross measures drift far offshore under the ocean. The old colliery workings are still interconnected and thus water collecting in abandoned workings of the Phalen Seam can flow freely into No. 1B and then down into No. 26. Figure 2 shows a plan of the Lingan/No. 26 and Phalen/No. 1B workings. Old flooded workings in the Phalen Seam flank the Phalen Colliery workings to the east (No. 1B Colliery) and west (No. 15 Colliery).
