Geochemical Evaluation of Mine Water Quality in an Open-pit Site Remediated by Backfilling and Sealing

Abstract A geochemical evaluation of the mine water quality at a remediated open-pit mine site, Kimheden, was performed in 2009. Kimheden is a small copper mine situated in Västerbotten, northern Sweden, which was operated in the 1970s by Boliden AB. It was subsequently backfilled with waste rock and sealed with clayey till in 1996. Surface water and groundwater samples were taken on site in summer 2009 and on a regular basis in the main watercourse of the mine by the mining company since 1983. The results show that the metal concentrations decreased and pH increased after remediation, indicating a favourable evolution of the water quality.

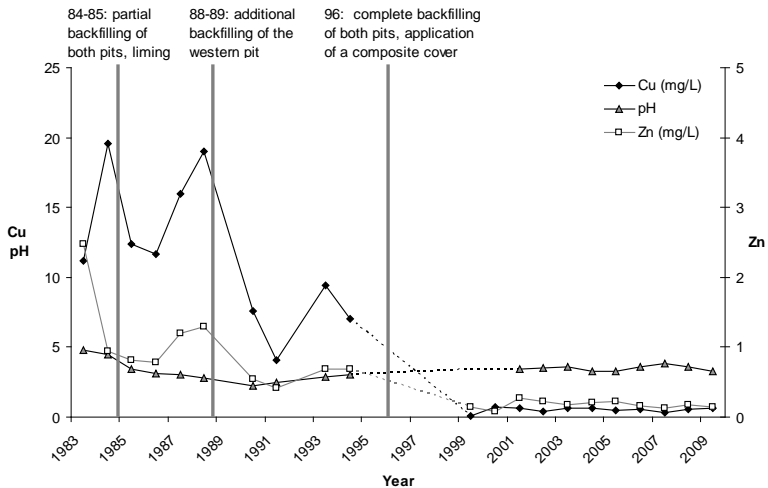
Figure 3 Copper and zinc concentrations and pH at sampling location SD between 1983 and 2009 (data from the mining company)

Mine water geochemical data before the first stage of the remedial activities (1982) are lacking. Nevertheless, the mining company started sampling in the watercourse in 1983 and has performed regular Cu, Zn and pH measurements since then. The purpose is to assess the evolution of the main parameters in the water quality as a result of the remediation attempts, and to discriminate which factors are the most influential for a successful rehabilitation. The most regular measurements were taken at SD downstream of the mine site and are shown in Fig. 3.

Both Cu and Zn exhibit a substantial decrease since 1983. The decrease occurred progressively over the rehabilitation process, but only after the last remediation stage the concentrations got stable. The evolution of pH does not reveal a distinct trend, but the values after rehabilitation are also stabilised and they are slightly higher than before the last remediation stage.
