## **Control of Seepage from Uranium Mill Tailings Ponds in the Elliot Lake Area**

by J. B. Davis, Principal,  
Golder Associates,  
R. A. Knapp, Manager, Industrial Treatment,  
James F. MacLaren Limited,  
and K. W. Sinclair, Senior Civil Engineer,  
Rio Algom Limited,  
Toronto, Ontario, Canada

### ABSTRACT

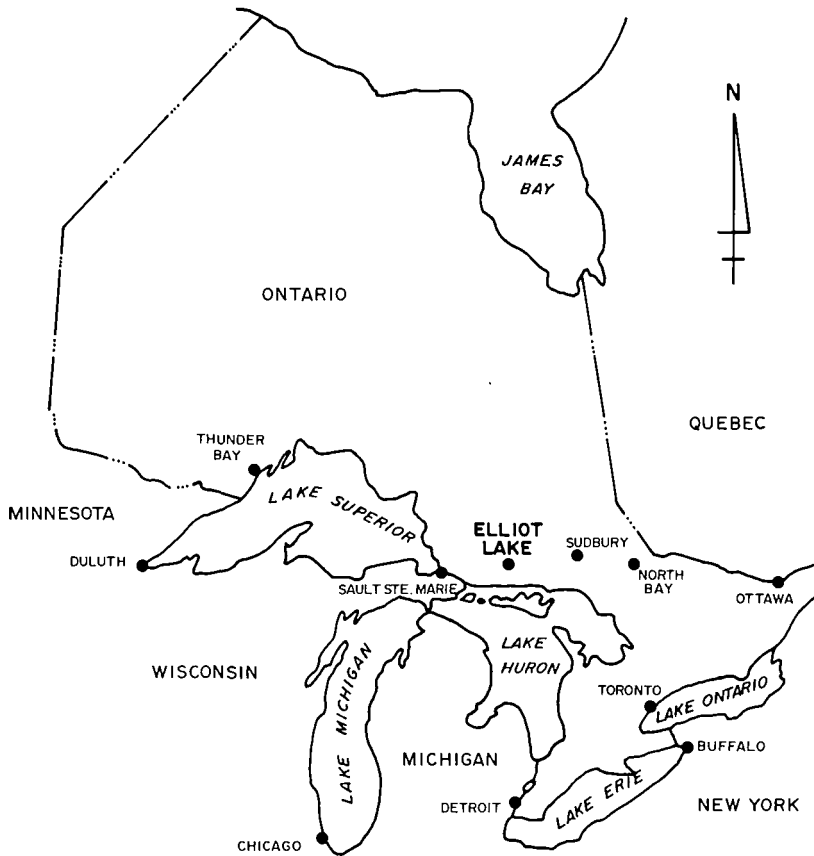
Figure 1 - Site Location Plan

The Elliot Lake mining area is located in north-central Ontario at about longitude 82 degrees 36 minutes west, latitude 46 degrees 24 minutes north (see Figure 1). The topography is fairly characteristic of the Canadian Shield and may be described as rugged but of relatively low relief; elevation differences being generally in the order of 100 to 200 feet or less. Topographic highs consist typically
