Remediation of an Uranium Mining Waste Rock Dump in Slovenia

Thomas METSCHIES¹, Ivan GANTAR², Peter DOLENC², Michael PAUL¹

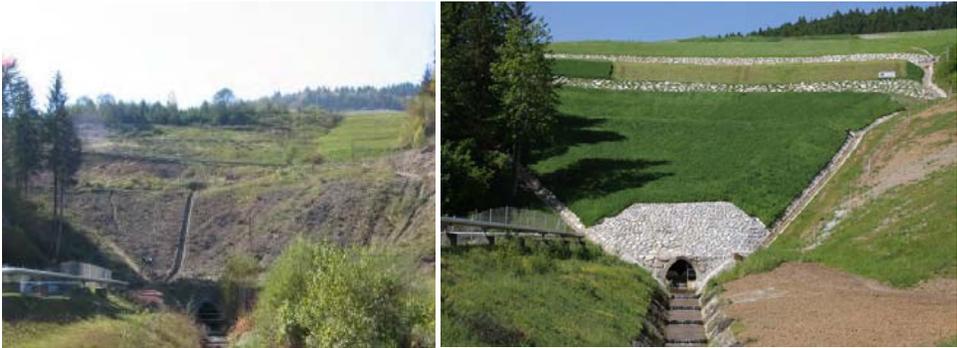
The reshaped slope inclination is about 20° (ratio $\approx 1 : 2.8$) with slope lengths between 25 m and a maximum of 40 m. Vehicle accessible berms were constructed to allow future maintenance of the object. Because of the restricted space at the toe area the lower three slopes are partially steeper with an inclinations of up to 34°. These parts are covered with large stones called 'rock lining' to ensure sufficient erosion protection (Fig. 1).

Figure 1 Eastern slope of the mine waste rock dump Jazbec prior to (2005) and during remediation (2008).

Reshaping and covering of the mine waste rock dump was realised between 2006 and 2008. Trial covering conducted prior to full-scale application showed that the planned cover could be realised even on the steeper slopes. This test also allowed a decision on a proper construction technology taking into account the given site conditions. Internal limitations to contouring of the Jazbec dump were posed (1) by the presence of the "red mud" buried in the upper parts and in the mantle zone of the dump and (2) the limited space at the dump toe not allowing a dump contour extension. Cutting into the red mud had to be avoided mainly for radiological reasons. Therefore, any major excavation during contouring was carefully avoided in the final contour design.

The cover was constructed from locally available material. Different functional layers were prepared by selective winning and application of different compaction rates. A 0.4 m thick sealing layer was built using more fine-grained material compacted to greater than 95 % standard proctor density. The layers on top of the sealing layer, with a total thickness of 1.3 m, should protect the sealing layer and offer sufficient water holding capacity to support the vegetation and to reduce direct infiltration. On top of the cover a 0.25 m thick vegetation layer was placed to offer optimum conditions for the development of the vegetation.
