HYDRAULIC PLACEMENT OF A DRY COVER SYSTEM - DESIGN AND PERFORMANCE MONITORING OF THE KENNECOTT RIDGEWAY MINE TAILINGS DAM COVER SYSTEM¹

R. Duckett² and M. O’Kane³

Abstract. The Kennecott Ridgeway Mining Company (KRMC) tailings facility was built using run of mine waste and downstream embankment construction techniques. Approximately 60% of the 60 million tons of processed tailings have a negative net neutralization potential. KRMC conducted a cost-benefit analysis supported by a detailed cover system design and determined that a hydraulically placed cover system was the preferred closure option for the tailings facility. The tailings mass (124 ha, or 307 acres) was covered with 2.7 million tons of clay material (saprolite) using hydraulic placement from both centre-point and ring discharge points following cessation of operations in November 1999. Approximately 90% of the tailings surface area is now covered with greater than 90 cm (36 inches) of cover material.

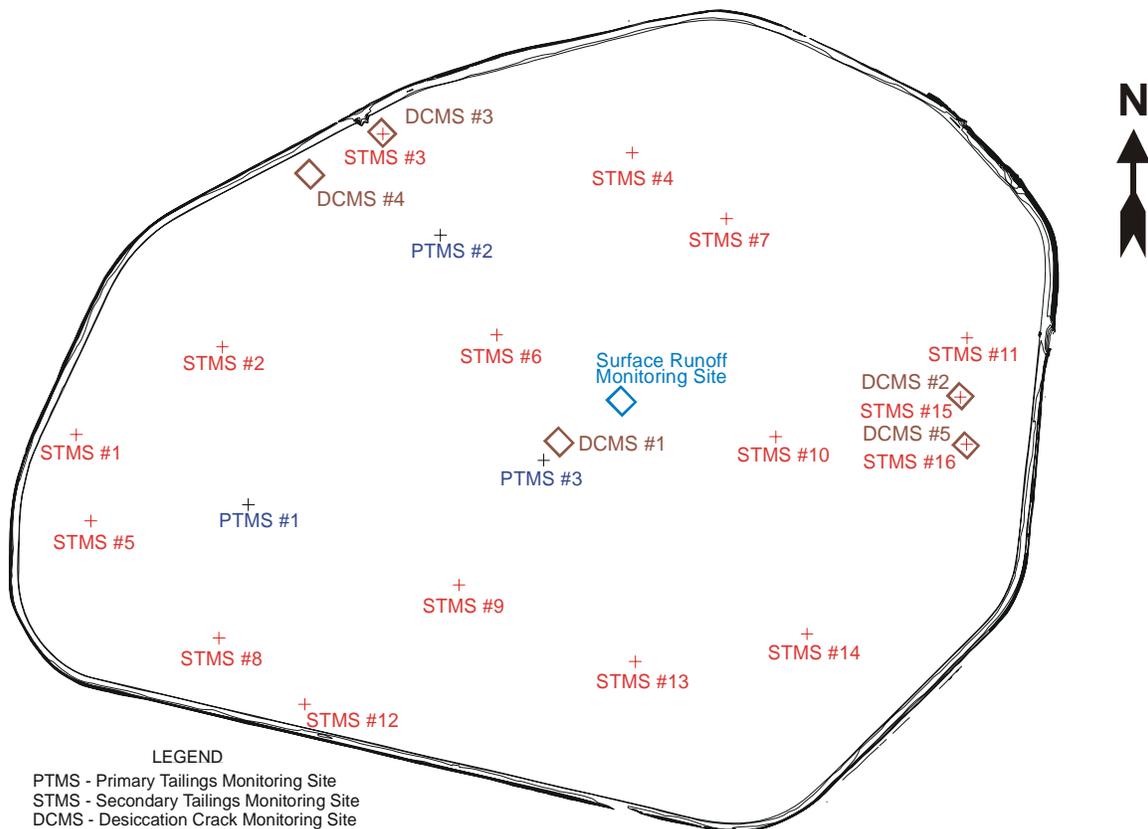
Figure 1. Schematic showing location of the tailings dam cover system performance monitoring system.

KRMC installed three primary tailings monitoring sites (PTMS) in September 2001, each including profiles of suction / temperature sensors, volumetric water content sensors, and gas sampling ports. Sixteen secondary tailings monitoring sites (STMS) were also established in September 2001, each consisting of a PVC access tube for insertion of a portable moisture sensing probe. An automated data acquisition system was installed at each PTMS to monitor the sensors. A tipping bucket rain gauge was also installed at each PTMS. The gas sampling ports at each PTMS are used to measure *in situ* gaseous O₂ and carbon dioxide concentrations, using a portable analyzer, within and below the cover material. The portable moisture-sensing probe used at each STMS and PTMS is connected to a portable datalogger that stores the moisture data. Figure 1 shows the STMS and PTMS locations for the tailings dam cover performance monitoring system.

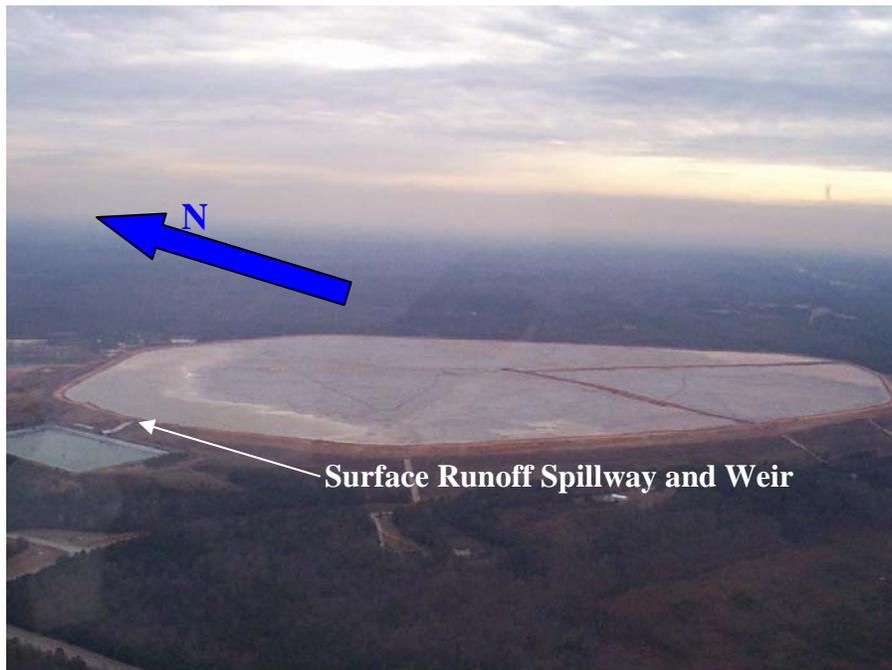
Figure 2. Aerial photograph of the tailings dam (note surface runoff spillway / monitoring location).

Surface runoff for the entire tailings facility is monitored using a broad crested weir (location noted in Fig. 2). Initially, water level depths were measured manually using a staff gauge. An automated depth level monitoring system was installed in April 2005. In addition, a Bowen Ratio (BR) system was installed adjacent to PTMS #3 in April 2005 to measure actual evapotranspiration from the cover system.

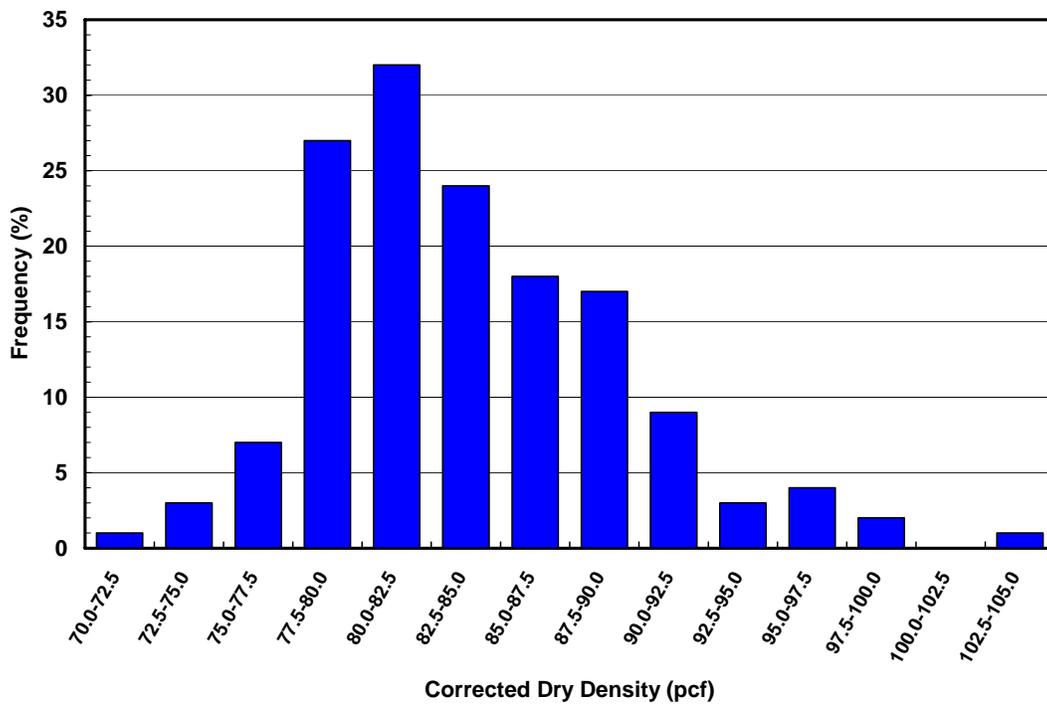
Figure 3. Frequency distribution of corrected *in situ* density conditions for the near surface cover material.

A nuclear densometer was used to assess variations of the *in situ* density and moisture conditions of the cover surface, as well as during development of the trenches used to install the monitoring sensors. One-hundred and forty-nine nuclear densometer measurements were taken across four grid lines to determine density and moisture variations across the cover system. Figure 3 shows the frequency distribution over a range of densities, while the trend between moisture content and dry density is shown in Fig. 4. Note that all dry density values shown in Fig. 3, 4, and 5 are corrected, based on gravimetric moisture content measurements of grab samples obtained immediately following the *in situ* density measurement. Figure 5 is a generated plan view of the spatial dry density distributions measured on the surface of the cover system.

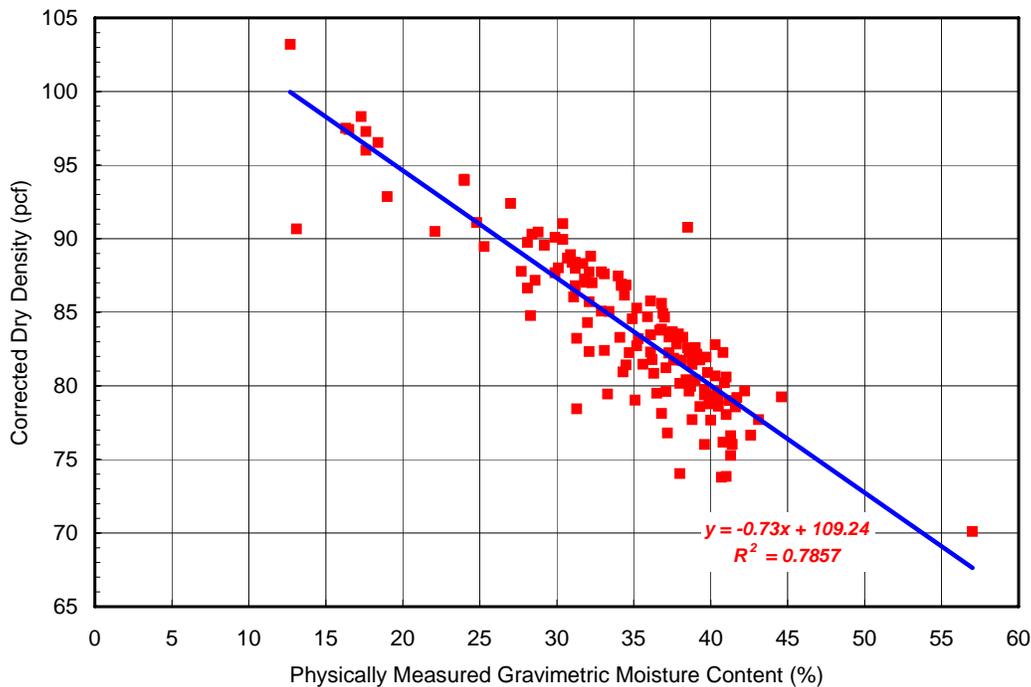
Figure 4. Relationship between corrected dry density and physically measured gravimetric moisture content for the near surface tailings dam cover material.

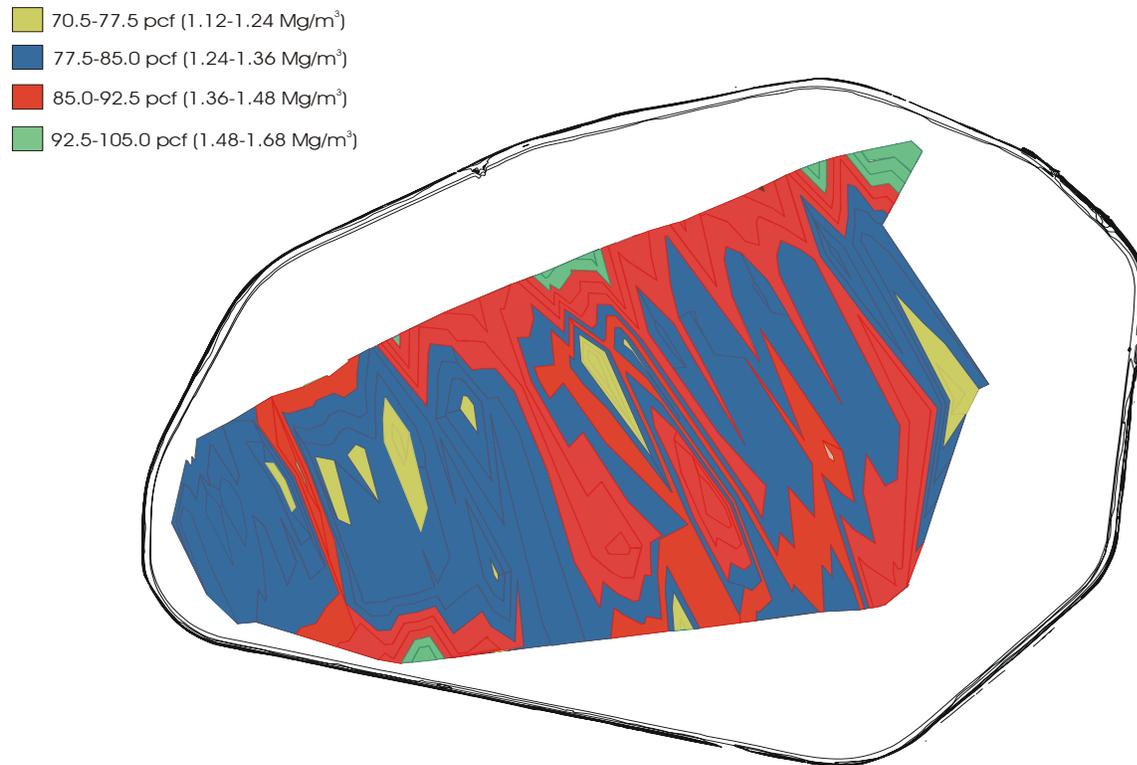
Figure 5. Tailings dam cover system plan view of the spatial distribution of corrected *in situ* density conditions for the near surface cover material.

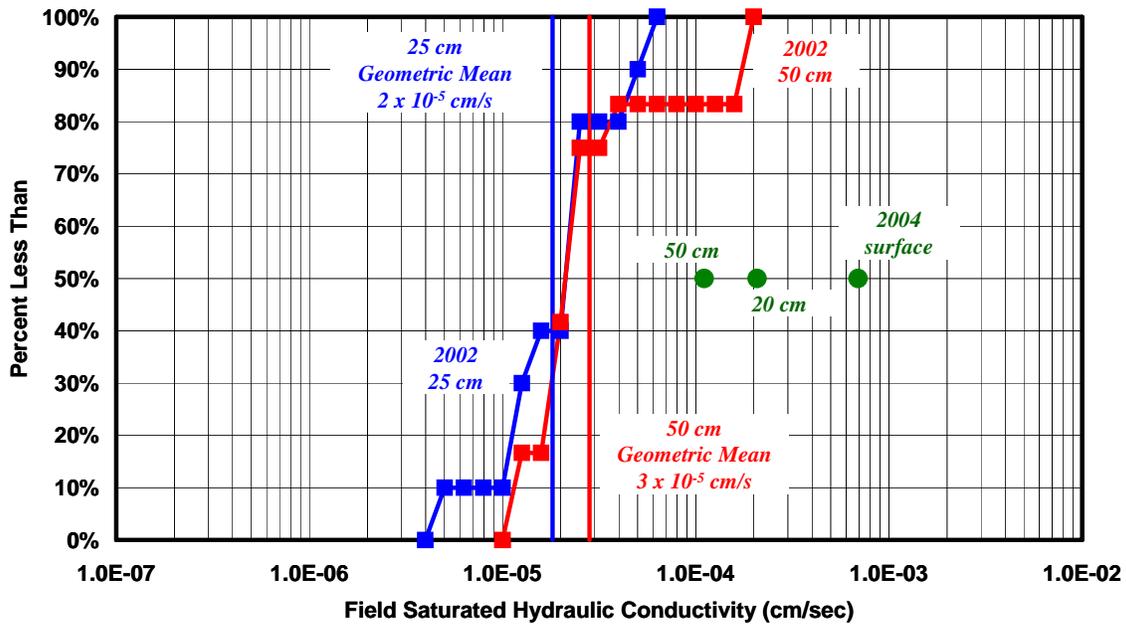
Figure 6. Field saturated hydraulic conductivity measurements at PTMS #2.

Figure 6 shows K_{fs} values measured in 2002 and 2004 at PTMS #2. Of note, is that in 2002 field saturated hydraulic conductivity of the cover material was one, to one-and-one-half orders of magnitude higher than that measured in the laboratory. This is attributed to soil structure that had developed in the field, which cannot be replicated in the laboratory, particularly for non-compacted conditions. Furthermore, while the number of tests conducted in 2004 was not sufficient to determine whether the measured increase in K_{fs} was significantly higher than in 2002, it would appear that the K_{fs} of the cover material increased by another one to two orders of magnitude. The implication is that it is difficult to envisage that laboratory saturated hydraulic

conductivity testing of non-compacted or “loosely” placed growth medium material would be representative of field conditions.

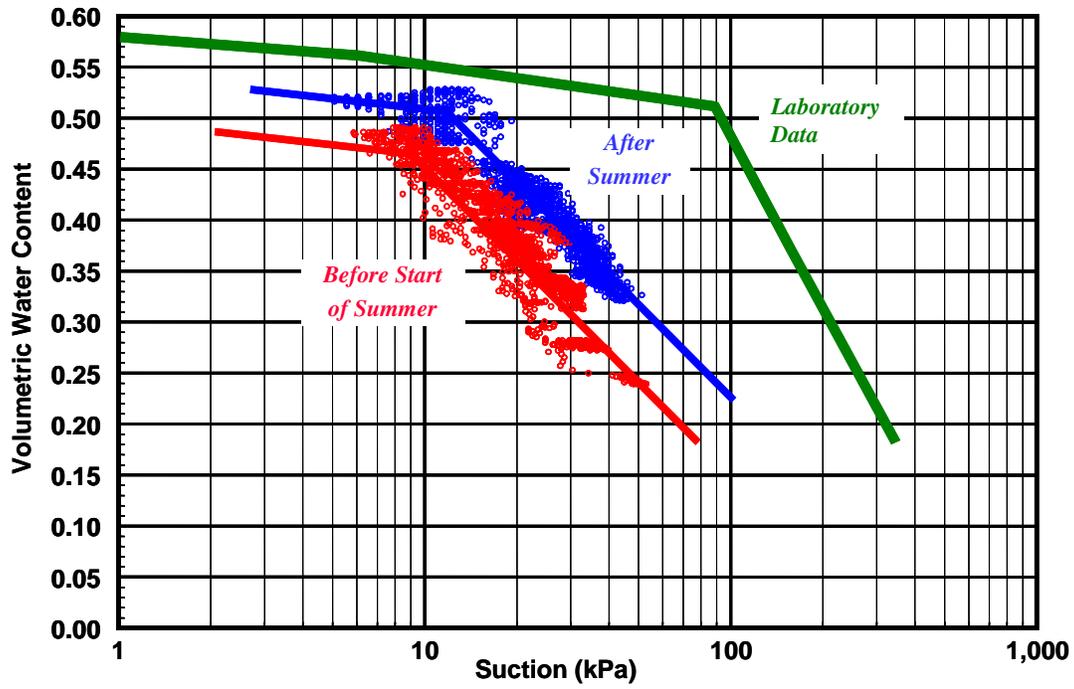
Figure 7. Field and laboratory moisture retention curves at a depth of 20 cm at PTMS #2.

Figure 7 shows *in situ* moisture retention curves for the cover material at a depth of 20 cm (8 inches), as compared to the laboratory measured moisture retention curve. The field moisture retention curves were generated by plotting *in situ* volumetric water content data against *in situ* suction values, each obtained from sensors installed adjacent to one another at a depth of 20 cm (8 inches). The laboratory measurements indicate the cover material has an air entry value nearly an order of magnitude higher than that determined based on field conditions. The difference between field and laboratory conditions is attributed to the development of soil structure, which cannot be replicated in the laboratory on a reconstituted sample, making it difficult to develop laboratory moisture retention curves representative of field conditions for non-compacted, or loosely placed near surface cover material.

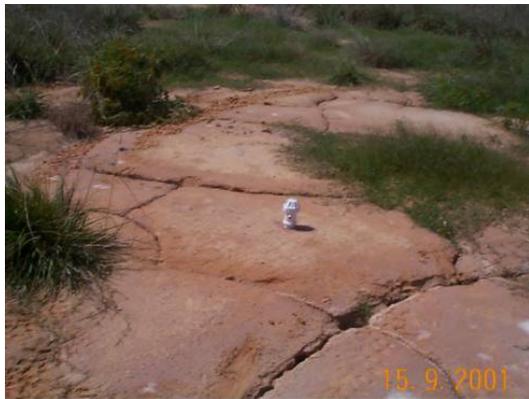
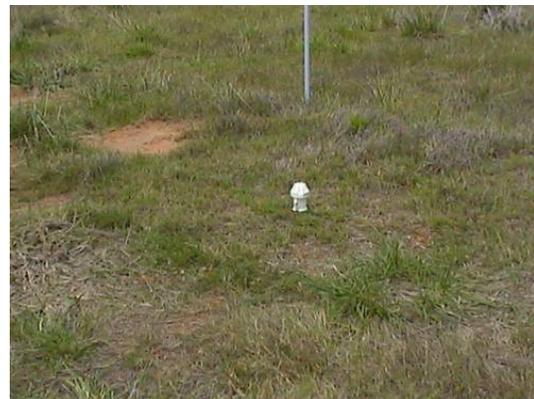
Figure 8. (a) Photograph of STMS #3 area in 2001, and (b) in 2004.

Vegetation of the cover system began with test areas along the second centre point ramp in May 2000. Bermuda grasses, millet, and sercia lespedeza have proven adapt at growing in the sapolite without the use of topsoil placement. Vegetation of the surface has to date been completed using an LGP loader unit for scarifying and broadcast seeding. Desiccation cracks resulting from hydraulic placement of cover material and subsequent drying, as well as during dry climate conditions, are “healing”, for the most part, during rain events and as a result of vegetation growth. Figures 8a and 8b are photographs of the same area (at STMS #3) in 2001 and 2004, respectively. The improvements in conditions as shown in Fig. 8a and 8b are

representative of a large majority of the cover system. However, cover material in areas near the ring dike is slightly coarser textured (i.e. near the outer edges of the cover system), and as such the cracking in these areas, which was a result of placing the material hydraulically and its subsequent drying, has not healed to the same extent as shown in Fig. 8b.

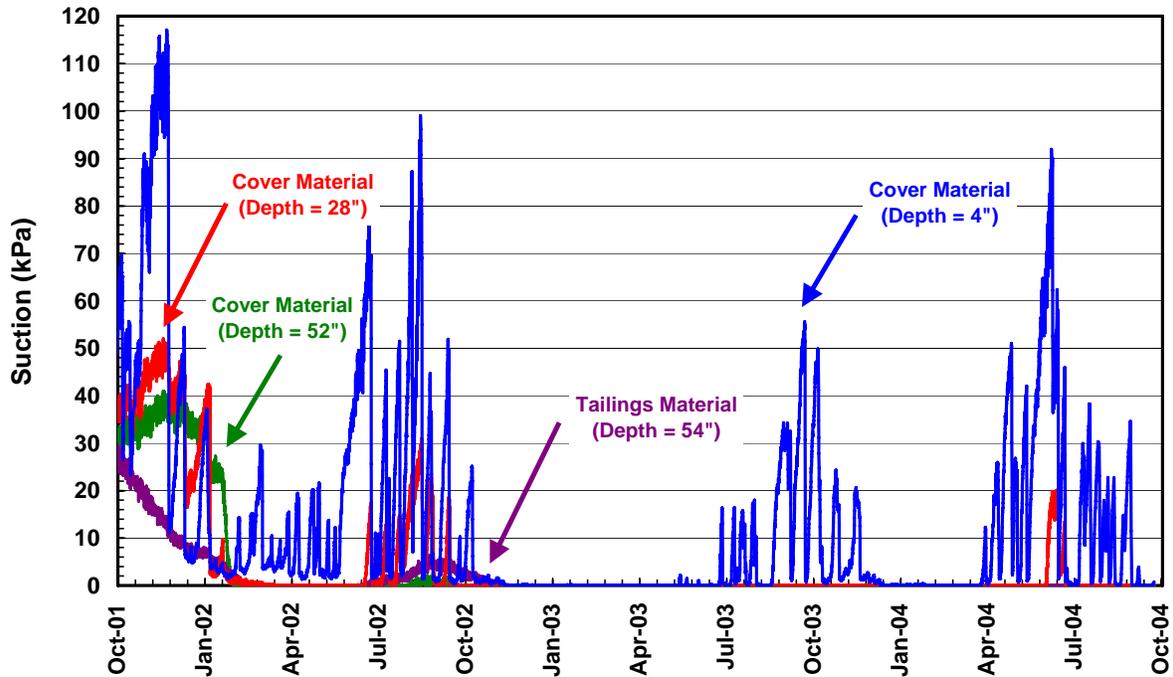
Figure 9. Field matric suction as a function of time for the sensors installed in the cover and tailings material at PTMS #1.

Matric suction as a function of time for three TC sensors installed in the cover material and one TC sensor installed in the tailings material at PTMS #1 is shown in Fig. 9. The TC sensors located at depths of 132 cm (52 inches) (cover material) and 137 cm (54 inches) (tailings material) recorded constant matric suctions of approximately 0 kPa during the monitoring period (October 2002 to September 2004). This indicates that the base of the cover materials and the upper tailings profile are very near, or at, saturated conditions.

The sensor at a depth of 71 cm (28 inches) recorded suctions near 0 kPa for the entire monitoring period, except June 2004 when suctions of around 10 kPa were measured. This indicates a drying front reached a depth of at least 71 cm (28 inches) during the summer of 2004. The TC sensor located at a depth of 10 cm (4 inches) responded to atmospheric forcing during the month of October and November 2003 and then recorded a constant matric suction of approximately 0 kPa until late March 2004. Once again, the sensor at the 10 cm (4 inch) depth is responding to atmospheric forcing indicating that the upper layers of the cover system are beginning to de-saturate. Accuracy of the TC sensors reduces for suction conditions less than 10 kPa because the sensor operates on the principal of heat dissipation and the air entry value of the ceramic sensor is approximately 10 kPa. However, it is clear from the field measurements, that overall, near saturated conditions existed within the cover system and the underlying tailings at this location during the majority of the monitoring period. Although the data is not presented, the automated *in situ* volumetric water content sensors also indicate that near saturated conditions are prevalent. Similar *in situ* moisture conditions were measured at PTMS# 2 and PTMS #3, as was presented in Fig. 9 for PTMS #1. In addition, the STMS monitoring locations consistently record high saturation conditions for the cover and underlying tailings material.

At the suction conditions measured, high saturation conditions exist, which implies that O₂ diffusion to the underlying tailings material is minimized, thereby controlling oxidation of the tailings material.
