Tailing dam management practices - A review of 3 case studies

Abstract

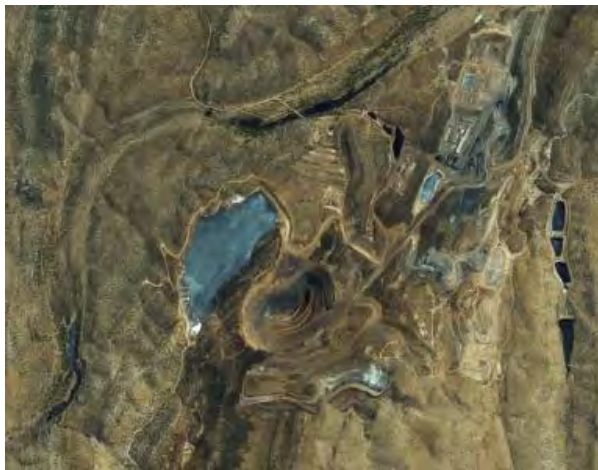
Figure 1 Mine tailings nearing capacity

The 2009 rainfall event affected many mines in northern Queensland especially those unproductive at the time. The flooded mine study 2, is north of Lady Annie mine. The mine pit was flooded, the evaporation ponds and dams were full and they were 3,381 megalitres above the reporting level. The mine Owners and DERM were concerned how to lower the stored volume before the following wet season.

There was no simple 'quick fix' for the tailings dam and mine pit water. Their discharge licence only allowed them to release when the receiving creek was flowing, which was during the rainy season and the licence was capped to 500 ML per year.

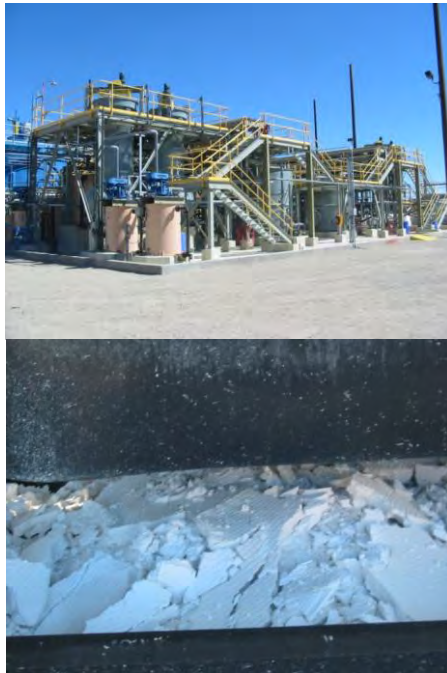
Figure 2 IX treatment option for removing high sulfates and the Gypsum bi-product (BioteQ's Sulf-IX™ process plant)

Ion exchange (IX) is a two-bed process using lime and sulphuric acid as the regenerants and produced pure gypsum as the waste product. Once the waste stream is dewatered it can sold to the building industry.

IX would regenerate on a 12-hour cycle and provided ~90% efficiency. Possible ion imbalance could affect the receiving ecosystem. CO₂ was added to maintain the alkalinity and pH to near background levels was a requirement. The IX waste stream is dewatered using plate and frame membrane press, eliminating the need for crystallisation. The press centrate is returned to the head of the treatment stream and the pure gypsum can be sold to the building material industry. The dollar per unit water volume treated for the IX process was ~\$0.60 per m³, based
